TECHNICAL INFORMATION

KV6 Variable Intake Manifold System (VIS) Motor Diagnostic Aid

No: 19/01/06/NAS
FGN 310-00
Ref: 19/03/03/NAS
TA02TB01, TA021901, TA031901
Issue: 1
Date: 26 June 2006

VIS MOTOR DTC, MANIFOLD RATTLE NOISE AND ENGINE PERFORMANCE DIAGNOSIS

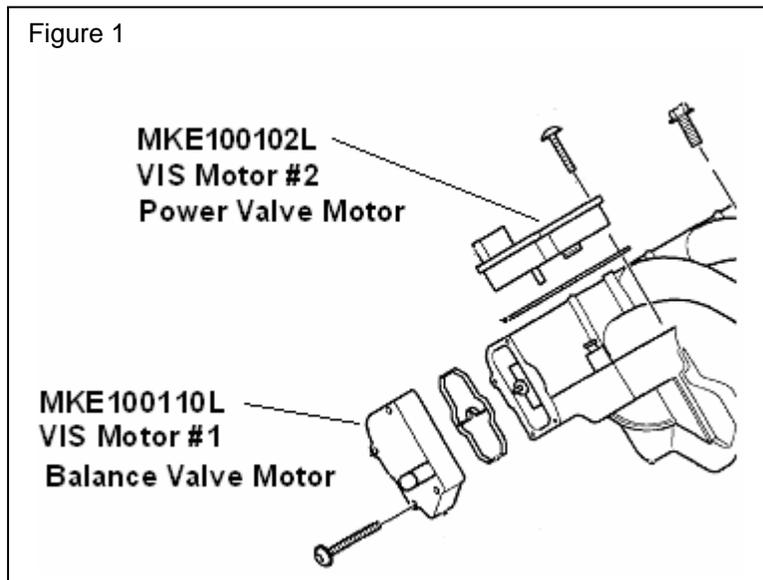
△ **NOTE:** Land Rover service and parts literature, including MicroCat and TestBook/T4, use a range of descriptions for the two Variable Intake Manifold System (VIS) motors installed on the Freelander KV6 engine intake manifold. The part numbers and descriptions listed below and in Figure 1 should be cross-referenced with T4 and Table 1 for correct DTC diagnosis.

- MKE100110L....."Balance Valve Motor" (VIS Motor #1) Qty 1 (if required)
- MKE100102L....."Power/Butterfly Valve Motor" (VIS Motor #2) Qty 1 (if required)
- LKB000120.....Upper intake manifold assembly Qty 1 (if required)

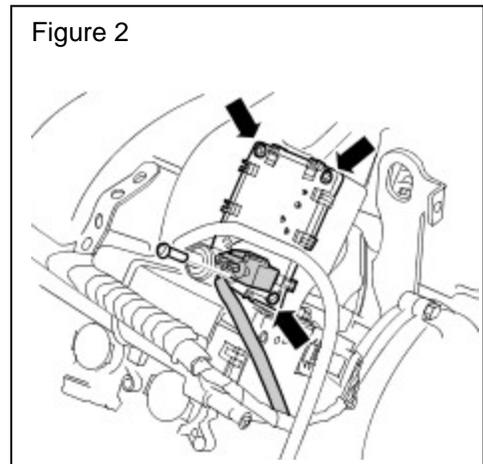
Figure 2

4. Remove the four retaining screws securing VIS motor #2 to the intake manifold assembly. (Figure 2)
5. Carefully remove VIS motor #2 from the intake manifold.

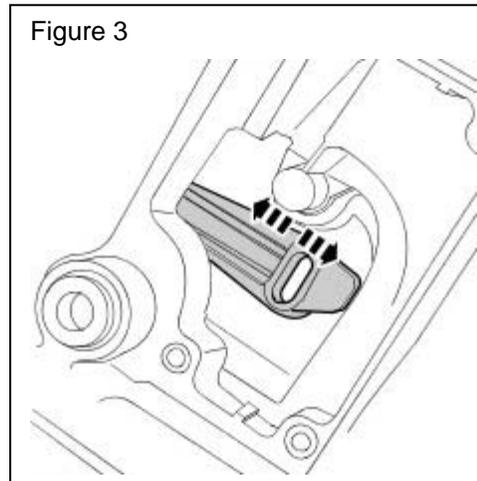
**NOTE:** The VIS "power valve motor" operates a control arm that adjusts the butterfly valve positions. The butterflies are not spring-loaded. (Figure 3)

6. Verify that the VIS intake flap control arm is operating correctly by completing the following checks:
 - Move the control arm through the full range of lateral movement (Arrowed in Figure 3).

**NOTE:** When gently pressed down toward the engine and released, the intake flap control arm is operating correctly if some resistance is felt when depressing and springs back to its original position without any rattles, clicks or loose feeling after releasing.

7. If the checks reveal either of the following conditions, refer to GTR section 30-3 operation 30.15.37 and replace the intake manifold assembly (LKB000120):
 - The lateral operation of the control arm is stiff, notchy, jams or feels loose.
 - After depressing and releasing, the control arm does not spring back to the original position, feels loose, rattles or clicks.
8. If the control arm operates correctly, investigate another cause for an engine noise.
