Failure in Fuel Injector Nozzles Used in Diesel Engines

Abstract: This paper aims to conduct a study of the problems associated with the wear of the needles and fuel injection nozzles utilized in diesel engines. The wear found on the needles is mainly associated to impurities in the fuel oil and microcavitation occurred due to high pressure in the phase of the air compression for combustion of the combustible fluid. These pressures associated with the temperature and the fluid velocity results in the occurrence of vaporization, which releases shock waves that cause damage to the affected surface. The impurities solid particles from the fuel oil cause problems inside the nozzles as obstruction of the holes and wear on the needle tip and nozzle seat surface. These failures affect in the atomization of the fuel, since the deterioration of the internal passages of the nozzles interferes in the spray formation and in the end passage of the fluid. For the execution of this study it will be used digital microscopic analysis in specimens that suffered damage, in order to investigate the effects of fuel property, and the temperature conditions and pressure in the formation of the wear on t

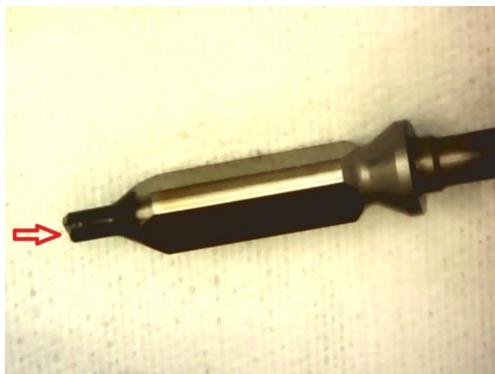
During the analysis, it was found that the needle of the injector nozzle has excessive wear on the tip, resulting in a higher flow at the specified limit (Fig. 1). The fracture by fatigue was caused by contact under high cyclic stress of the needle tip with the internal nozzle region (Fig. 1b) [8]. The initial crack fracture was initiated by the erosive wear.

The Figs. 1a and 1b show the needle nozzle with the presence of failure caused by wear by erosion with solid particles (Fig. 2b—central region) as well as fatigue fracture (Fig. 2b—outer region). Failure by

erosion with solid particles was caused by contaminated fuel [7].

Fig. 1 (a) Macroscopic wear of the needle and (b) wear at the needle tip.

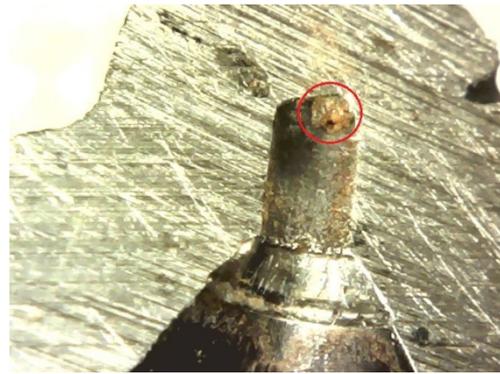
Fig 2a shows the wear by erosion with solid particles located in the fuel inlet port. The cause of this wear was due to contaminated fuel [7].

Fig. 2 Analysis microscopic wear on fuel injector nozzle (a) localized erosion wear by the oil inlet hole and (b) of the inner nozzle region with cavitation pits.

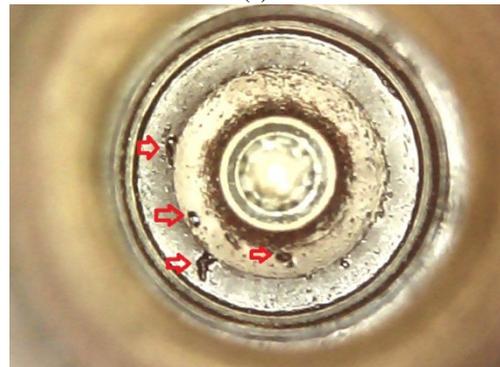
(b)

It was conducted one metallographic cut in the nozzle to examine the inside of the nozzle (Figs. 2a and 2b). Fig. 2b shows the macrography of the internal region of the nozzle where occurs the limit of the needle, the arrow shows the abrasive wear under high cyclic stress caused by contact of this area with the needle tip. It is also observed a hard, dark layer that is organic deposits caused by fuel impurities [7].

According to Fig. 2b, there was the occurrence of wear by cavitation in the inner region near the nozzle head. Cavitation occurred due to the reduction of pressure in the fuel flowing in the inner region of the nozzle. The reduction of pressure in the liquid fuel caused nucleation and growth of air bubbles that collapsed (exploded). The energy released by these

explosions promoted the impact of liquid fuel against the inner regions of the nozzle. The shock due to the impact caused the plastic deformation and material removal, resulting in failure formed as deep and rounded microcrateras called pits, as indicated by arrows in Fig. 2b.
