# TECHNICAL INFORMATION

## Water Ingress to Headliner

No: 76/04/04/NAS

Discovery Series II (TL)

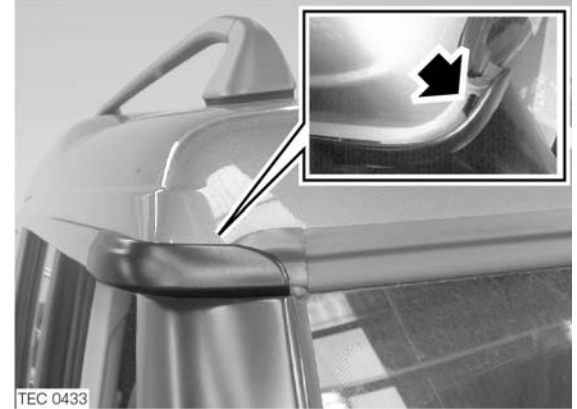
Figure 1

1. Carefully lift the clip securing the drip rail corner trim to the drip rail. (Arrowed in Figure 1)
2. Inspect the drip rail seam joint for a gap or void.

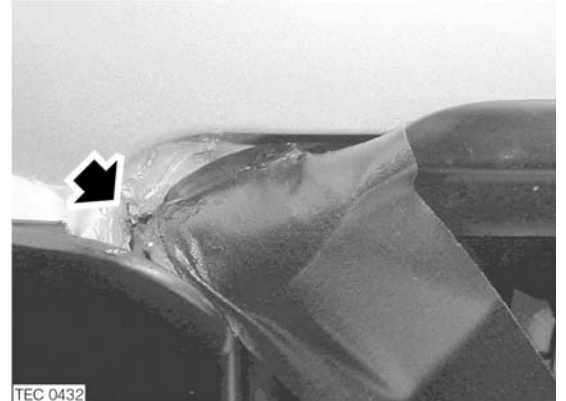
Figure 4

1. Carefully pull back the corner of the windscreen upper seal and use tape to secure the trim moulding to the windshield glass. (Figure 3).
2. Inspect for pin-holes or cracks around the 'A' post-to-roof joint, and the drip rail sealed joints (Arrowed in Figure 4).
3. Refer to RAVE/GTR section 76.64.15.21 and carefully remove interior A-post trim and sun visor assembly.
4. Spray soap water into the affected area outside and test the corner of the windscreen upper seal with low-pressure air nozzle directing the air stream through the sun visor and/or the A-post mounting hole.
5. If no pin-holes, cracks, or air bubbles are found, remove tape securing the windshield upper moulding to the windshield and push the trim moulding back into position.
