## Technical Bulletin # 1021

**Transmission:** *JA5A-EL, JF506E (Jatco 5 spd)*

**Subject:** *2-3 flare, slips in 3rd, 4th & 5th or reverse, No 3rd, 4th, 5th or reverse*

**Application:** *Mazda, VW, Land Rover, Jaguar*

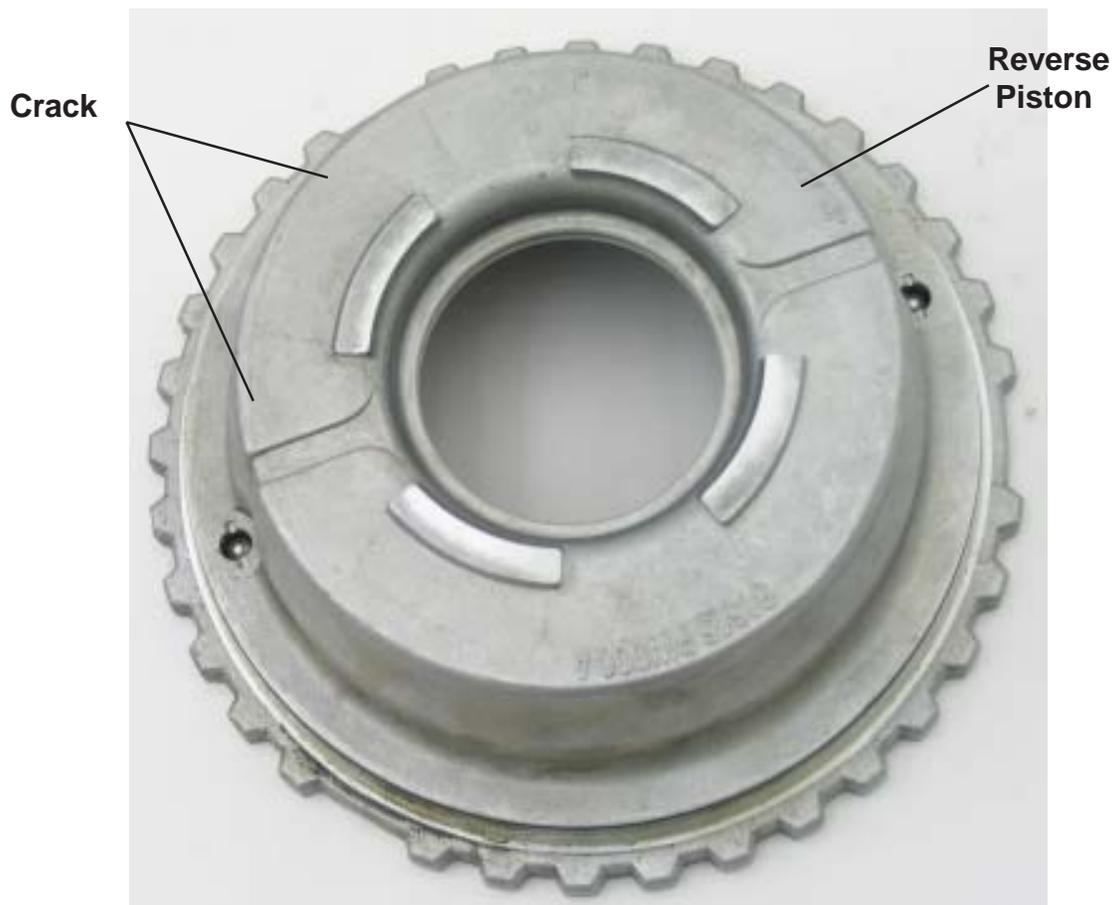
One or more of the above symptoms can be caused by a cracked Reverse piston. The piston has been updated to strengthen the piston in the area where it cracks. Mazda part # FP03-19-480.

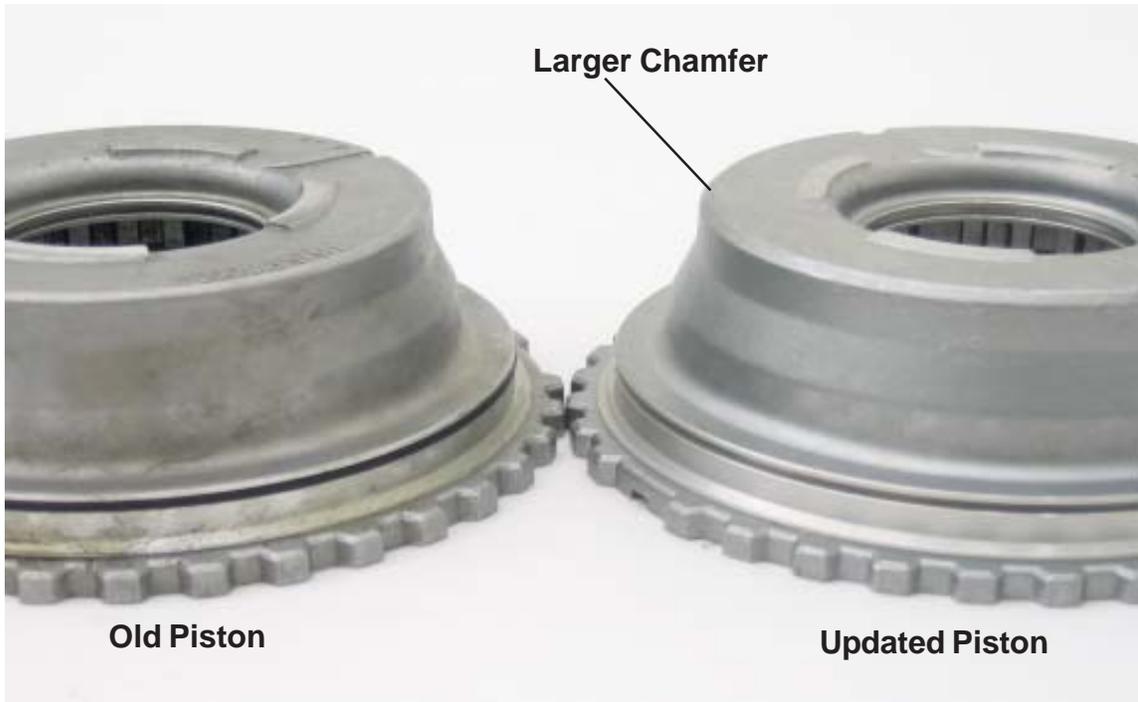
The updated Reverse Piston is thicker and can be identified by a larger chamfer.

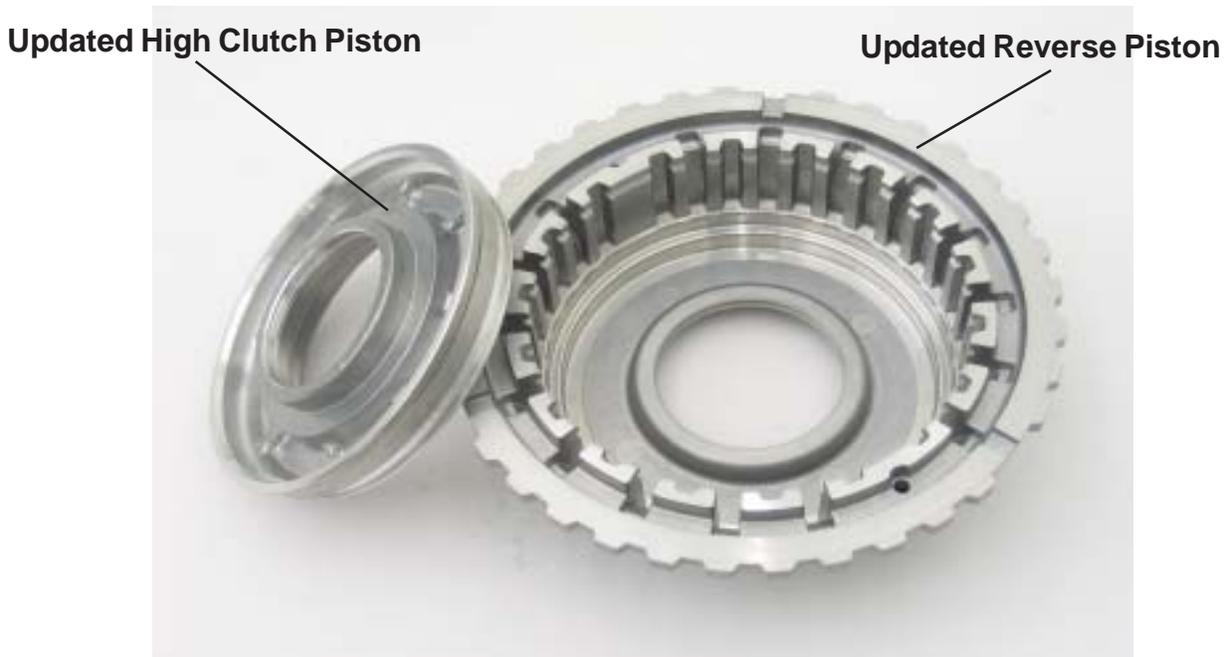
Because the updated Reverse Piston is thicker, the High Clutch piston has also been updated and comes with the updated Reverse Piston.
