SERVICE MGR.	<input checked="" type="checkbox"/>	SUBJECT 'E' Post Trim Area - Water Ingress		issue 2		
RECEPTION	<input checked="" type="checkbox"/>

WORKSHOP	<input checked="" type="checkbox"/>					
PARTS	<input checked="" type="checkbox"/>					
MODEL		AFFECTED VEHICLES				
Discovery		LP				
		LH				
		LJ	081991 onward			
		LD				
<p>DETAIL</p> <p>Investigations have shown that on some vehicles water can enter into the vehicle around the 'E' post, there can be several causes for water ingress in this area, all known water ingress paths and fixes are detailed on the flow chart attached.</p>						
<p>ACTION REQUIRED</p> <p>Upon customer complaint of water ingress around the 'E' post, follow the flow chart overleaf.</p>						
<p>PARTS INFORMATION</p> <p>Not applicable</p>		<p>ILLUSTRATION</p>

SUBJECT	
Rear End Door Seal - Water Ingress	
MODEL	AFFECTED VEHICLES
Discovery	LP LH LJ All LD

SUBJECT
Sunroof -Water Ingress

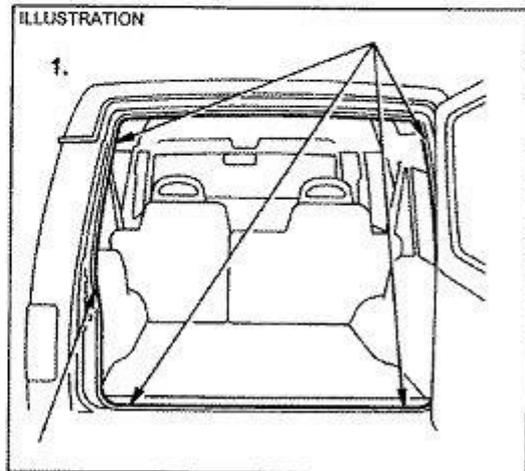
As part of ongoing quality improvements a new double bubble seal has been introduced onto the rear tail door. Early indications have identified a potential water leak from this area due to seals fitting incorrectly on a misformed seal flange. Investigations by Land Rover engineers have found that following procedure overcomes this issue on all vehicles.

1. Remove rear end door tread strip.
2. Remove rear end door seal from failed vehicle.
3. Using a craft knife, cut any excess trim tape that has been wrapped around the rear end door aperture see illustration 3.
4. Dress any flanges that appear to have panel mismatch to obtain a tight finish see illustration 1&2.
5. Smooth in Butyl around the four areas where the panel meets and form a channel to obtain a smooth finish for the foam tape see illustration 1&2.
6. Carefully apply the foam tape around the aperture as close as possible to the edge of the panel. Remove backing paper, smooth out, avoid any creases see illustration 1.

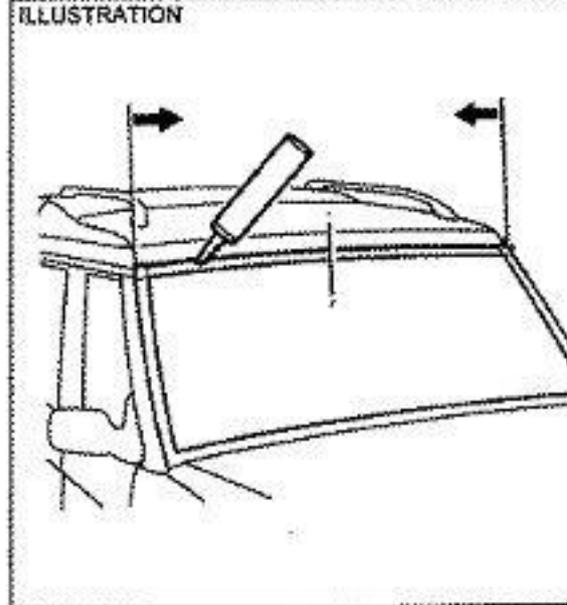
To overcome water ingress through the upper section of the windscreen seal a process has been developed to introduce a supplementary sealing operation behind the seal. Should a vehicle exhibit water ingress this area follow the procedure below.

Peel back the windscreen rubber at the top for access.
Thoroughly clean area to be sealed using cleaner provided.
Locate sealant nozzle between top windscreen rubber and roof panel, extrude bead of sealant (continuous) from the centre of the vehicle towards the corners (see illustration opposite).
Finish sealing in the corner.
Clean off any access sealant from the windscreen/ rubber and paint.

Care point: angle the sealant away from the painted panel.

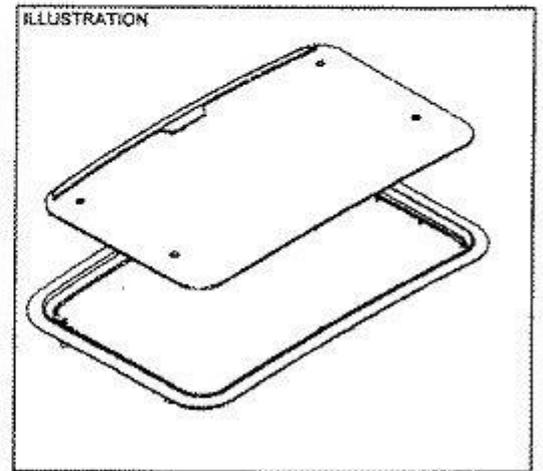
DETAIL
A small number of reports have been received that identify water ingress through both front and rear sunroofs. The reports indicate 2 areas of concern, 1) water drips from the water dam and appears to drip from the sunroof handle / motor and headlining, this may be due to the absence of the water dam gasket. The water dam gasket will be fitted to all sunroofs by the manufacturers from Vin number 148332
2. Water ingress between the sunroof glass and glass seal
Following recent improvements to the sunroof, which increases the glass seal crush to eliminate water going between the sunroof glass and seal, a spacer kit will be required to ensure interchangeability between the modified and pre-modified lower tray and guide tube assembly.
NOTE: This bulletin replaces 76/13/95/EN, the information contained within this bulletin has been amended to replace previous sunroof issues.

PROCEDURE
Process for fix No 1 Gasket missing from the water dam, refer to the workshop manual section 76 sunroof Electric/Manual.
1. Remove front inner sunroof catch cover and check for water ingress.
2. Remove 2 off torque head bit fixings (size TX 20) and remove the sunroof catch body.
3. Using a torch and probe check if the water dam gasket is present (the gasket can be identified by the cross hatching on the surface, or a probe can be inserted inside the catch, if glass contact is made the gasket is missing).
4. If the gasket is missing replace the glass panel with a new assembly see parts information.
5. If the gasket is present re-fit catch, re-tighten catch fixings to 2 Nm.
6. Ensure a 5mm gap exists between the front edge of the sunroof and inside edge of the upper frame.
7. When the new sunroof assembly is fitted, check the sunroof operation and re-test for water ingress.

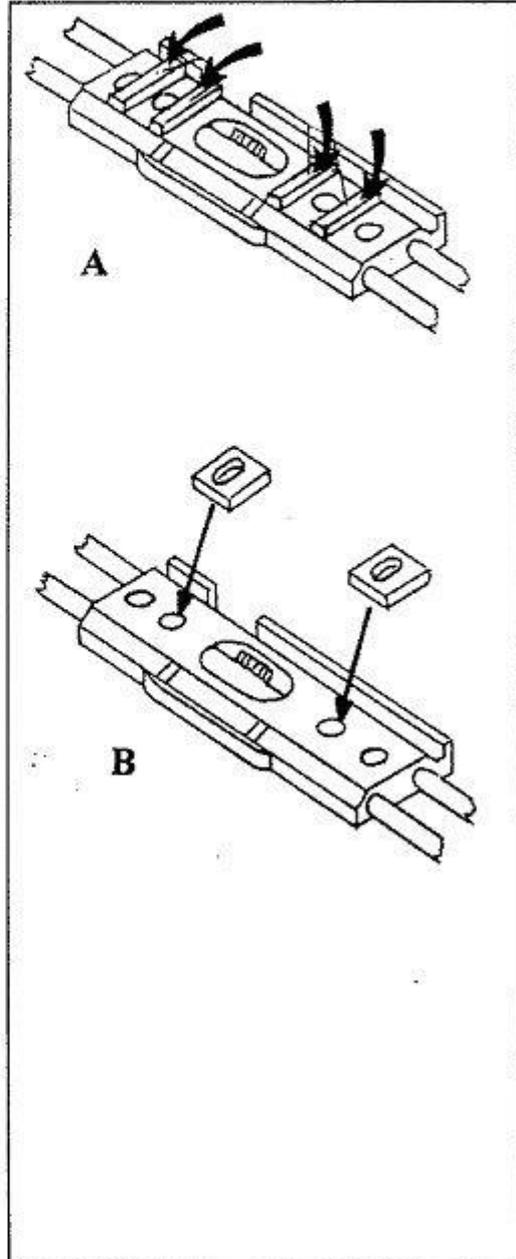
MODIFIED GUIDE TUBE (ILLUSTRATION A)

Underside view between upper frame and guide tube.

GUIDE TUBE UNMODIFIED (ILLUSTRATION B)

When fitting a modified lower tray to an unmodified guide tube x 2 spacers must be fitted to the guide tube.

Gently lift the guide tube assembly off the two locating pegs on the upper frame to gain enough clearance to insert the spacers over the two inboard holes as indicated then reseat the guide tube assembly.

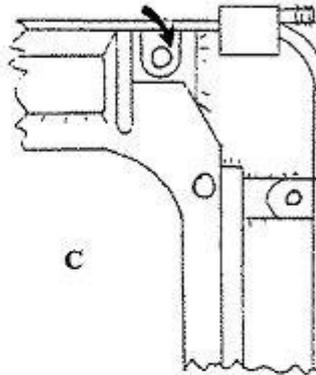
MODIFIED LOWER TRAY ILLUSTRATION 'C'

Underside view look for 'U' shaped impression around corner hole as shown opposite.

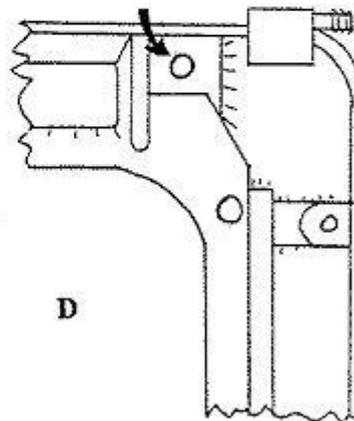
LOWER TRAY UNMODIFIED 'D'

Underside view no impression around hole as shown opposite.

When fitting a modified guide tube assembly to an unmodified lower tray x 4 spacers must be fitted to the inside of the lower tray as indicated opposite.
