Discovery Water Ingress Manual

CIRCULATE TO:-		TECHNICAL INFORMATION		LAND-ROVER
SERVICE MGR.	<input checked="" type="checkbox"/>	SUBJECT 'E' Post Trim Area - Water Ingress		issue 2
RECEPTION	<input checked="" type="checkbox"/>

SUBJECT		
Upper Windscreen Rubber - Water ingress		
MODEL	AFFECTED VEHICLES	
Discovery	LP	
	LH	
	LJ	
	LD

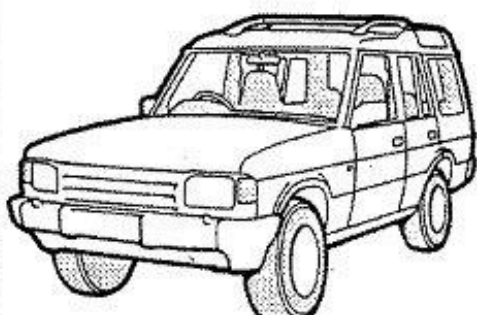
WORKSHOP	<input checked="" type="checkbox"/>			
PARTS	<input checked="" type="checkbox"/>			
MODEL Discovery		AFFECTED VEHICLES LP LH LJ 081991 onward LD		
<p>DETAIL</p> <p>Investigations have shown that on some vehicles water can enter into the vehicle around the 'E' post, there can be several causes for water ingress in this area, all known water ingress paths and fixes are detailed on the flow chart attached.</p> <p>ACTION REQUIRED Upon customer complaint of water ingress around the 'E' post, follow the flow chart overleaf.</p>				
<p>PARTS INFORMATION</p> <p>Not applicable</p>		<p>ILLUSTRATION</p>

Water drips from alpine light
(see illustration, arrow B)

Reseal alpine light glass to rubber and rubber to
body on outside surface

Check fixed glass sealing and reseal as
necessary (see illustration arrow C)

Check for cracks around flange see 'E' on
illustration, reseal each side of flange.
The flange has been moved inside can't
rail to improve water ingress concerns from
Vins 199607 and 530346

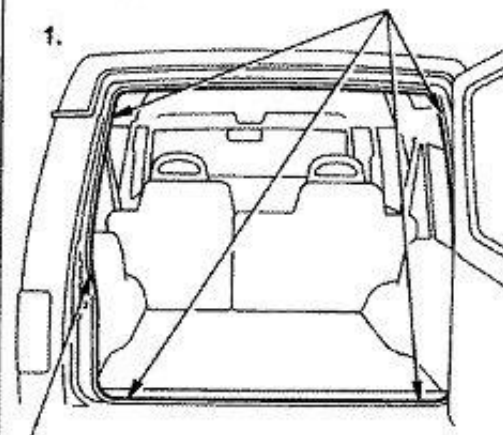
As part of ongoing quality improvements a new double bubble seal has been introduced onto the rear tail door. Early indications have identified a potential water leak from this area due to seals fitting incorrectly on a misformed seal flange. Investigations by Land Rover engineers have found that following procedure overcomes this issue on all vehicles.

1. Remove rear end door tread strip.
2. Remove rear end door seal from failed vehicle.
3. Using a craft knife, cut any excess trim tape that has been wrapped around the rear end door aperture see illustration 3.
4. Dress any flanges that appear to have panel mismatch to obtain a tight finish see illustration 1&2.
5. Smooth in Butyl around the four areas where the panel meets and form a channel to obtain a smooth finish for the foam tape see illustration 1&2.
6. Carefully apply the foam tape around the aperture as close as possible to the edge of the panel. Remove backing paper, smooth out, avoid any creases see illustration 1.

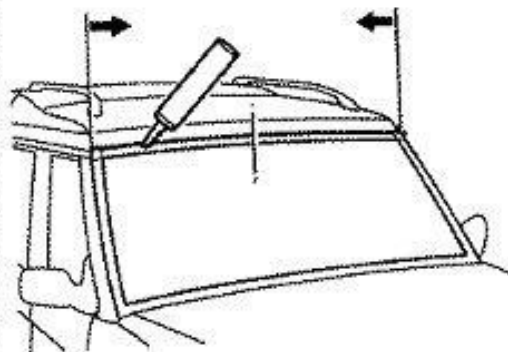
To overcome water ingress through the upper section of the windscreen seal a process has been developed to introduce a supplementary sealing operation behind the seal. Should a vehicle exhibit water ingress from this area follow the procedure below.

Peel back the windscreen rubber at the top for access.
Thoroughly clean area to be sealed using cleaner provided.
Locate sealant nozzle between top windscreen rubber and roof panel, extrude bead of sealant (continuous) from the centre of the vehicle towards the corners (see illustration opposite).
Finish sealing in the corner.
Clean off any excess sealant from the windscreen/ rubber and paint.

Care point: angle the sealant away from the painted panel.

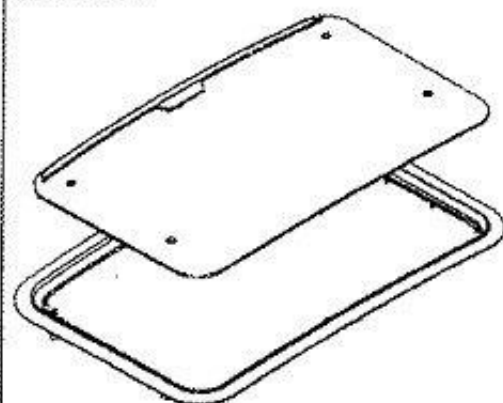
A small number of reports have been received that identify water ingress through both front and rear sunroofs. The reports indicate 2 areas of concern, 1) water drips from the water dam and appears to drip from the sunroof handle / motor and headlining, this may be due to the absence of the water dam gasket. The water dam gasket will be fitted to all sunroofs by the manufacturers from Vin number 148332

2. Water ingress between the sunroof glass and glass seal

Process for fix No 1 Gasket missing from the water dam, refer to the workshop manual section 76 sunroof Electric/Manual.

1. Remove front inner sunroof catch cover and check for water ingress.
2. Remove 2 off torque head bit fixings (size TX 20) and remove the sunroof catch body.
3. Using a torch and probe check if the water dam gasket is present (the gasket can be identified by the cross hatching on the surface, or a probe can be inserted inside the catch, if glass contact is made the gasket is missing).
4. If the gasket is missing replace the glass panel with a new assembly see parts information.
5. If the gasket is present re-fit catch, re-tighten catch fixings to 2 Nm.
6. Ensure a 5mm gap exists between the front edge of the sunroof and inside edge of the upper frame.
7. When the new sunroof assembly is fitted, check the sunroof operation and re-test for water ingress.

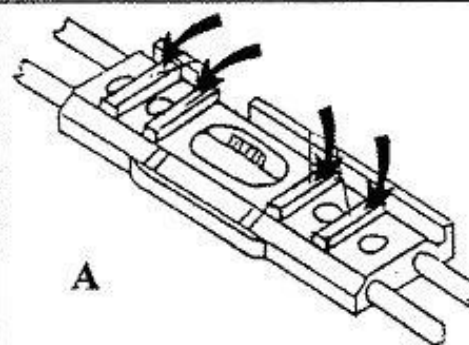
MODIFIED GUIDE TUBE (ILLUSTRATION A)

Underside view between upper frame and guide tube.

When fitting a modified lower tray to an unmodified guide tube x 2 spacers must be fitted to the guide tube.

Gently lift the guide tube assembly off the two locating pegs on the upper frame to gain enough clearance to insert the spacers over the two inboard holes as indicated then reseal the guide tube assembly.

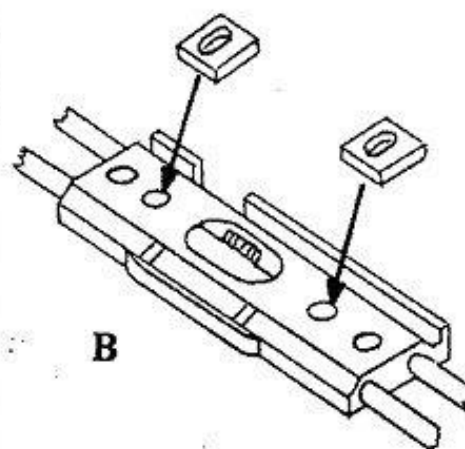
GUIDE TUBE UNMODIFIED (ILLUSTRATION B)

Underside view between upper frame and guide tube.

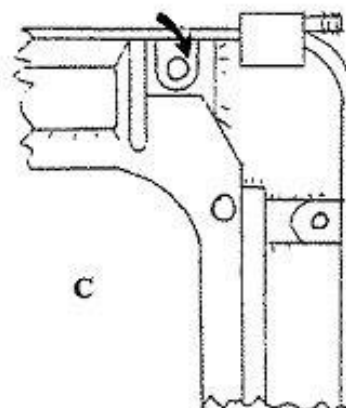
MODIFIED LOWER TRAY ILLUSTRATION 'C'

Underside view look for 'U' shaped impression around corner hole as shown opposite.

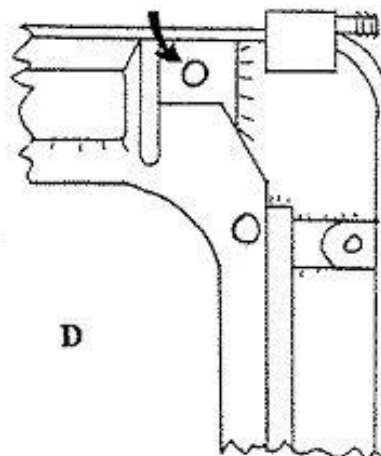
LOWER TRAY UNMODIFIED 'D'

Underside view no impression around hole as shown opposite.

Fit x 4 spacers as indicated opposite to the inside of the lower tray.

When fitting a modified guide tube assembly to an unmodified lower tray x 4 spacers must be fitted to the inside of the lower tray as indicated opposite.
