# A Case of Mistaken Identity, Part 2

## “Impossible?”

By Ed Lee

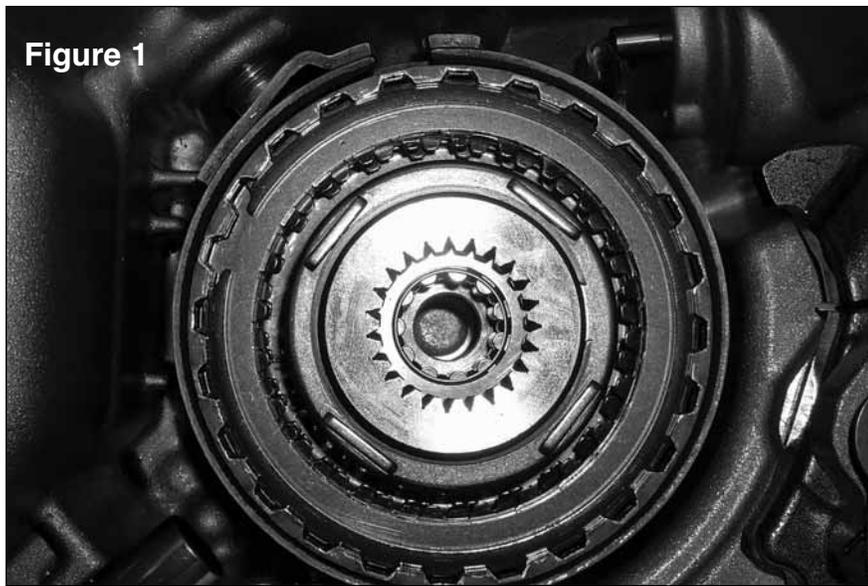
Figure 1

First you need to realize what is involved in the process of returning the band to its anchored position. The band looks like a shrunken-down version of the forward band in a 4T60-E. When the band is in its proper position in the case it looks as it is pictured in Figure 1. The anchor stud fits into the

oval hole on one end of the band and the servo pushes against the other end of the band for band apply. The natural spring tension of the band aids in its release of the drum as the servo releases its pressure on the band.
