GLOVEBOX AREA RATTLE

TECHNICAL SERVICE BULLETIN

Reference Number(s): 76/08/99/NAS,Â Date of Issue:Â May 19, 1999

LAND ROVER: Discovery Series II

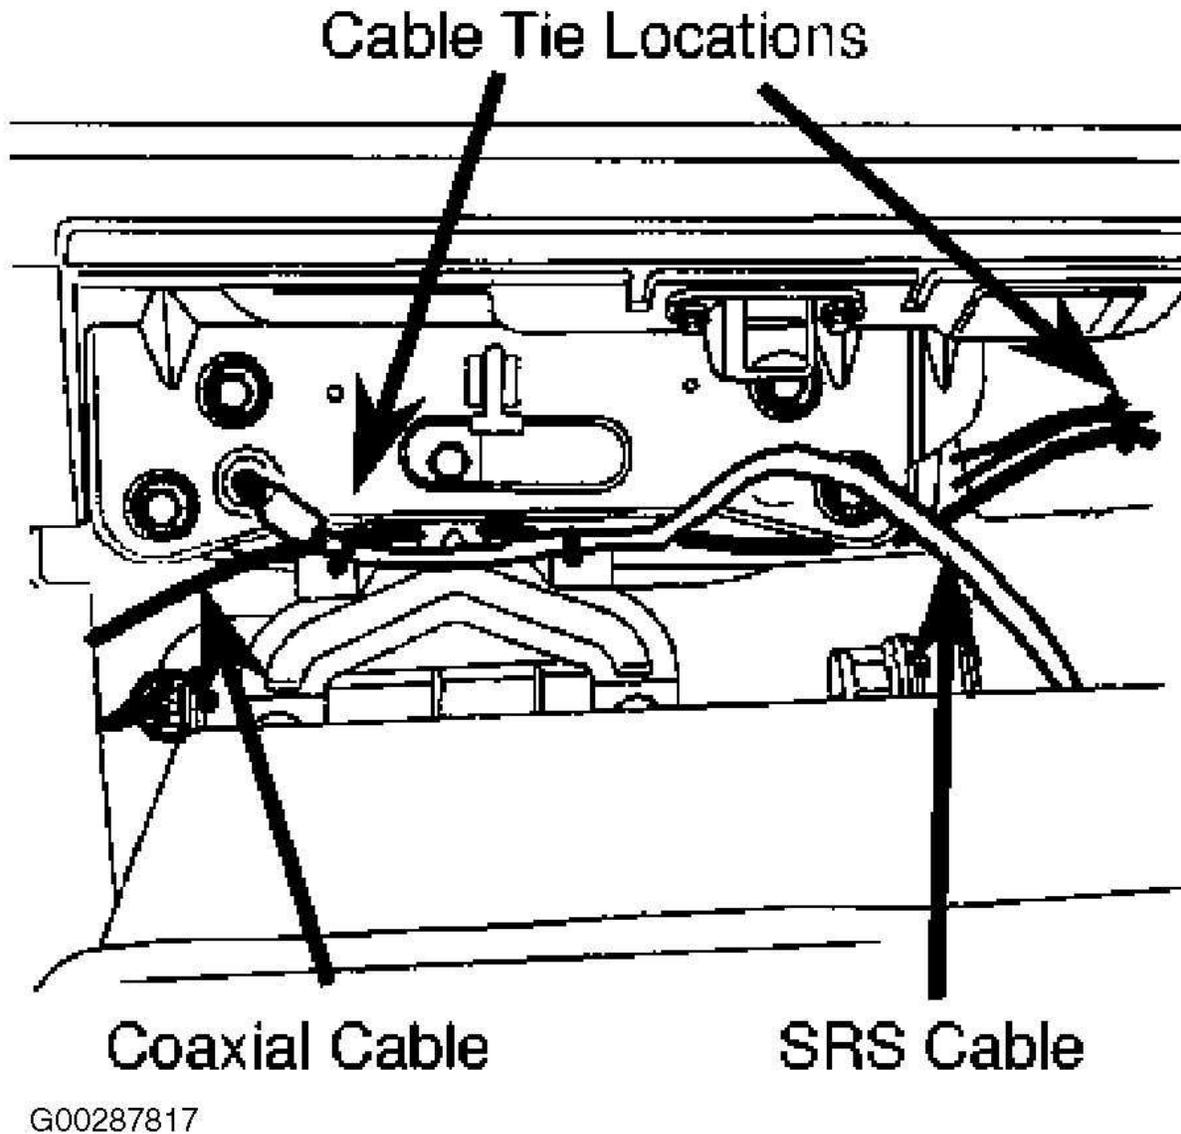
The customer may notice an intermittent rattle from behind the glovebox.

Fig. 1: Cable Tie Locations

4. If inspection reveals that routing and cable tie are not properly made, remove the two bolts securing the blower-mounting bracket.
5. Locate the cable behind the HVAC blower and install the mounting bracket.
6. Secure the SRS wire and coaxial cable to the blower mounting bracket on left side with a cable tie. See [Fig. 1](#).
7. If slack is apparent in cable cluster on right side, secure with a cable tie.
