TECHNICAL BULLETIN

No: LA-501-012

Passenger Compartment Water Ingress

Land Rover LR3 (LA)

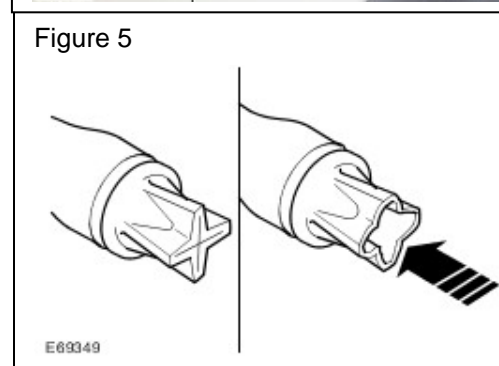
Figure 5

NOTE: If both the routing of the roof opening panel drain tube is correct and the valve of the roof opening panel drain tube cannot be faulted, the foam insulation pad may be the cause. The foam sound-deadening pad may have been installed in such a way as to block the roof opening panel drain tube.

4. If the tube is not protruding through the hole in the body perform the following steps to correctly position the roof opening panel drain tube:
 - Refer to GTR Workshop Manual Section 76.13.27 and remove the cowl side trim panel to gain access to the roof opening panel drain tube.
 - Connect and secure the drain tube through the hole
 - Verify the valve of the roof opening panel drain tube can be fully opened. (Figure 5)
 - If the valve can not be opened, cut as required to permit full opening. (Figure 5)
 - Install cowl side trim panel

5. Remove and then install the foam sound-deadening pad, taking care to ensure that the roof opening panel drain tube valve locates in the indent in the foam insulation pad to avoid crimping the tube.
6. Confirm free-flow of water by repeating "Test Sunroof Drains" procedure for the right front drain.
7. If satisfactory test is completed install the duct and fender air intake grill.
8. If satisfactory test is NOT completed, blow out the drain tube with compressed air and test again.

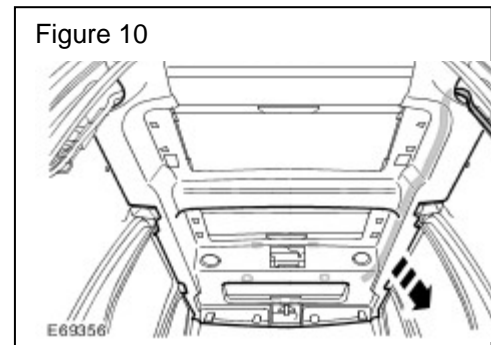
Figure 10

- Collapsed elbow joints
 - Pinched tube
 - Inclined routing

9. If the concern has still NOT been corrected refer to GTR Section 76.64.15 and remove the headliner to gain access to the drain tube. (Figure 10)
10. Inspect for misrouting or kinking of the roof opening panel drain tube, paying particular attention to:

11. Repair drain tube routing as necessary and retest.
12. If satisfactory test is completed, install the headliner.
13. Install the C-pillar lower trim panel.
14. Install the fender splash shield pulled away to access roof opening panel drain tube.

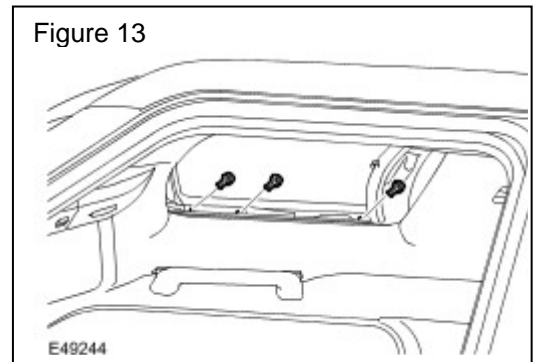
Figure 13

NOTE: When all of the drain tubes are confirmed as functioning correctly the Torx screws securing the glass roof panel can be tested as a leak source.

1. Open the roof opening panel blind, leaving the roof opening panel closed.
2. Verify that the glass is centered in its opening.
3. Verify that the front edge is set flush or up to 1.0 mm (0.040 in) below the roof line.

4. Verify that the rear edge is set flush or up to 1.0 mm (0.040 in) higher than the roof line.
5. From inside the vehicle, verify that all six (6) Torx screws securing the roof opening panel are correctly positioned and tightened to **6 Nm (4.5 lbf-ft)**. (Figure 13)

6. If the roof opening panel is not set within the specified conditions or if any Torx screw is loose, align the roof opening panel as follows:
 - Loosen the six (6) roof opening panel Torx screws

- Align the roof opening panel so it is centered in all directions to the exterior roof panel opening
 - Verify that the exterior front and rear edges are set within the specified conditions

- Tighten the six (6) roof opening panel Torx screws to **6 Nm (4.5 lbf-ft)**.
7. Verify proper operation of the roof opening panel.
8. Close the roof opening panel blind.
