TECHNICAL INFORMATION

**LAND
-ROVER**

'E' Post Trim Area - Water Ingress

Discovery

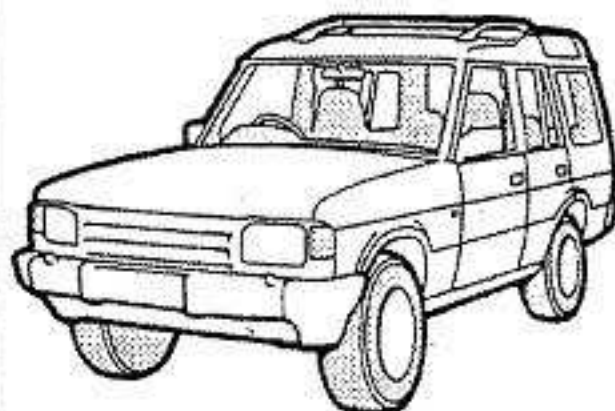
ILLUSTRATION

Investigations have shown that on some vehicles water can enter into the vehicle around the 'E' post, there can be several causes for water ingress in this area, all known water ingress paths and fixes are detailed on the flow chart attached.

Upon customer complaint of water ingress around the 'E' post, follow the flow chart overleaf.

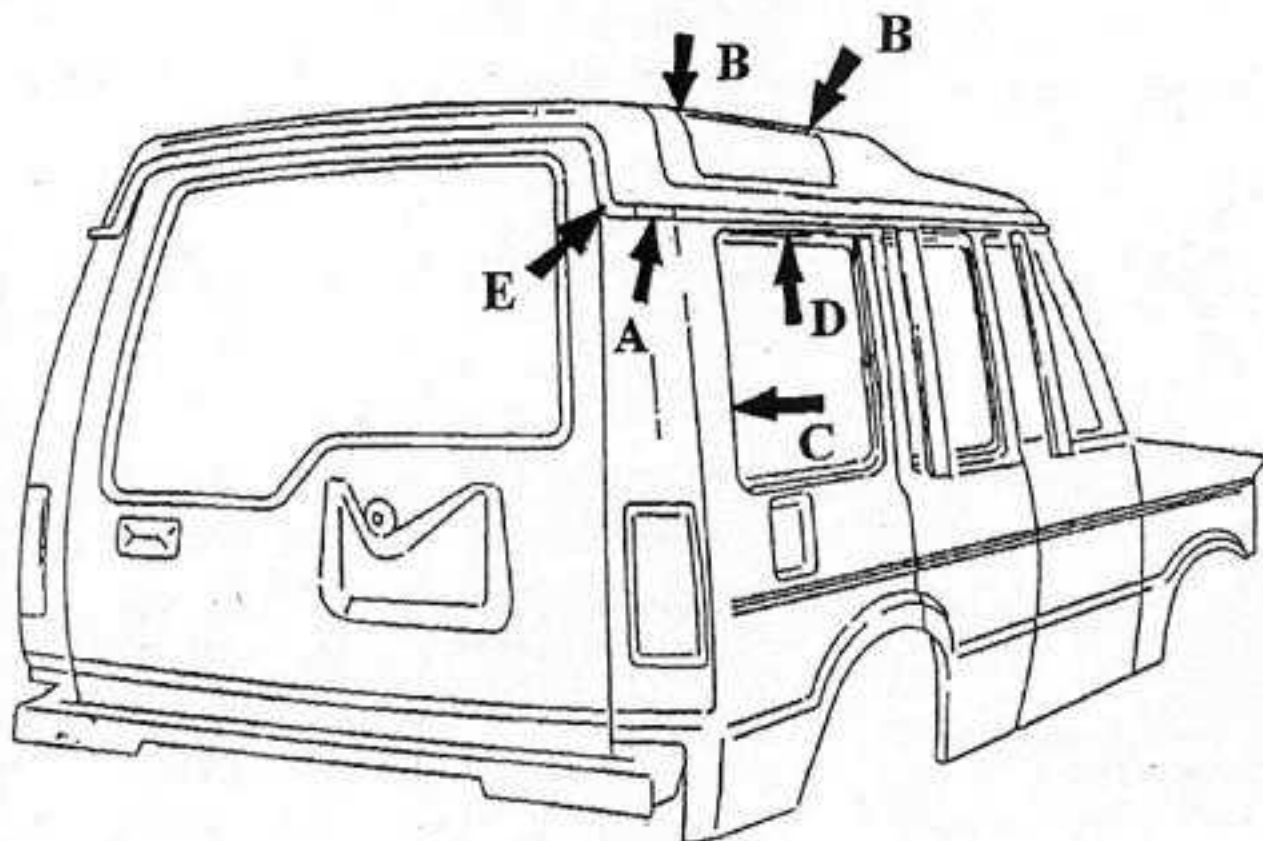
Water drips from alpine light
 (see illustration, arrow B)

Water drips from cantrail inner near 'E' post

Reseal alpine light glass to rubber and rubber to
 body on outside surface

Check fixed glass sealing and reseal as
 necessary (see illustration arrow C)

Check for cracks around flange see 'E' on
 illustration, reseal each side of flange.
 The flange has been moved inside can't
 rail to improve water ingress concerns from
 Vins 199607 and 530346

Inspect Zinc tape for pin holes and reseal as necessary
 (see illustration arrow A)

Inspect cantrail to bodyside joint for pin holes and reseal as necessary
 (see illustration arrow D)

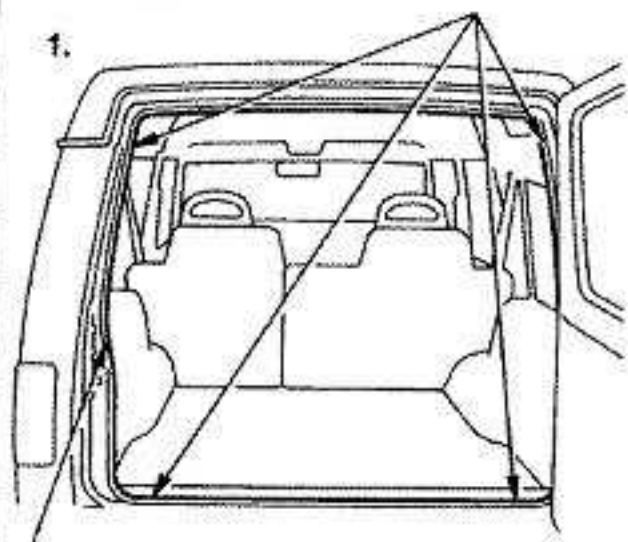
As part of ongoing quality improvements a new double bubble seal has been introduced onto the rear tail door. Early indications have identified a potential water leak from this area due to seals fitting incorrectly on a misformed seal flange. Investigations by Land Rover engineers have found that following procedure overcomes this issue on all vehicles.

1. Remove rear end door tread strip.
2. Remove rear end door seal from failed vehicle.
3. Using a craft knife, cut any excess trim tape that has been wrapped around the rear end door aperture see illustration 3.
4. Dress any flanges that appear to have panel mismatch to obtain a tight finish see illustration 1&2.
5. Smooth in Butyl around the four areas where the panel meets and form a channel to obtain a smooth finish for the foam tape see illustration 1&2.
6. Carefully apply the foam tape around the aperture as close as possible to the edge of the panel. Remove backing paper, smooth out, avoid any creases see illustration 1.

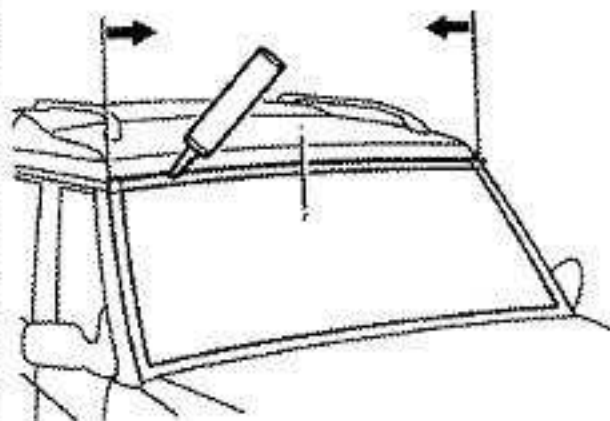
ILLUSTRATION

To overcome water ingress through the upper section of the windscreen seal a process has been developed to introduce a supplementary sealing operation behind the seal. Should a vehicle exhibit water ingress from this area follow the procedure below.

Locate sealant nozzle between top windscreen rubber and roof panel, extrude bead of sealant (continuous) from the centre of the vehicle towards the corners (see illustration opposite).

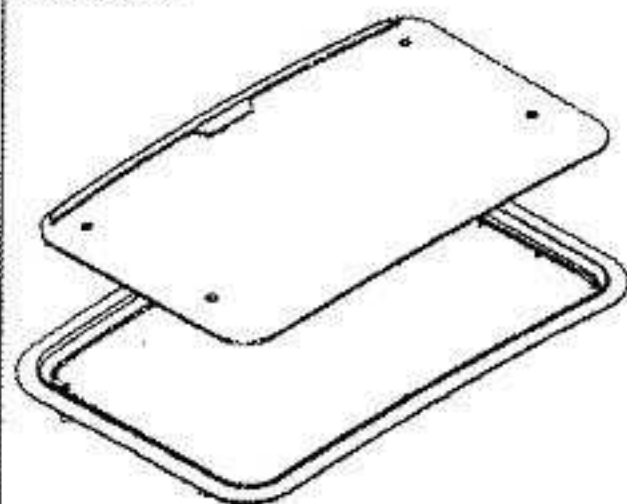
ILLUSTRATION

A small number of reports have been received that identify water ingress through both front and rear sunroofs. The reports indicate 2 areas of concern, 1) water drips from the water dam and appears to drip from the sunroof handle / motor and headlining, this may be due to the absence of the water dam gasket.

2. Water ingress between the sunroof glass and glass seal

Process for fix No 1 Gasket missing from the water dam, refer to the workshop manual section 76 sunroof Electric/Manual.

3. Using a torch and probe check if the water dam gasket is present (the gasket can be identified by the cross hatching on the surface, or a probe can be inserted inside the catch, if glass contact is made the gasket is missing).

4. If the gasket is missing replace the glass panel with a new assembly see parts information.

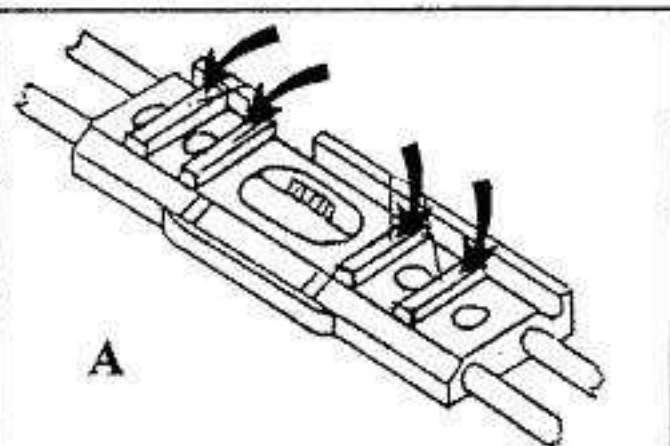
A

MODIFIED GUIDE TUBE (ILLUSTRATION A)

Underside view between upper frame and guide tube.

When fitting a modified lower tray to an unmodified guide tube x 2 spacers must be fitted to the guide tube.

Gently lift the guide tube assembly off the two locating pegs on the upper frame to gain enough clearance to insert the spacers over the two inboard holes as indicated then reseal the guide tube assembly.

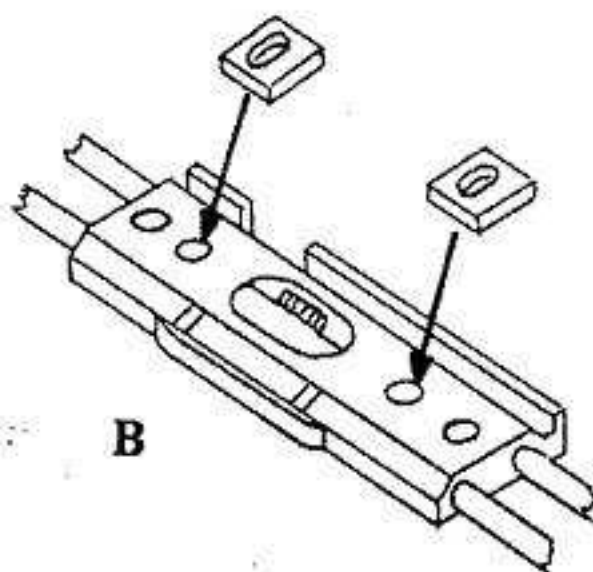
B

GUIDE TUBE UNMODIFIED (ILLUSTRATION B)

Underside view between upper frame and guide tube.

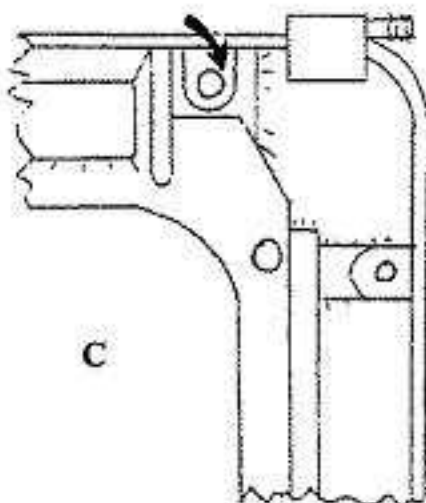
MODIFIED LOWER TRAY ILLUSTRATION 'C'

Underside view look for 'U' shaped impression around corner hole as shown opposite.

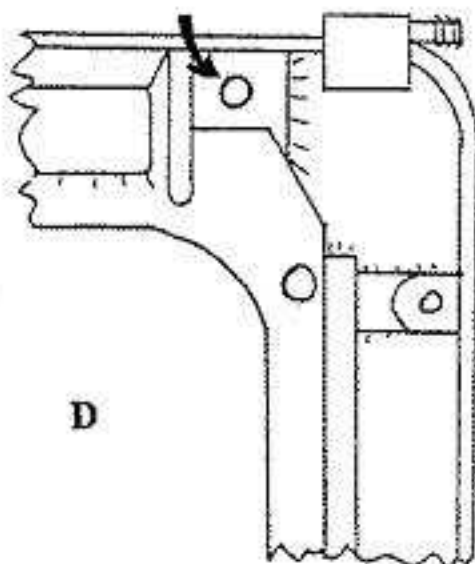
LOWER TRAY UNMODIFIED 'D'

Underside view no impression around hole as shown opposite.
