Front Differential Recall for Range Rover III (up to 2005)

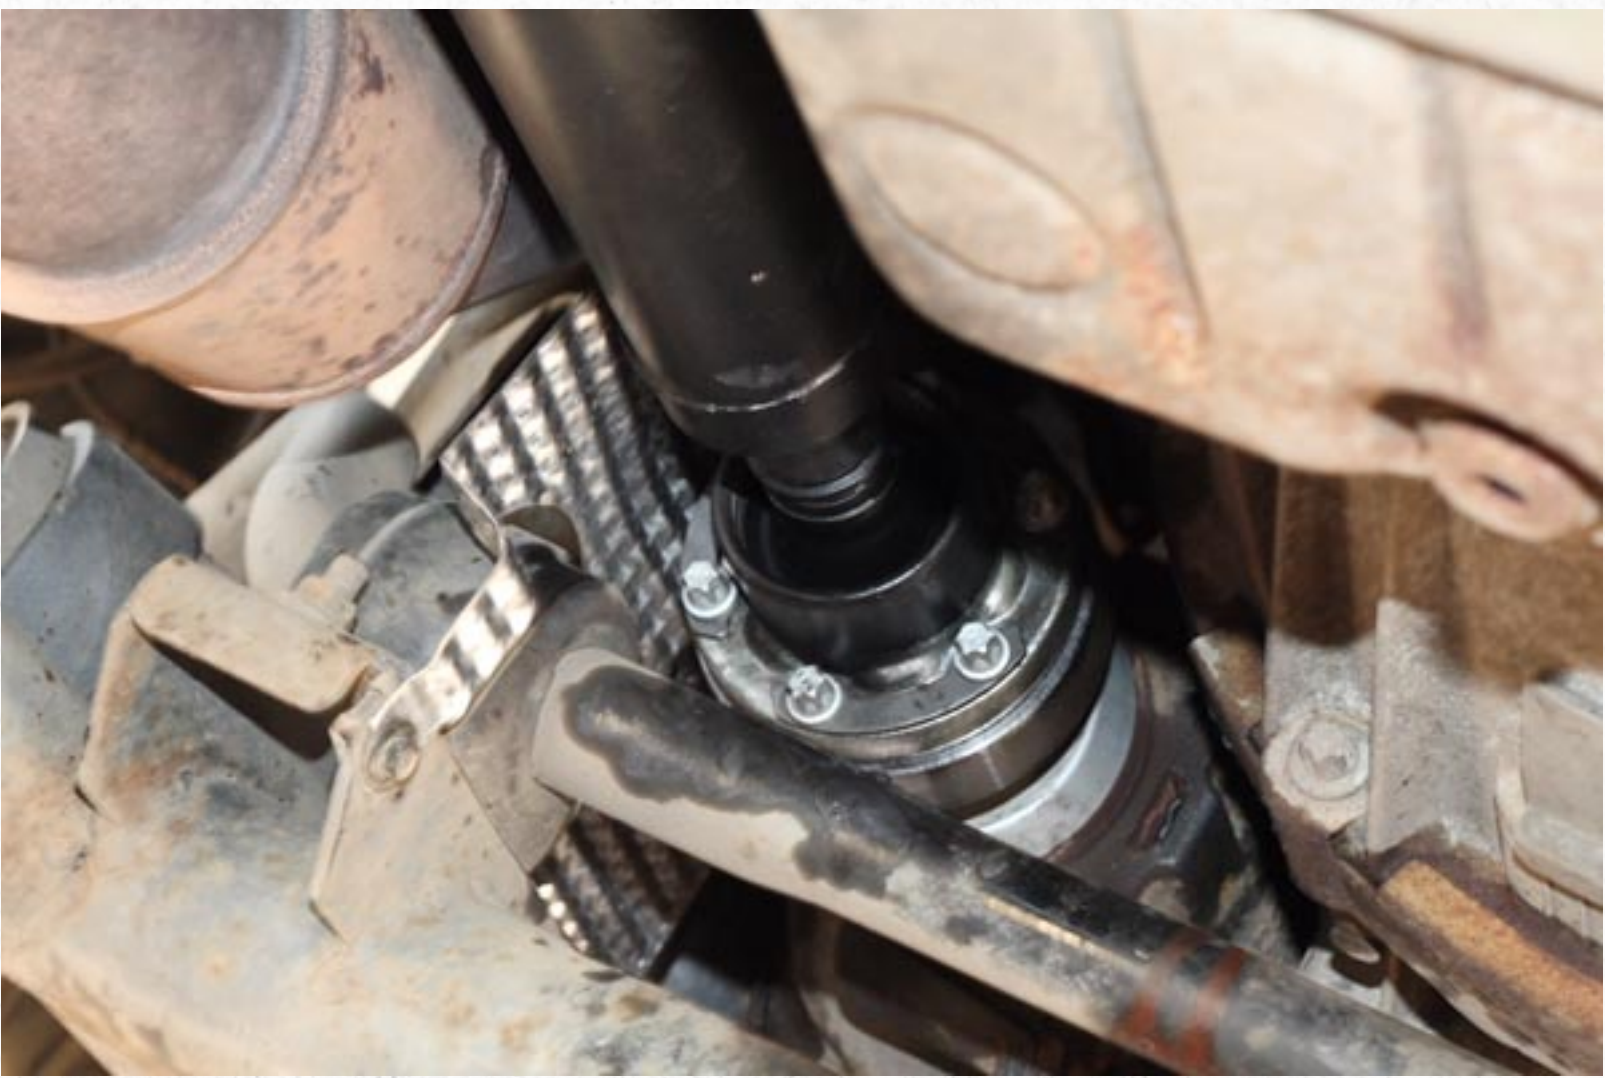
Photo: View (looking forward) of front drifeshaft on 2002 build date Mk III Range Rover. Note new flexible coupling at forward end of drive shaft where it enters the differential. Photo courtesy of Rangerovers.net forum member Fisha from Scotland.

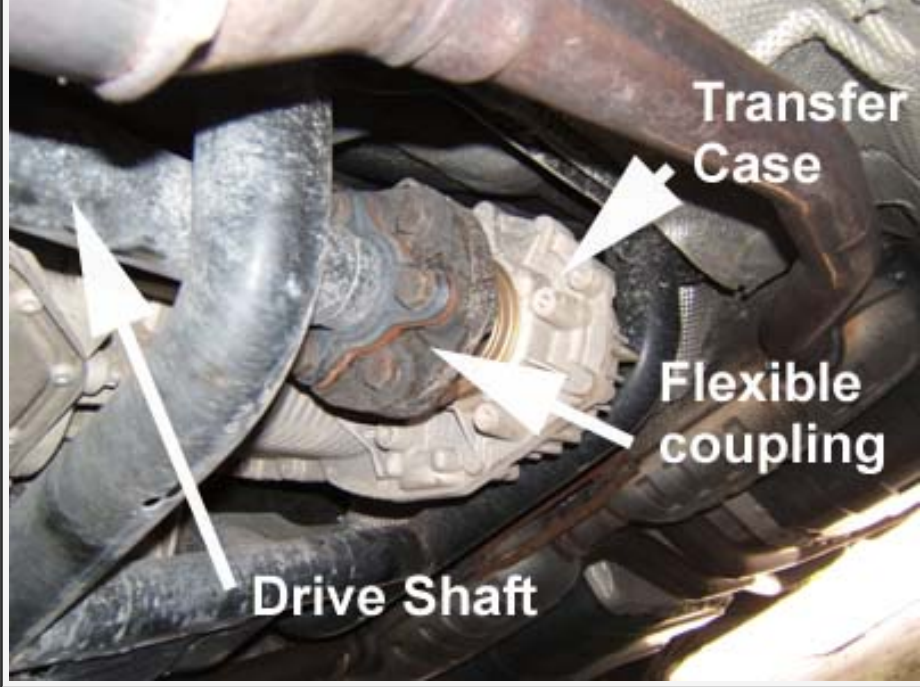
The front driveshaft/diff design, derived from the BMW X5, had a flexible coupling at the rear end only (see photos below left). It therefore relied on very accurate alignment of the diff input shaft with the front prop shaft/drive shaft. When alignment drifted away from perfection, the splines at this connection would be subject to excessive wear and eventually disintegrate. Several service campaigns to realign the diff did not seem to solve the problem permanently.

View looking rearwards showing front driveshaft coming forward from transfer case. Note flexible coupling at transfer case end of the shaft.

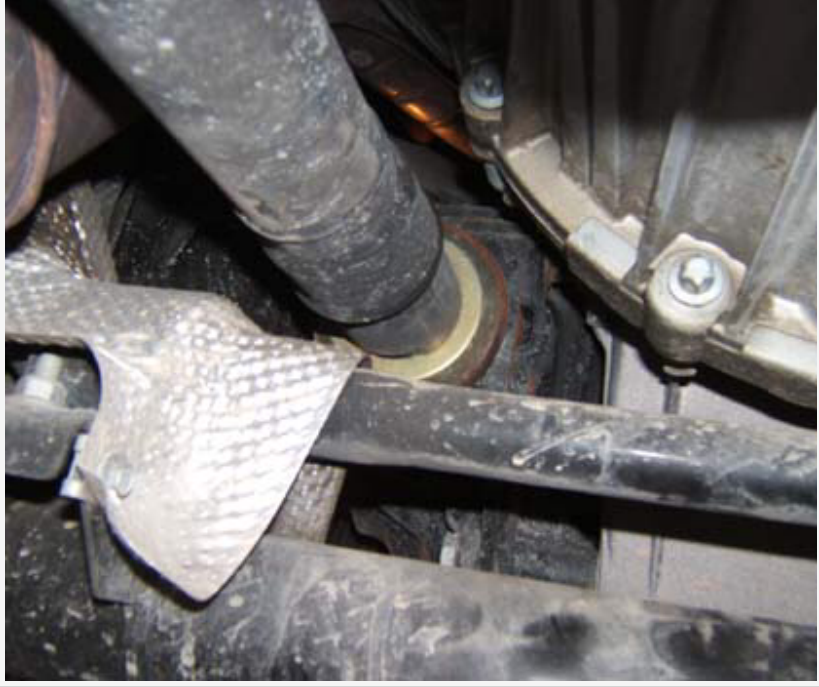
As reported on Rangerovers.net starting from the early days of the Mk III model, the problem lay in the design of the front driveshaft, which had no flexible coupling at the front end, so that any minor misalignment put severe stress on the front diff input splines, leading to failure and immobilization of the vehicle. In our view, Land Rover's original design was perfectly reasonable from an engineering point of view, since the engine and transmission were all bolted together as one unit and theoretically would not need provision for flexiblity in the drive shaft. But once the failures started to happen, it was obvious that the assembly must not be as rigid as hoped, and what was needed was a driveshaft with flexible couplings at both ends. Indeed, this was the design adopted in the 2006 model year upgrade. However it took a long time for Land Rover to admit there was a real problem with the earlier models. During this period of uncertainty, aftermarket driveshafts with the necessary flexible joints at both ends were produced by third party manufacturers. Now that Land Rover has made an official solution available free fo charge, we applaud the company for this action which should close the door on the whole episode and help enhance Land Rover's reputation for reliability.

Front end of original driveshaft, where it enters the front diff, without flex coupling of any kind.

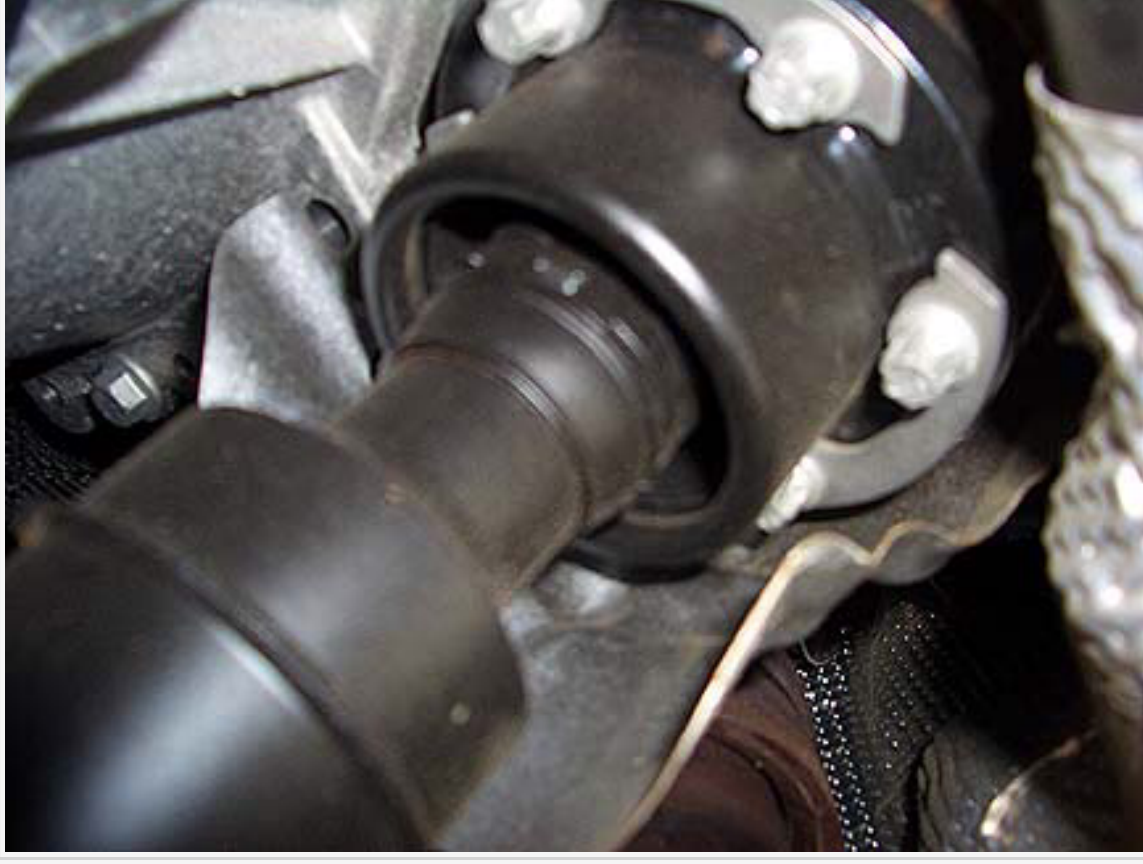
Flexible coupling used on front end of redesigned drive shaft for 2006 and up models with Jaguar-derived engine.

When the 2006 models came out, using the Jaguar engines, the front driveshaft design was changed to eliminate this reliance on accurate alignment, by providing a flexible joint at the front end of the drive shaft (see photo below left). When the newly designed front driveshaft finally came out, its new flexible CV joint at the front end (photo below right) remarkably resembled the 2006 design. This also required a new carrier on the front diff itself to accept the new driveshaft. The same simple flex coupling as before is retained at the rear end of the shaft.

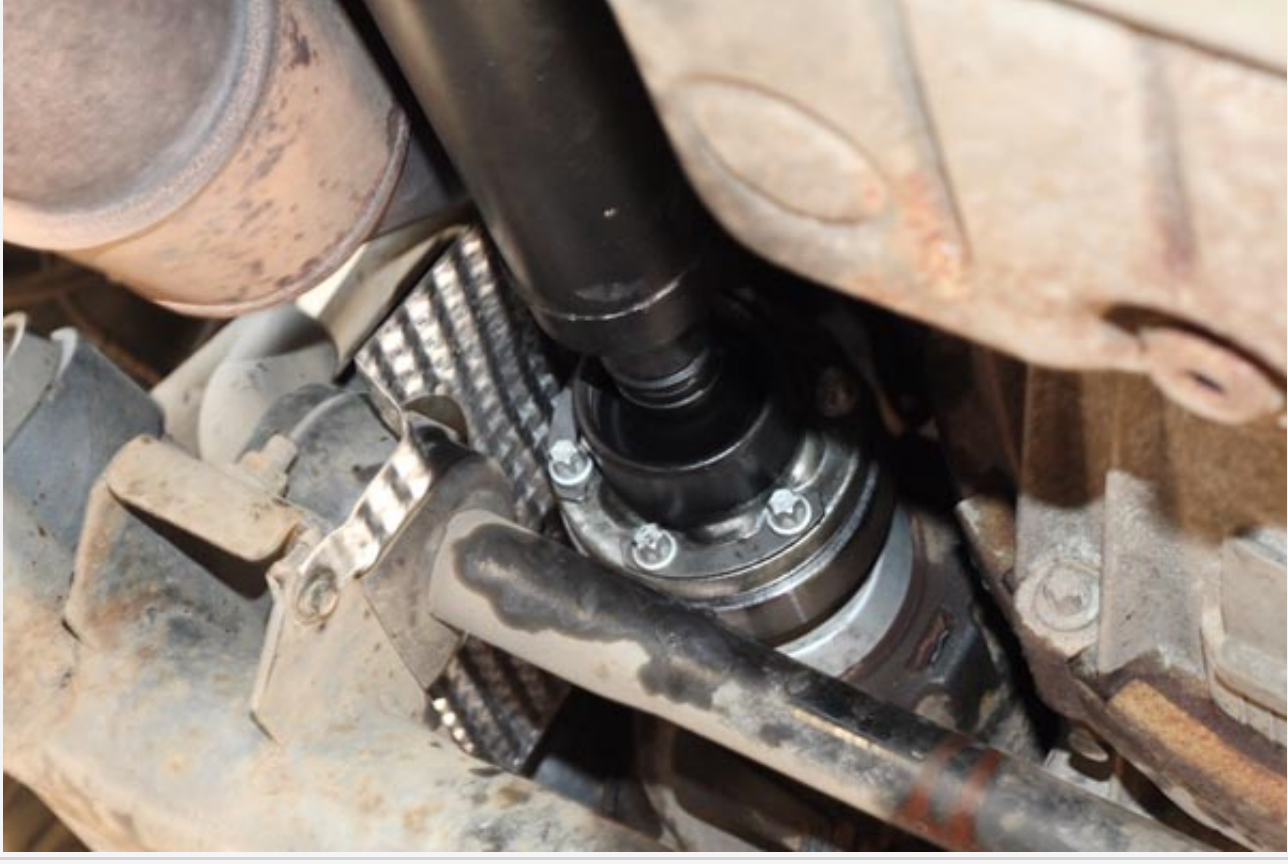
Flexible coupling at front end of new driveshaft for 2003-2005 models. Note resemblance to 2006 design. Note new heat shield, also installed as part of the service action, to the left of the drive shaft to shield it from the catalytic converter.

The new design eliminates the need for the front diff to be aligned so accurately. Officially, the operation is referred to as the "Front Differential to Propshaft Spline SVC Action". When I had mine done (September 2008) the complete list of parts used in the operation was as follows:
