TECHNICAL BULLETIN

MODEL/DERIVATIVE:
Range Rover

Bulletin N°: **0012**
CDS. ref: **L8483bu**
Issue: **1**
Date: **02.06.99**

PROBLEM:
ELECTRONIC AIR SUSPENSION (EAS) NOISE - COMPRESSOR MOUNTS

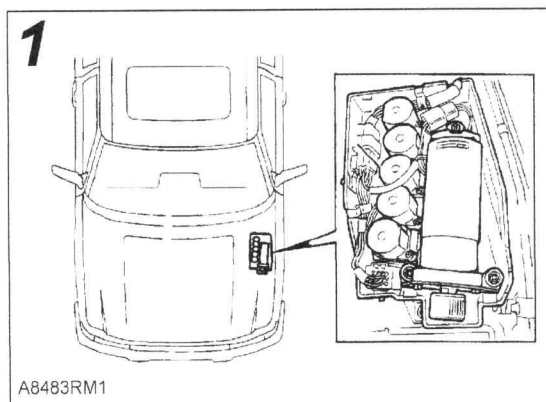
Reports of a droning noise transmitted into vehicle. The noise is apparent in the region of the front left hand corner of the vehicle and on investigation is found to originate from the air supply unit (illustration 1).

CAUSE:
Deterioration of the EAS compressor rubber mounts.

ACTION:
Modified compressor mounts have been fitted to all vehicles from VIN XA 420550 onwards. These latest mounts can be fitted to earlier vehicles by following the procedure below:
