TECHNICAL BULLETIN

Freelander

Bulletin N°: 0076
CDS. ref: L8664bu
Issue: 2
Date: 22.06.04

WATER INGRESS INTO VEHICLE

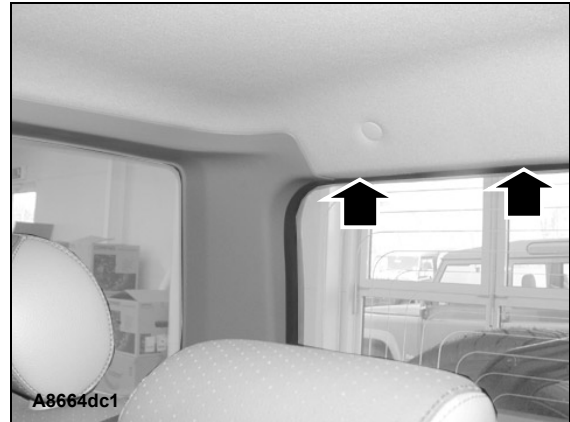
1

Wet or stained rear edge of headlining

Water ingress point rear edge of headlining

To ensure that lokuts are pushed fully home to seal to the panel.

- 1. Remove taildoor glass side finishers (arrowed in illustration 2), refer to Workshop Manual, Doors, repair number 76.43.81 for removal and refit procedure.**
- 2. Carefully release taildoor upper finisher from fixings.**
- 3. Remove five screws securing taildoor upper finisher bracket to body.**
- 4. Ensure that the lokuts are pushed fully home to the panel.**
- 5. If lokuts are damaged or fail to locate correctly, replace with new lokuts, part number DYH100980. Defective lokuts can be cut out with a sharp blade taking care not to damage the panel.**
- 6. When satisfied that the lokuts are secure, apply water proof tape over them.**
- 7. Fit the taildoor upper finisher and glass side finishers. When the finishers are refitted the securing screws will penetrate the tape.**
- 8. Apply water to the suspected entry area to ensure leak has been cured.**

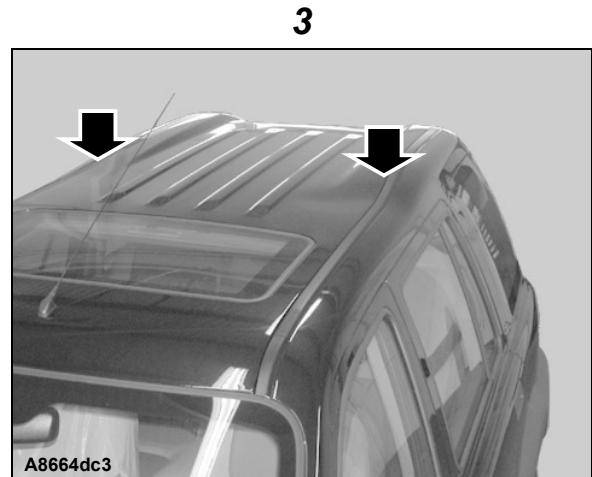
Wet or stained headlining

To ensure that roof channel seams are fully sealed.

- 1. Remove roof moulding, refer to Workshop Manual, Exterior Fittings, repair number 76.43.68.**
- 2. Inspect full length of roof channel seams for pin holes.**
- 3. Fill any holes with polyurethane sealant.**
- 4. Apply water to the suspected entry area to ensure leak has been cured.**
- 5. Fit roof moulding.**

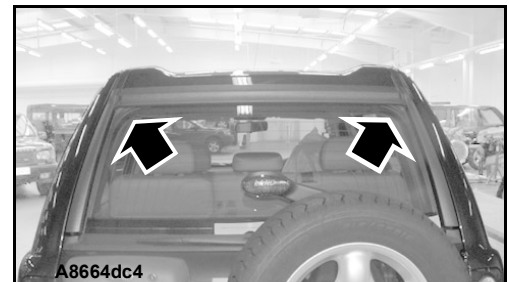
4

Water ingress from taildoor glass to seal

To ensure that the taildoor glass slides into position underneath the seal (arrowed in illustration 4) to prevent water ingress.

1. If door glass does not move into the correct position when closing, refer to Workshop Manual repair number 76.31.20 for glass adjustment procedure.

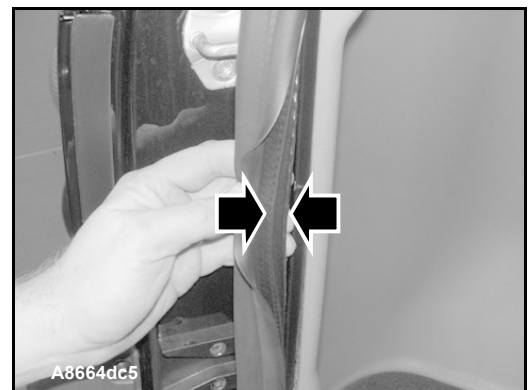
5

Water ingress via taildoor seal

To ensure the taildoor aperture seal is located onto the flange with sufficient clamping force to prevent leak.

1. Pull gently on the lower part of the seal to see if it releases from the flange.
2. If the aperture seal is not held securely, release the seal. Using a pair of pliers, close the metal carrier on the seal (arrowed in illustration 5). This will increase the clamping force on the flange.
3. Fit the seal to the flange, ensuring that it is now secure.

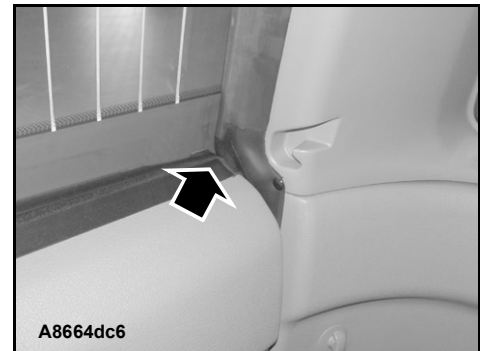
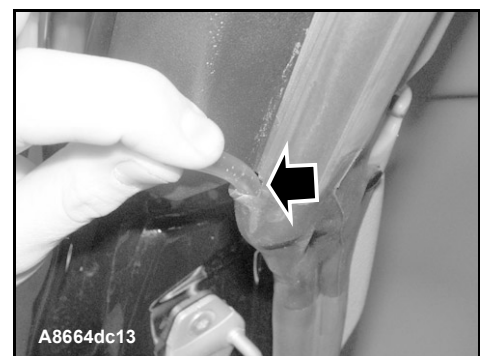
Water ingress via taildoor seal

To ensure taildoor aperture seal rubber insert is located and functioning correctly.

1. Look through the left and right hand rear quarter glass, for a visible gap between the taildoor aperture seal and the taildoor (arrowed in illustration 6).
2. If a gap can be seen, check that the taildoor is correctly set and aligned to the body.
3. Open the taildoor and inspect the aperture seal at waist line height to see if the rubber insert is at its highest position within its retaining rubber membrane.
4. If the rubber insert is not at its highest position, cut a piece of plastic tube to the correct length and glue into the membrane (arrowed in illustration 7), to increase the seal contact to the door.

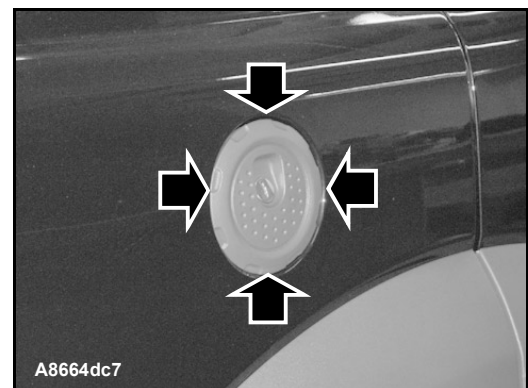
8

Interior quarter panels wet

To ensure that the fuel filler aperture is sealed correctly.

1. Remove the lower rear quarter trim casing, refer to Workshop Manual, repair number 76.13.12 for removal and refit procedure.
2. Apply water to the fuel filler area (arrowed in illustration 8), and check if water is entering the box section around the ventilation flaps, (The water will run down the wheel arch seam and into the box section).
3. If water is present remove fuel filler cap, seal the fuel filler aperture seam using Clear Polyurethane sealant.
4. Refit trim casing and fuel filler cap.

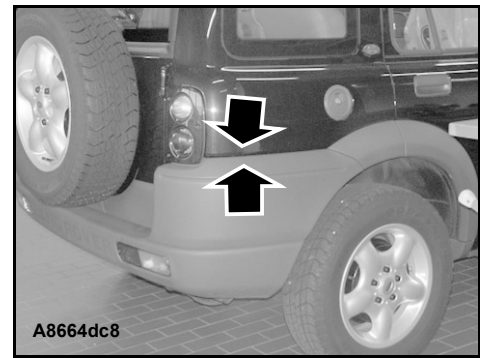
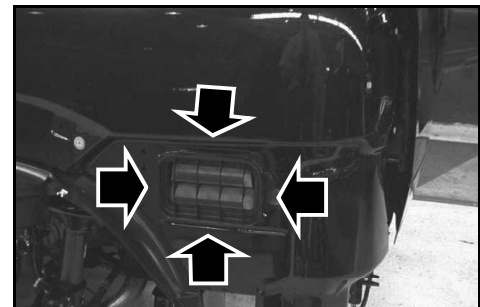
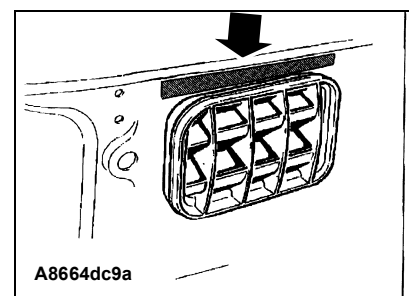
Interior quarter panels wet

To ensure rear body vents are sealed correctly and to prevent water ingress.

1. Remove the lower rear quarter trim casing, refer to Workshop Manual, repair number 76.13.12 for removal and refit procedure.
2. Apply a continuous flow of water between the rear bumper and side panel (arrowed in illustration 9).
3. Check to see if water is present at the box section below body vents.
4. If water is present remove bumper valance, refer to Workshop Manual, Exterior Fittings, repair number 76.22.74 for removal and refit procedure.
5. Apply Polyurethane sealant around edge of body vent (arrowed in illustration 10) sealing it to the body.
6. Clean area where shedder will be applied. Remove backing paper from shedder, place shedder over vent with adhesive strip along shaded area (illustration 10a). Ensure the shedder covers the body vent.
7. Before fitting bumper and trim casing, seal rear wheel arch seam, procedure 9.
8. Fit bumper and trim casing.

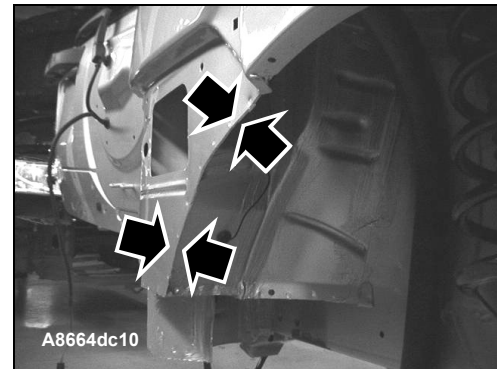
11

Interior quarter panels wet

To ensure wheel arch seams are sealed correctly to prevent water ingress.

1. Remove the lower rear quarter trim casing, refer to Workshop Manual, repair number 76.13.12 for removal and refit procedure.
2. Remove rear bumper valance, refer to Workshop Manual, Exterior fittings, repair number 76.22.74 for removal and refit procedure.
3. Remove rear wheel arch liner, refer to Workshop Manual, Exterior fittings, repair number 76.10.49 for removal and refit procedure.

4. Apply a continuous flow of water to the seam (arrowed in illustration 11).
5. Check to see if water is present in the box section.
6. If water is present in box section, seal rear wheel arch seam (arrowed in illustration 11), using polyurethane sealant.
7. Before fitting wheel arch liner, bumper and trim casing, seal body vent, procedure 8.
8. Fit wheel arch liner, bumper valance and trim casing

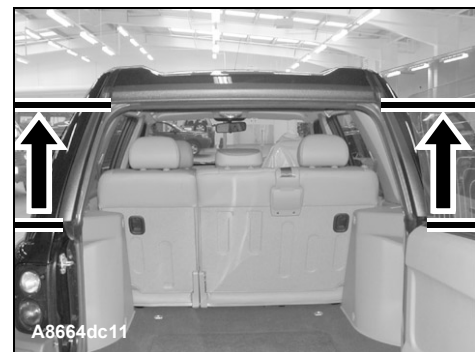
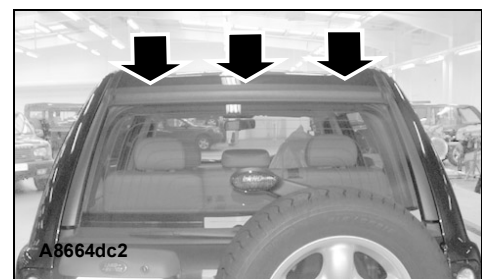
Wet 'E' post trims

To ensure that tail door aperture seal/sealant is water tight.

1. Remove 6 Torx screws securing luggage compartment carpet retainer.
2. Remove carpet retainer.
3. Open taildoor, apply a continuous flow of water to the taildoor aperture seal sealant, slowly working up each side from waist level, (arrowed in illustration 12).

4. Whilst applying water, check if water is present where the carpet retainer is normally fitted.
5. If a leak is detected in the sealant, fill the gap with polyurethane sealant.

6. Close taildoor, apply a continuous flow of water to the upper taildoor finisher (arrowed in illustration 13).
7. If water is present where the carpet retainer is normally fitted, carefully release taildoor upper finisher from fixings.

8. Remove five screws securing taildoor upper finisher bracket to body.
9. Fill gap in the sealant with polyurethane sealant.
10. Ensure that the lokuts are pushed fully home to the panel.

11. If lokuts are damaged or fail to locate correctly, replace with new lokuts, part number DYH100980. Defective lokuts can be cut out with a sharp blade taking care not to damage the panel.

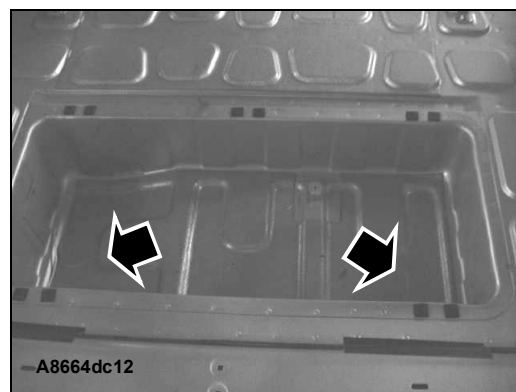
14

Water in stowage box

To ensure the fuesd bungs in the lockable stowage box are sealed correctly.

1. Remove the luggage compartment carpet, refer to Workshop Manual, Interior Trim Components, repair number 76.49.04 for removal and refit procedure.
2. Inspect 2 fused bungs to confirm that they are located securely in the floor, (arrowed in illustration 14).
3. Seal around the grommets with polyurethane sealant.
4. Fit carpet.

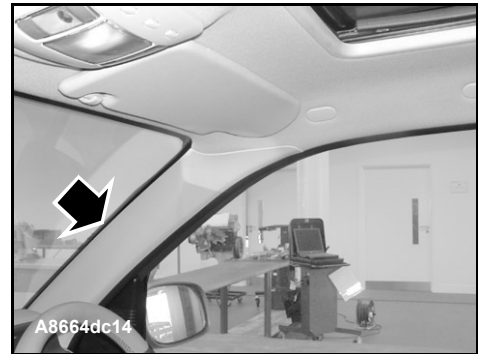
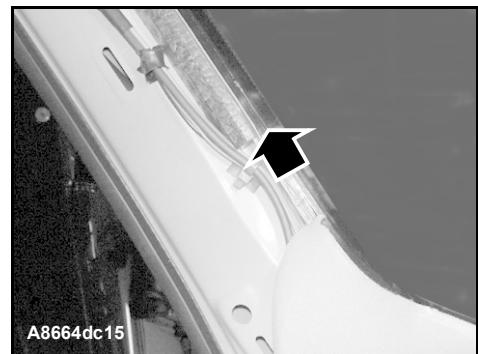
Wetness around sealant at top or sides of windscreen

To ensure that windscreen is fully sealed to body.

1. Remove 'A' post upper trim finishers (arrowed in illustration 15), refer to Workshop Manual, Interior Trim Components, repair number 76.13.26 for removal and refit procedure.
2. Remove sun visor, refer to Workshop Manual, Interior Trim Components, repair number 76.10.47 for removal and refit procedure.
3. Remove lens from interior lamp.
4. Remove 2 fixings securing front interior lamp to body and release from headlining. Disconnect multi plug and remove lamp.
5. Remove screw covers and screws from grab handles and remove handles.
6. Remove grab handle blanking plugs.
7. If necessary support headlining.
8. Apply water to the top and side edges of windscreen, whilst from inside the vehicle, check for water entering through the sealant.
9. Fill any holes between aperture and windscreen (arrowed in illustration 16), with polyurethane sealant.
10. Refit components that have been removed.

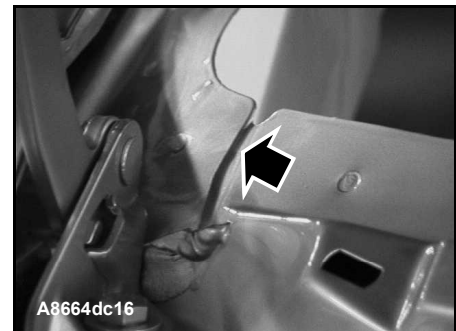
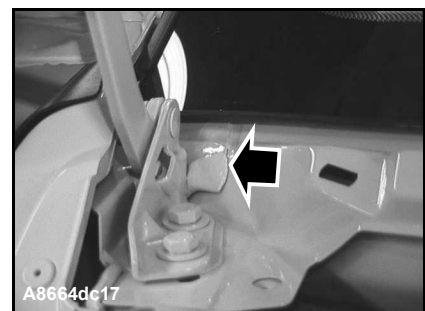
Wetness at base of 'A' posts

To ensure that windscreen aperture and hinge seams are fully sealed.

- 1. Apply sealant to areas (arrowed in illustrations 17 and 18).**

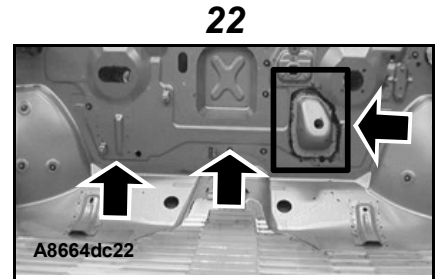
Wetness under fascia in footwell

Areas of spot weld blow holes

- 8. If water is present in the footwell, cut the NVH cover to reveal the water ingress point and seal the spot weld blow hole with polyurethane sealant.**

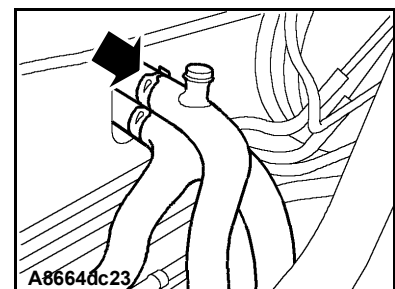
Wetness under fascia in footwell

- 1. Lift bonnet and apply water to heater pipes in the engine bay whilst checking for water in the footwell. The water will soak through the NVH cover on the bulkhead and run into the footwell.**
- 2. If water is present in footwell, refer to Workshop Manual, Cooling, for appropriate coolant drain procedure.**
- 3. Release 2 clips securing heater hoses to heater and disconnect hoses, (arrowed in illustration 23).**

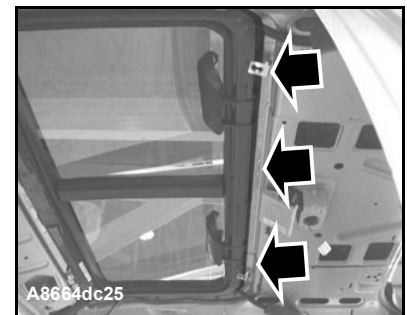
25

Wetness from sunroof

To ensure there is sufficient seal around sunroof aperture.

1. Apply water to sunroof whilst looking for water ingress around the sunroof aperture (arrowed in illustration 25).
2. Remove headlining, refer to Workshop Manual, Interior Trim Components, repair number 76.64.15 for removal and refit procedure.
3. Seal water ingress point with polyurethane sealant.
4. Refit headlining.
