TECHNICAL INFORMATION

No: 76/01/03/NAS

Water Ingress at Rear of Vehicle

Discovery Series II (LT)

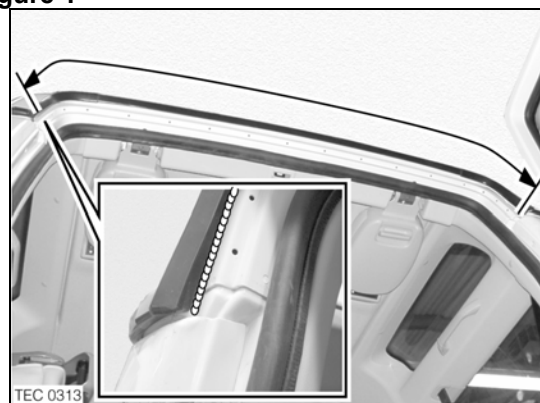
Figure 1

A sealing operation between the roof and the rear header outer joint may have been inadvertently omitted during production. The lack of sealant in the joint can permit water ingress.

1. Open the tail door.
2. Release 17 clips securing the tail door opening secondary seal to the body.
3. Remove the seal.
4. Clean between the roof and the rear header outer joint (Figure 1).
5. Apply a continuous bead of sealant between the roof and the rear header outer joint (Inset in Figure 1).
6. Wipe off any excess sealant.
7. Fit and secure the tail door opening secondary seal to the body.
8. Close the tail door.
