The symptoms of a split boost diaphragm are easy to identify. The split causes boost pressure from the turbo to pass along the spill rail pipe to the tank, causing the cap to blow off when you release it. Fuel also passes the opposite way into the turbo - causing the engine to run rich/smoke and the turbo will not work. The diaphragm can easily be replaced, although it's a bit fiddly to do due to the location of the housing between the engine block and injector pump main body.

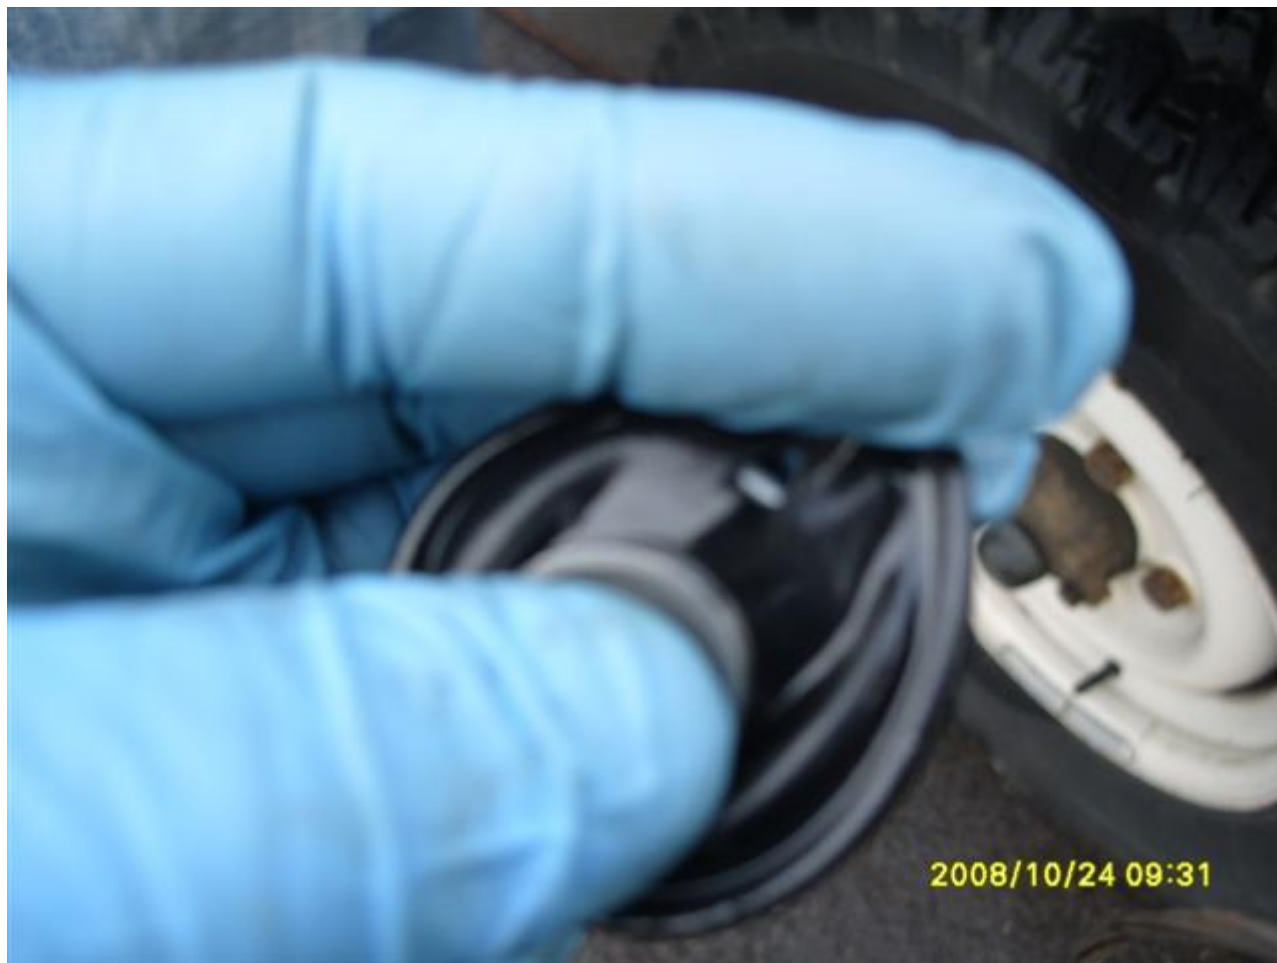
The cause of your problem
