## 2003 Mazda 6s 5 speed Automatic High/Reverse Clutch Repair 8-11-12

Transmission is a JATCO JF506E and it's used in Mazda's, Jaguars and Nissans

The Mazda # is JA5A-EL or 5F31J

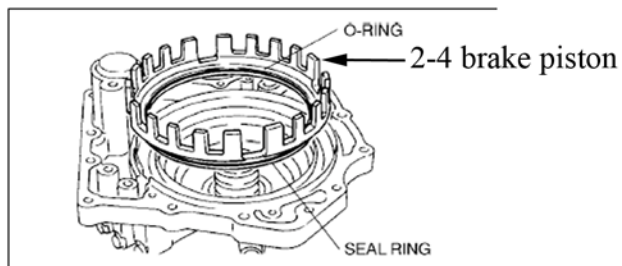
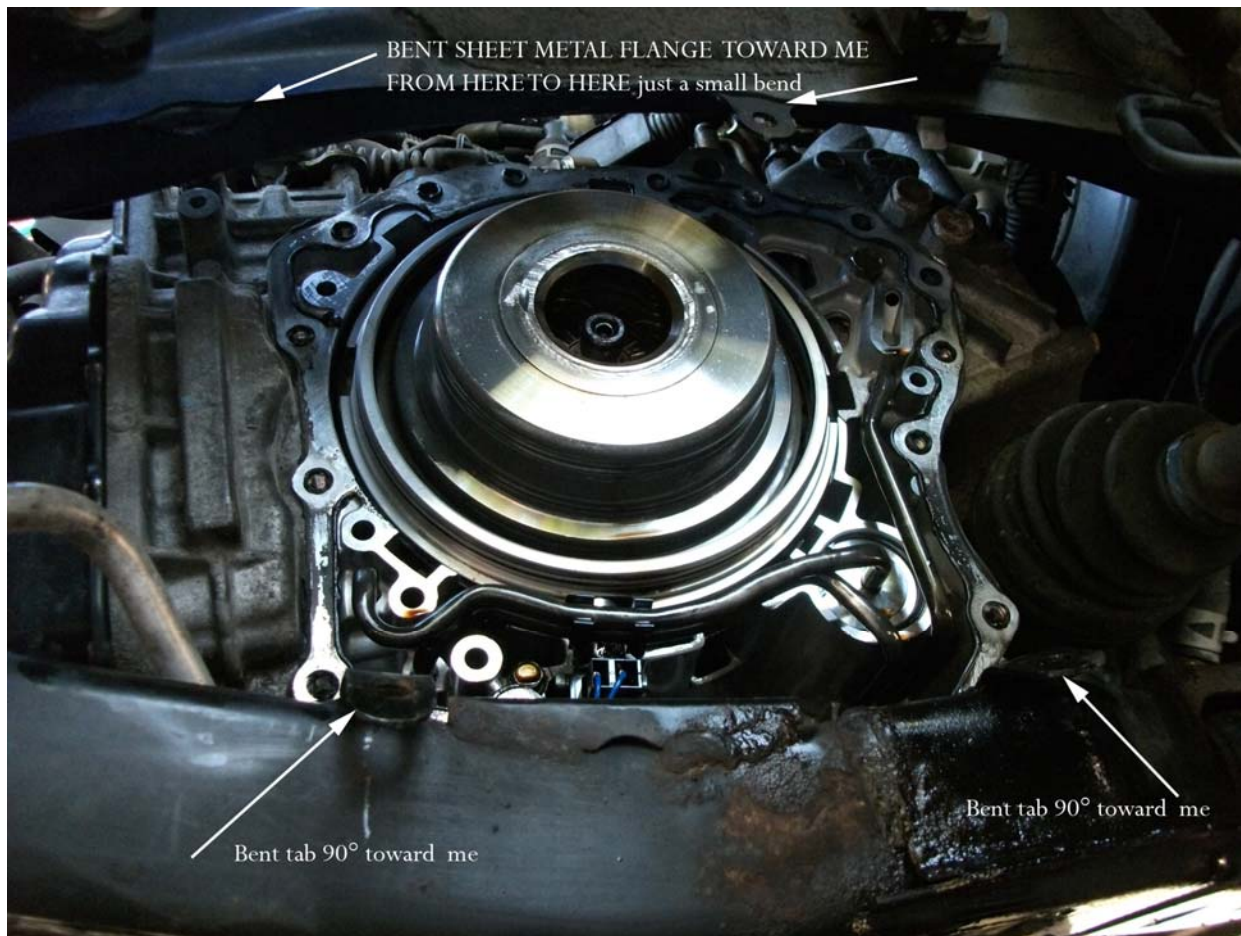
(Shown above with cover already off) Two long screw drivers work – it comes out of its bore in the cover pretty easy. Just work it back into the trans so it's out of your way (it's the outer ring in the photo above).

11. Once all the bolts are out of the cover a quick wrap from the top with long prybar that found a tiny overlap with the case broke it loose from the sealer. ½ qt oil will come out – be ready. The spring pack acting on the 2-4 brake piston will push the cover out about ¼". As you work the cover loose you will have to look inside from the top and work the 2-4 brake piston (see above) out of the cover bore so it stays in the trans.

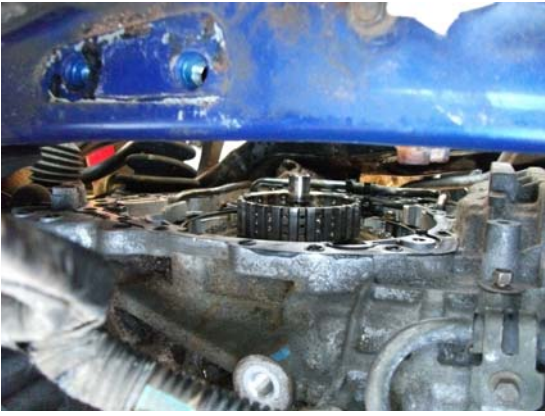
View from the top with high clutch already out:

10. The reverse/high clutch assembly just slides out and your ready to hit a clean bench to rebuild it. Pay particular attention to how the needle brgs came out as this is one of the only things that is not obvious in reassembly.

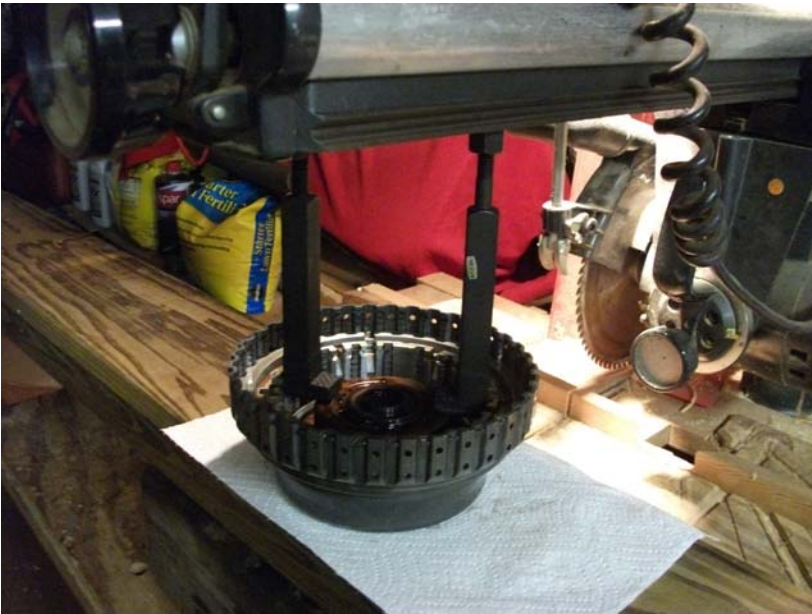
11. There is one holdup in getting this high clutch assy apart and that is getting the small snap ring off the high clutch hub as it is preloaded by a spring pack. They make a nice expensive tool to compress this but I used my radial arm saw as a press with two jaws from a gear puller to press down on the hub so I could release the snap ring. It's pretty stiff . The retainer plate and snap ring are easily bent so be careful. Note – for reassembly I had to take it to the trans shop – too stiff for my shade tree setup.

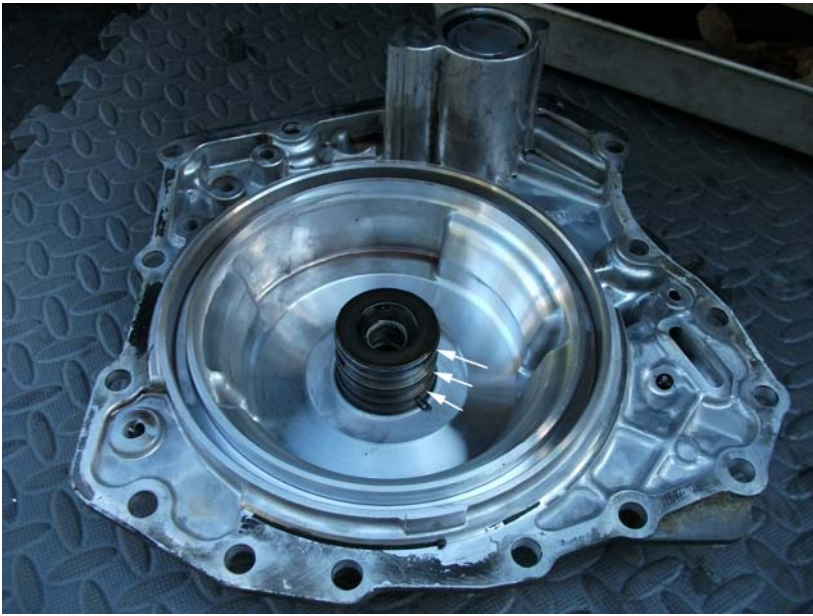
12. You will note in the end cover there is a piston shaped oil manifold with 3 teflon seal rings on it's OD and the face is a race for the needle brg that's inside the reverse/high clutch assembly. These seal rings looked pretty tore up on mine – replace them for sure – they are in the Ring Kit 183175A that's on my list. I think its likely this was my only problem but I feel better about replacing the high clutch piston as that is a known failure piece.

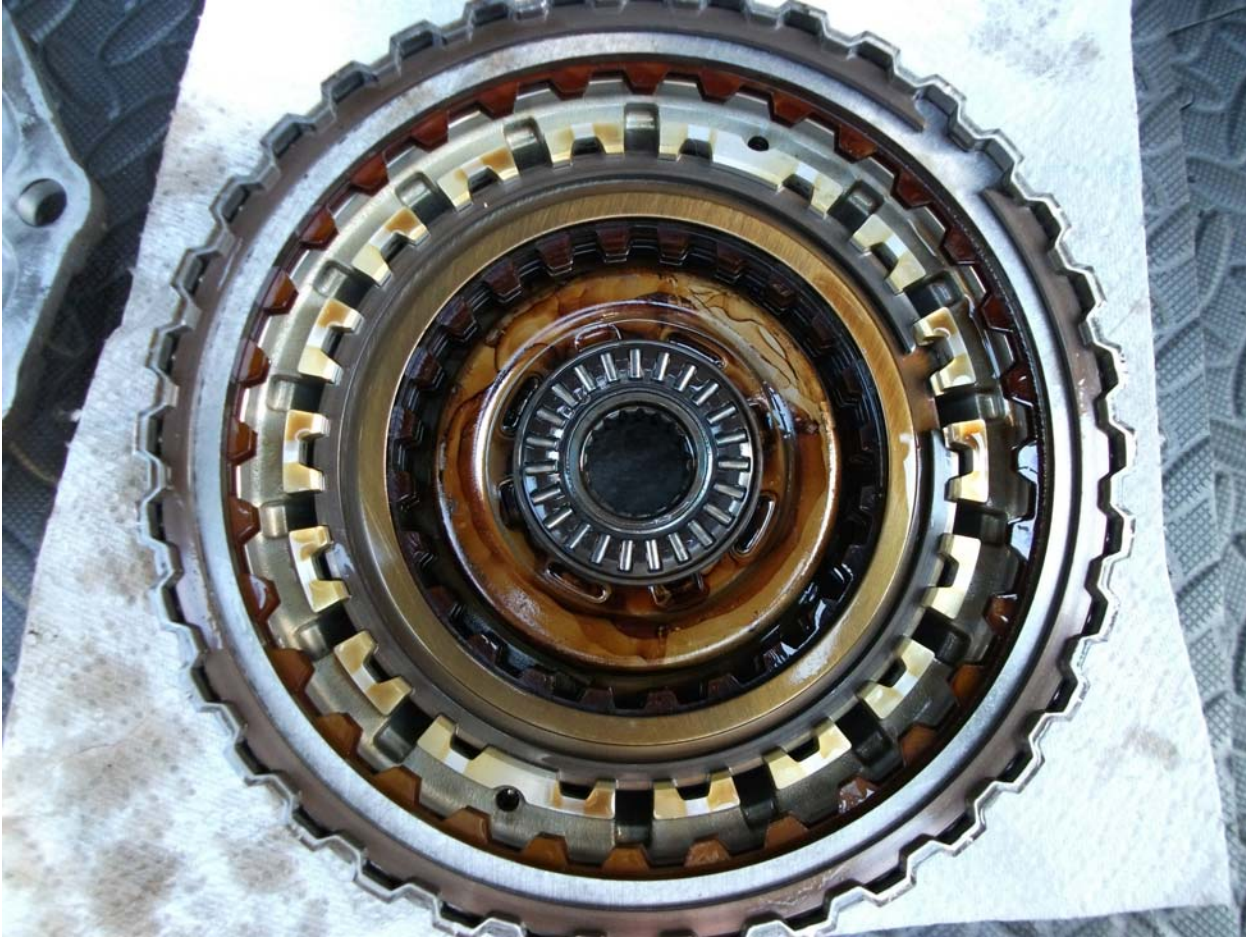
13. When disassembling the clutch pack unstack everything and number it. Pay particular attention to how the needle brgs came out as this is one of the only things that is not obvious in reassembly.
