Inoperability of Remote Due to Interference:

Mysterious Battery Drain on a 4.0/4.6:

Diagnosis and A Novel Cure

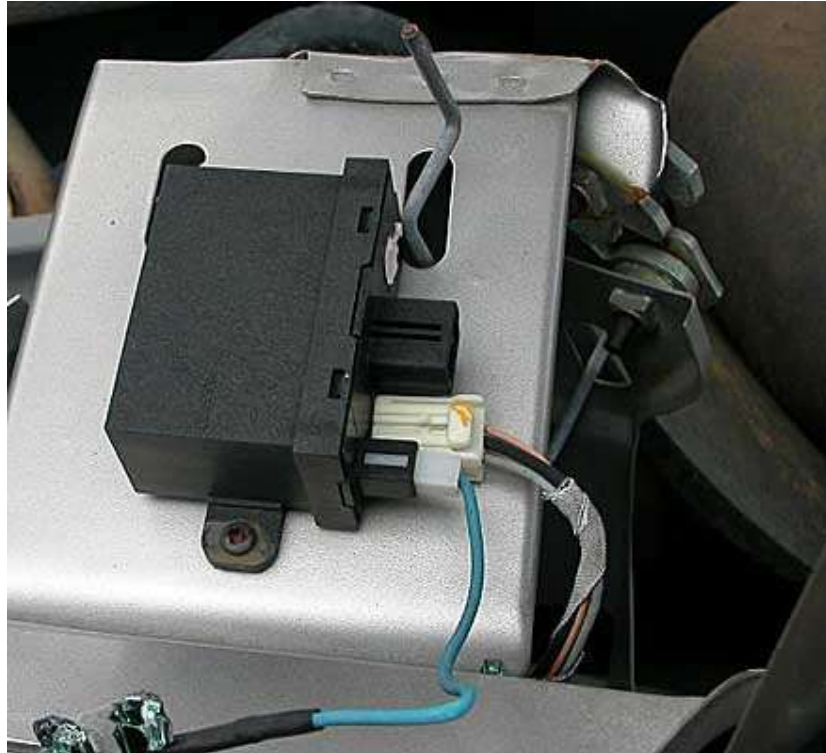
Photo at Right: RF Receiver for alarm system, located on top of rear seatback support under right rear parcel shelf. It is accessed by removing the parcel shelf trim. Rear seatback latch is at top right of photo. Note connection to window antenna at bottom of picture. Photo courtesy of Ron Beckett.

The same radio frequency is also used for many remote control devices in Europe and Australia and there is the possibility that these devices may cause interference. A partial fix became available in 2004 from the UK dealer network whereby the stock RF receiver (Part # AFR1953) was superseded by a new one (YWY500010) which was less subject to interference, but did not completely cure the interference problem. Accordingly, this has since been superseded by an even newer design, part number YWY500170. Owners with this latest update have not reported any further problem.

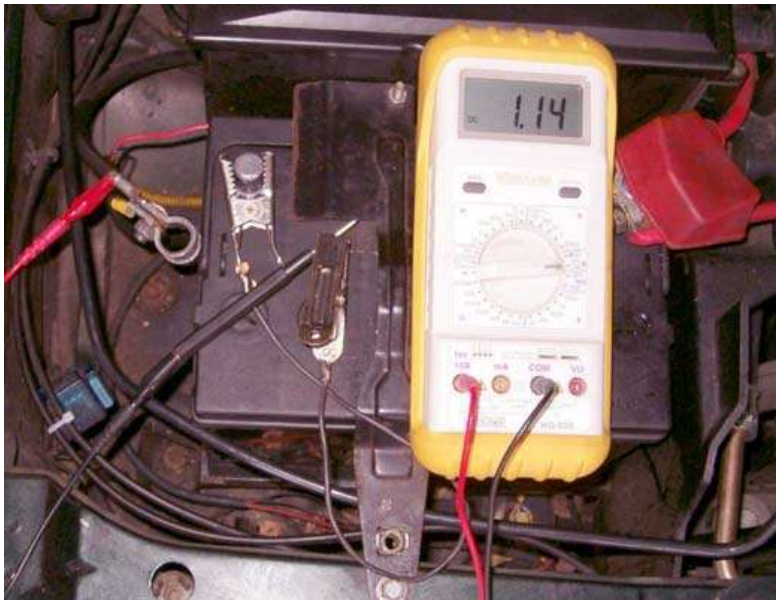
Photo at right: Andy's multimeter registers over an amp of drain with the BECM awake.

To establish the BeCM activity I used a multi-meter between the battery negative terminal and the negative lead to measure current drain. When the Rangey was shut, locked and alarmed the current drain was about 1.1A initially, then dropped to 0.57A and after 2 minutes went down to 0.02A (see photos above and below of the drain with the BECM awake and asleep respectively). This is what Rangey should do and she had no traceable fault, as was confirmed by a Landrover main dealer. (It seems that the selected gear position LED glows very faintly as an indicator that the BeCM is awake).

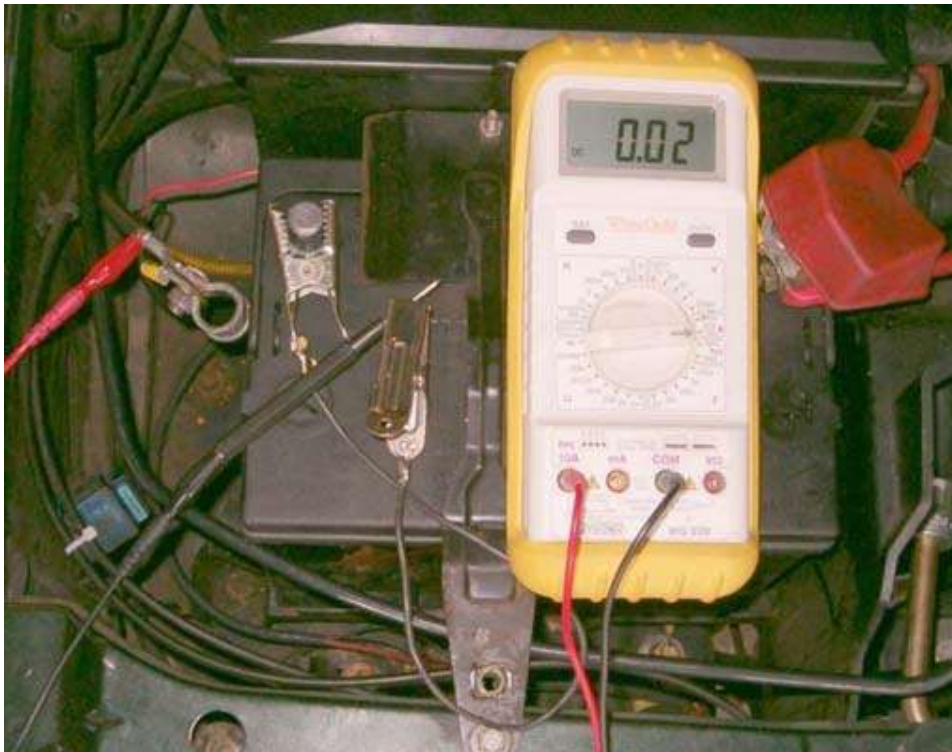
Photo: Andy's multimeter registers .02 amps (20 mA) with the BECM asleep.
