Take one discovery td5 ES with a perpetually soggy roof and a multitude of drips onto the drivers legs and rear seat and try to find out why its leaking and fix it without trashing all the clips, headlining and panels.

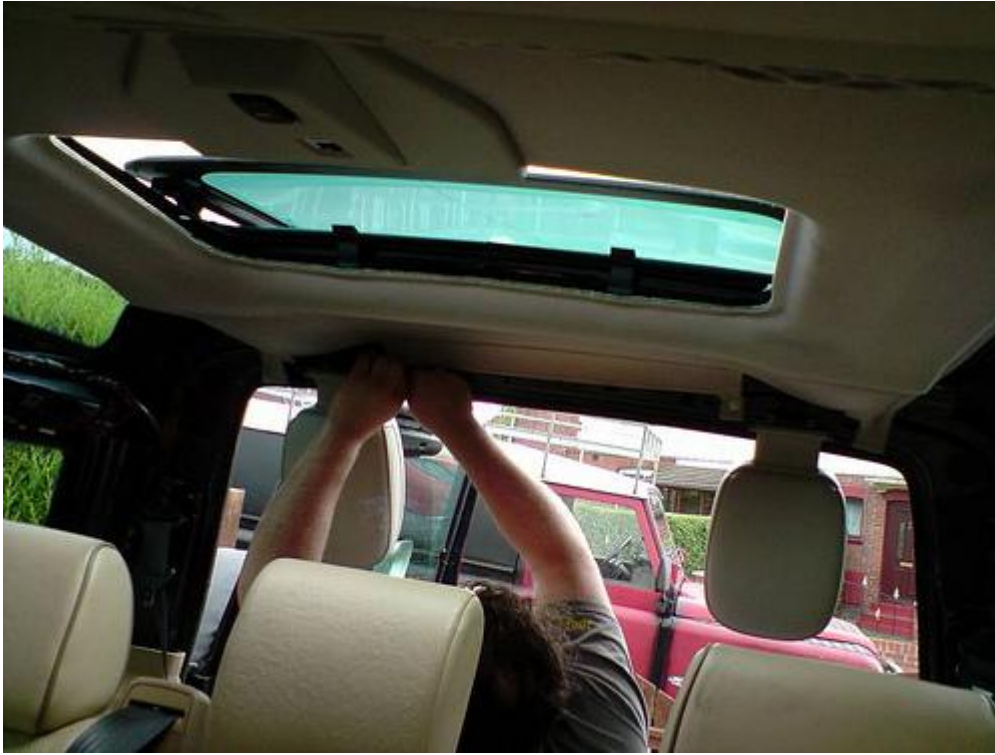
Drop the dickie seat headrest down and pull off the plastic trim along the top of the roof surrounding the headrest mounts. There are 2 little slider bits of trim that slot between the headrest and the main trim. Be careful of removing these as they are flimsy peices of cr@p.

Behind this panel are 2 small plastic clips holding the rooflining to the very back of the roof. remove.

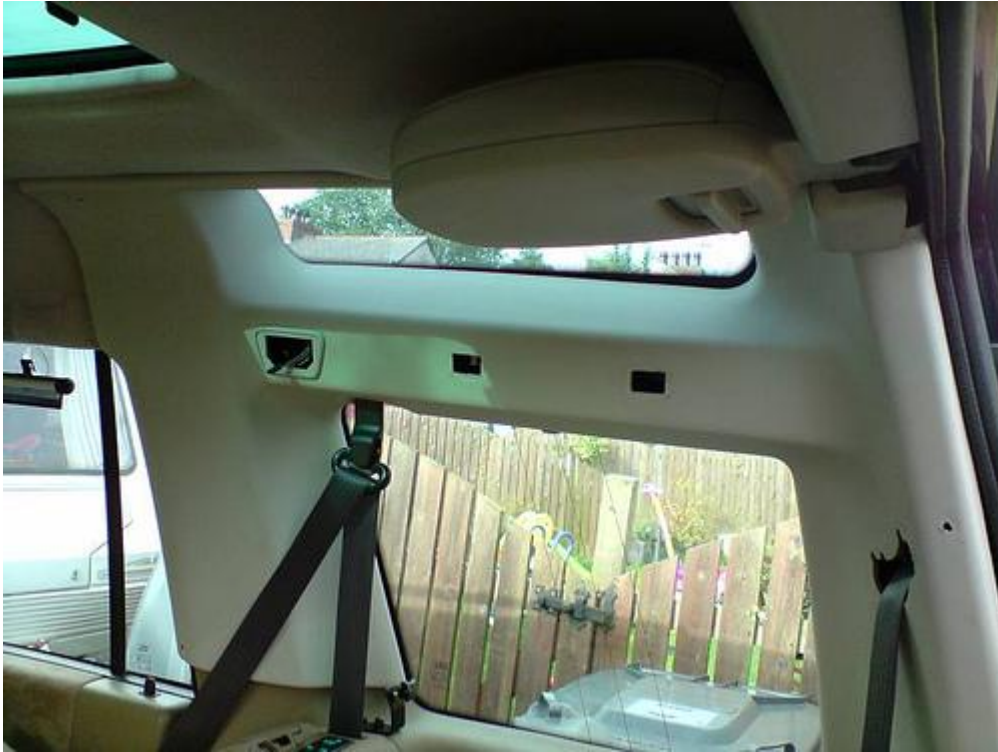
Once thats off, move on to the main side rear panels. These are held on by a combination of 5 long plastic pushclips and 2 little screws under plastic covers. The covers snap off really easily so be careful. then just pull off the alarm motion sensor, its held on by 2 metal friction clips and comes off easy enough.

Once you have removed the clips, you need to remove the rear grab handles. Each end of the handle has a little cover. Squeeze the covers between your fingers and they pop open. Behind each handle is a little black plastic spacer. **KEEP THESE REAR HANDLES AWAY FROM THE REST OF THE GRAB HANDLES** - as the bolts are alot longer and the other 4 grab handles in the car wont fit in these positions when it comes to refitting!

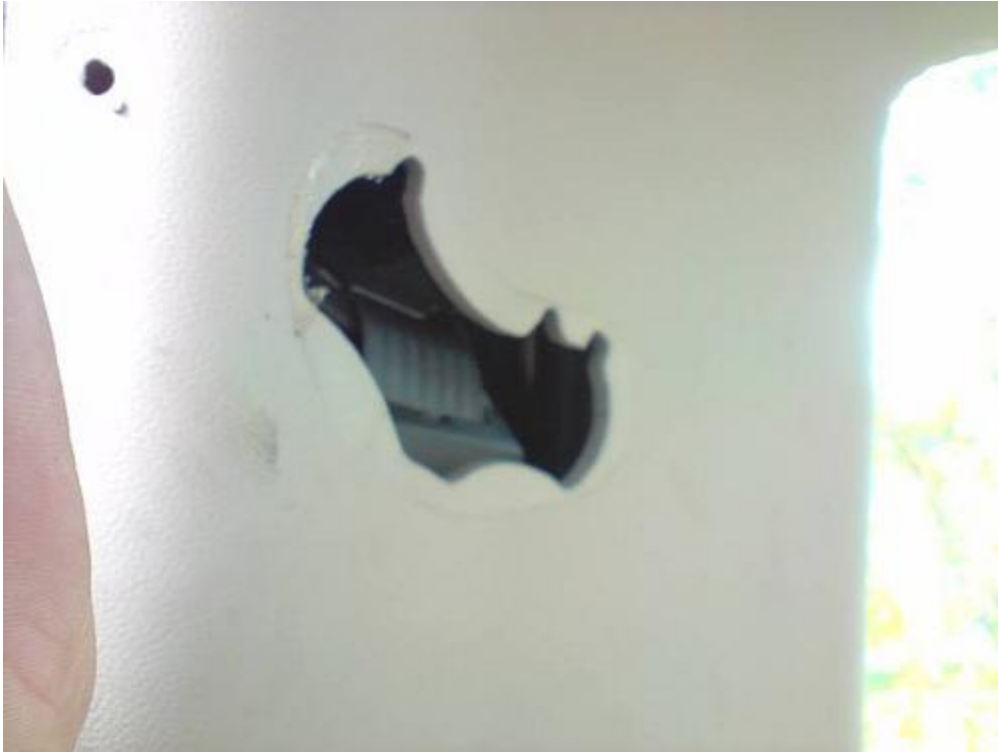
Now the only thing stopping you removing the panel is the rear dickie seat 3 point seatbelt. Remove the 17mm bottom anchor bolt and then remove the plastic trim covering the whole in the panel that the belt feeds through, there should now be enough room to feed the belt and clip through the hole and the rear panel should now be free,

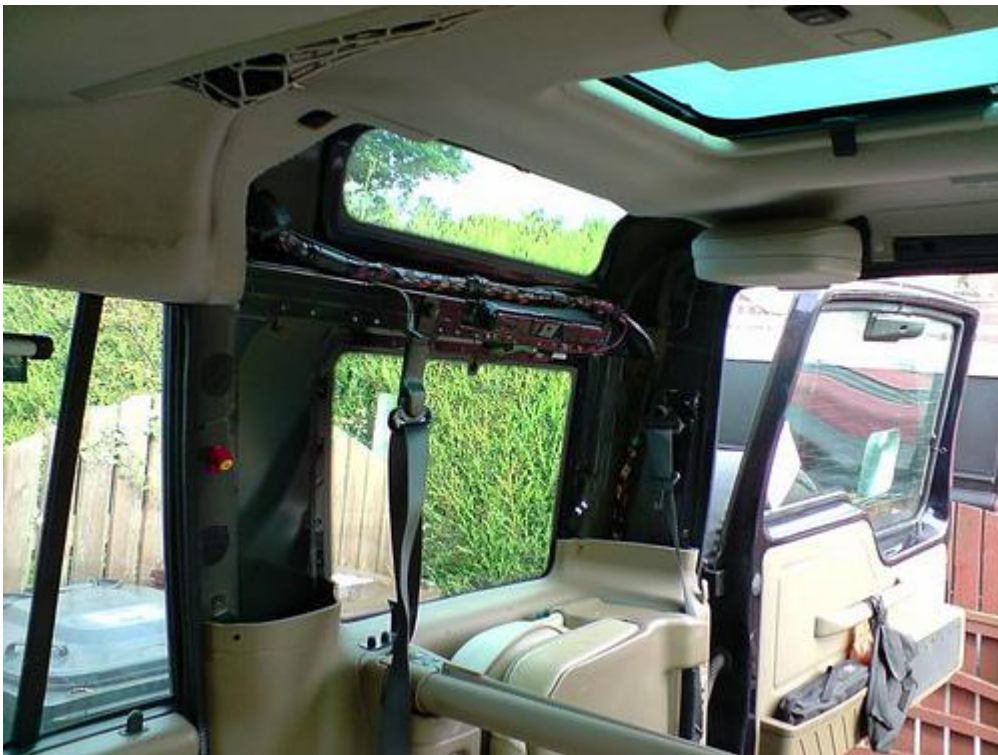
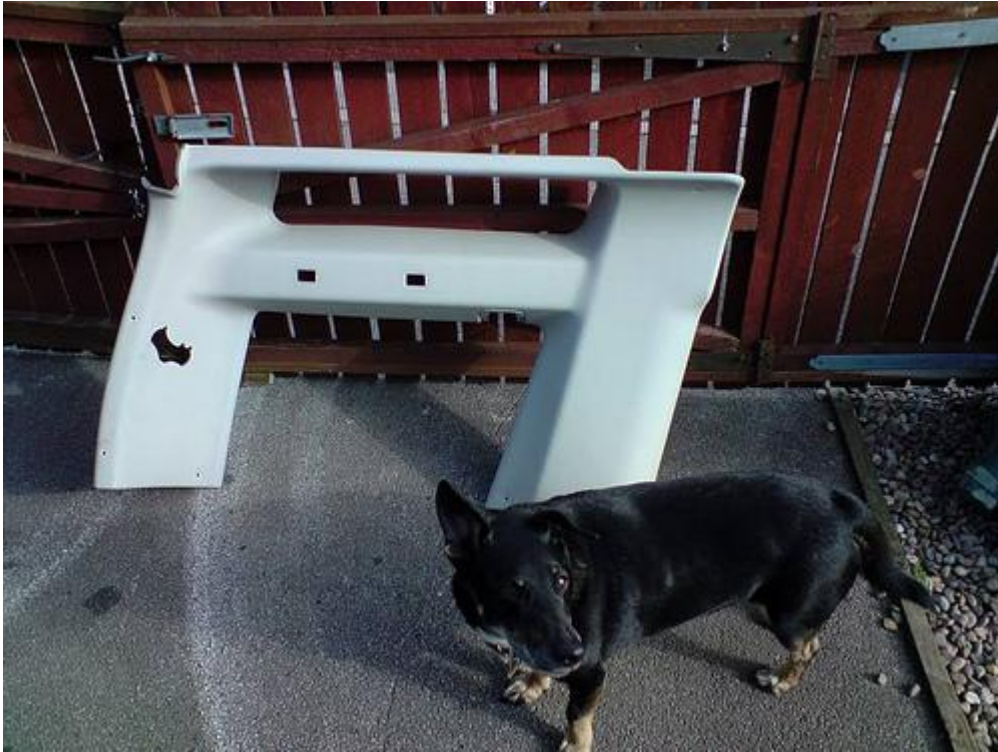
it isnt easy remove without damaging it, but if you push the bottom of the trim down and pull the top of the trim towards you it will pop out.

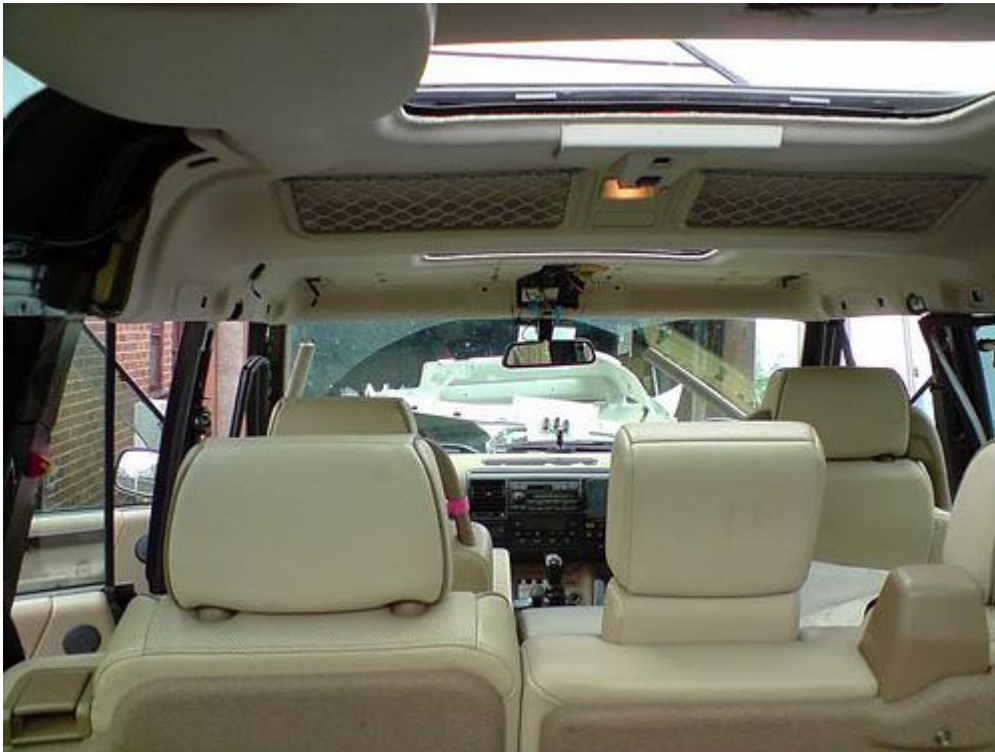
Prise out the lamp lense. The lamp itself is held directly to the roof by 2 8mm nuts. Remove the bulb first or you will make sparks and possibly let the smoke out of the wiring loom!

Next to the light is a small plastic panel hiding a screw. Prise the panel off and undo.

Prise out the sunroof switch (carefully) and there is a screw hidden under there as well.

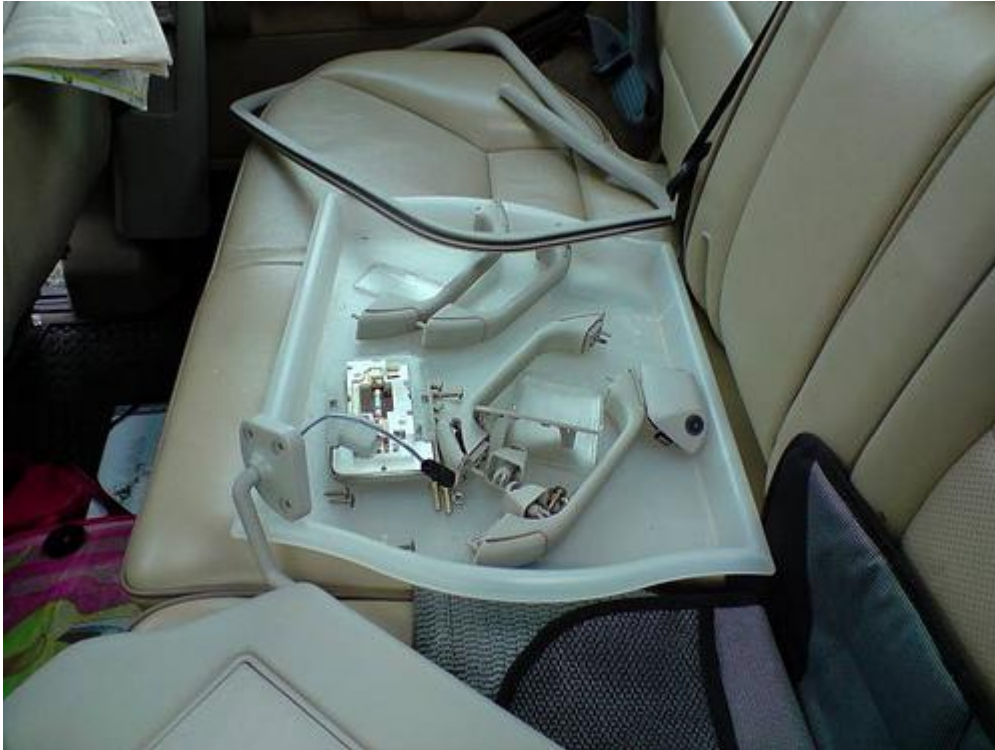
now pull off the felt trim that goes round the sunroof aperture and hides the join between the sunroof and the rooflining, and put to one side safely

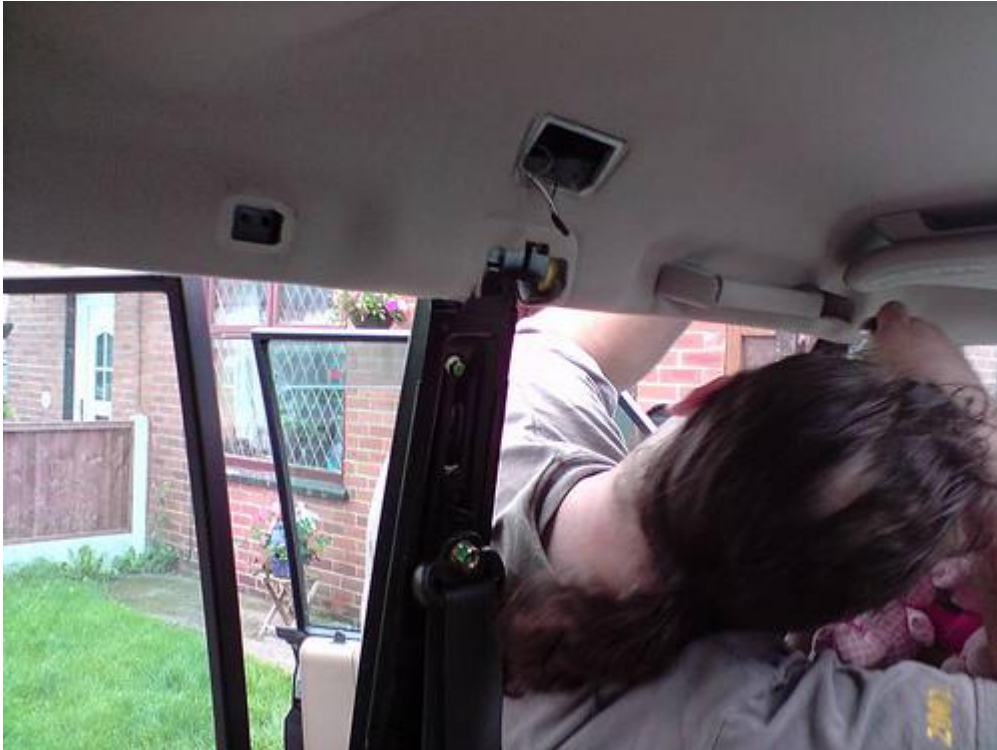
To do this pull off the rubber door seals on all 4 doors. This will give you access to the little clips (about 2mm wide and thin so careful) to go round the edge of the metal door pillars. Using point nosed pliers pull them outwards and then back. I think there were 4 on each panel. The panel is now held on by 2 large push connectors hidden behind the panel. Just grab hold of the panel and sharply tug it away from the door pillar and it will come away.

The panels between the doors won't come fully away as the front seat belts (and height adjusters) go through them - but pull the belt out a couple of feet and the panels will tuck out of the way behind the front seat headrests.

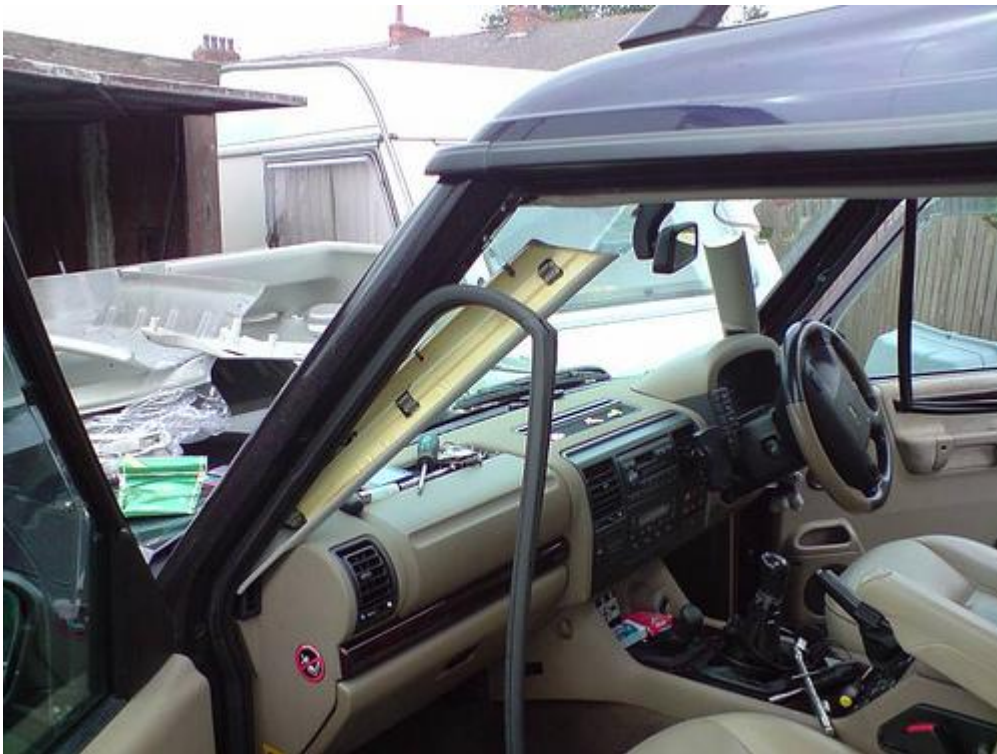
The front panels between the door and windscreen are also removed in the same way - but dont pull them too hard as the tweeters are built in and the spare wiring that connects to them was very short. Again i just left them dangling as they werent in the way.

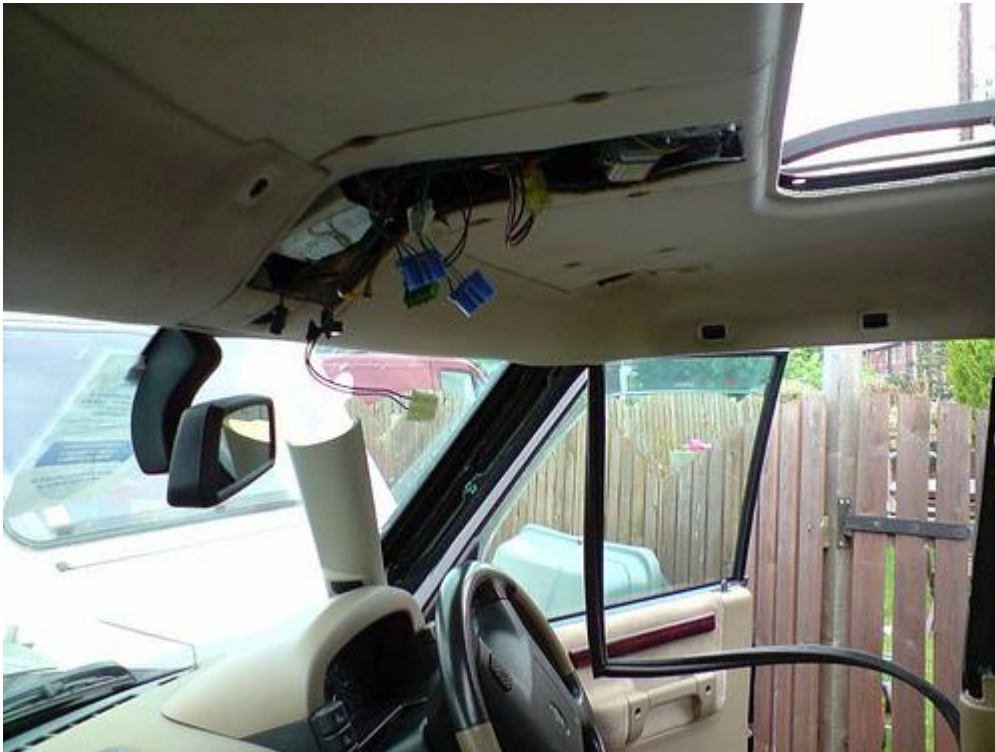
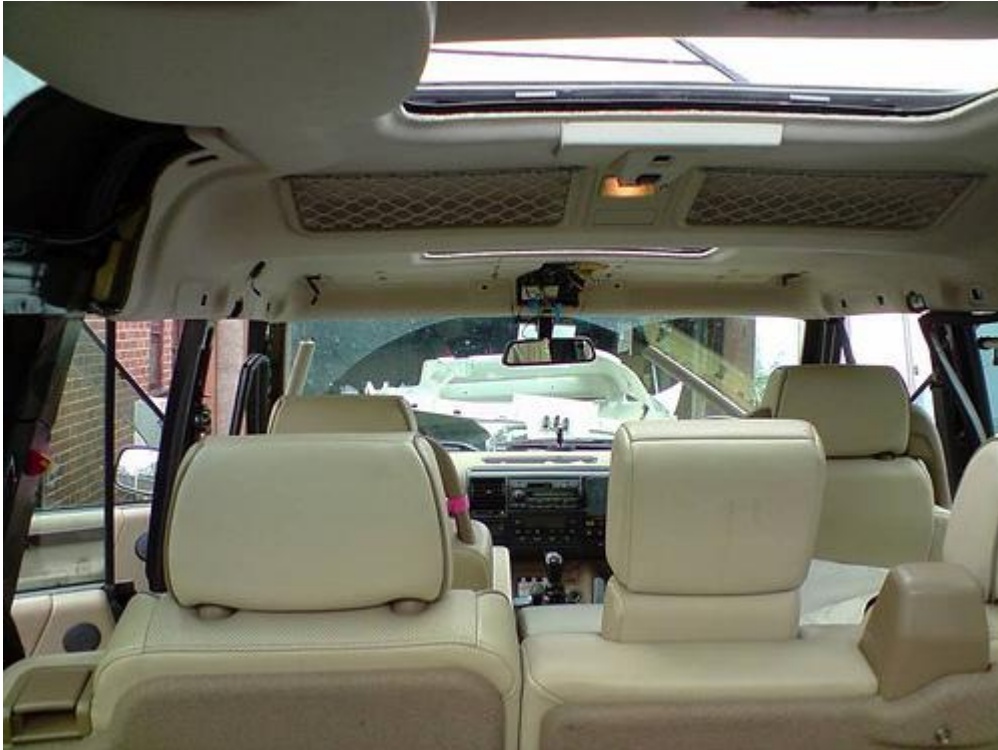
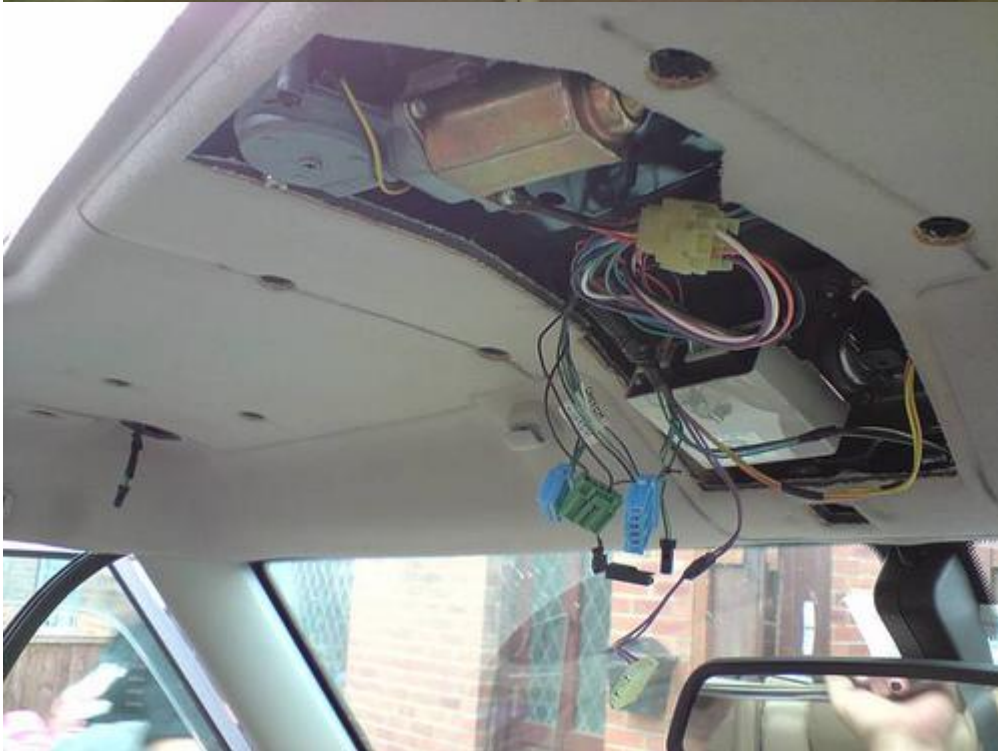
The whole centre console should now drop down.

Unclip the 3 big connectors to the sunroof switches, the connector and earth on the courtesy light and it's all out!

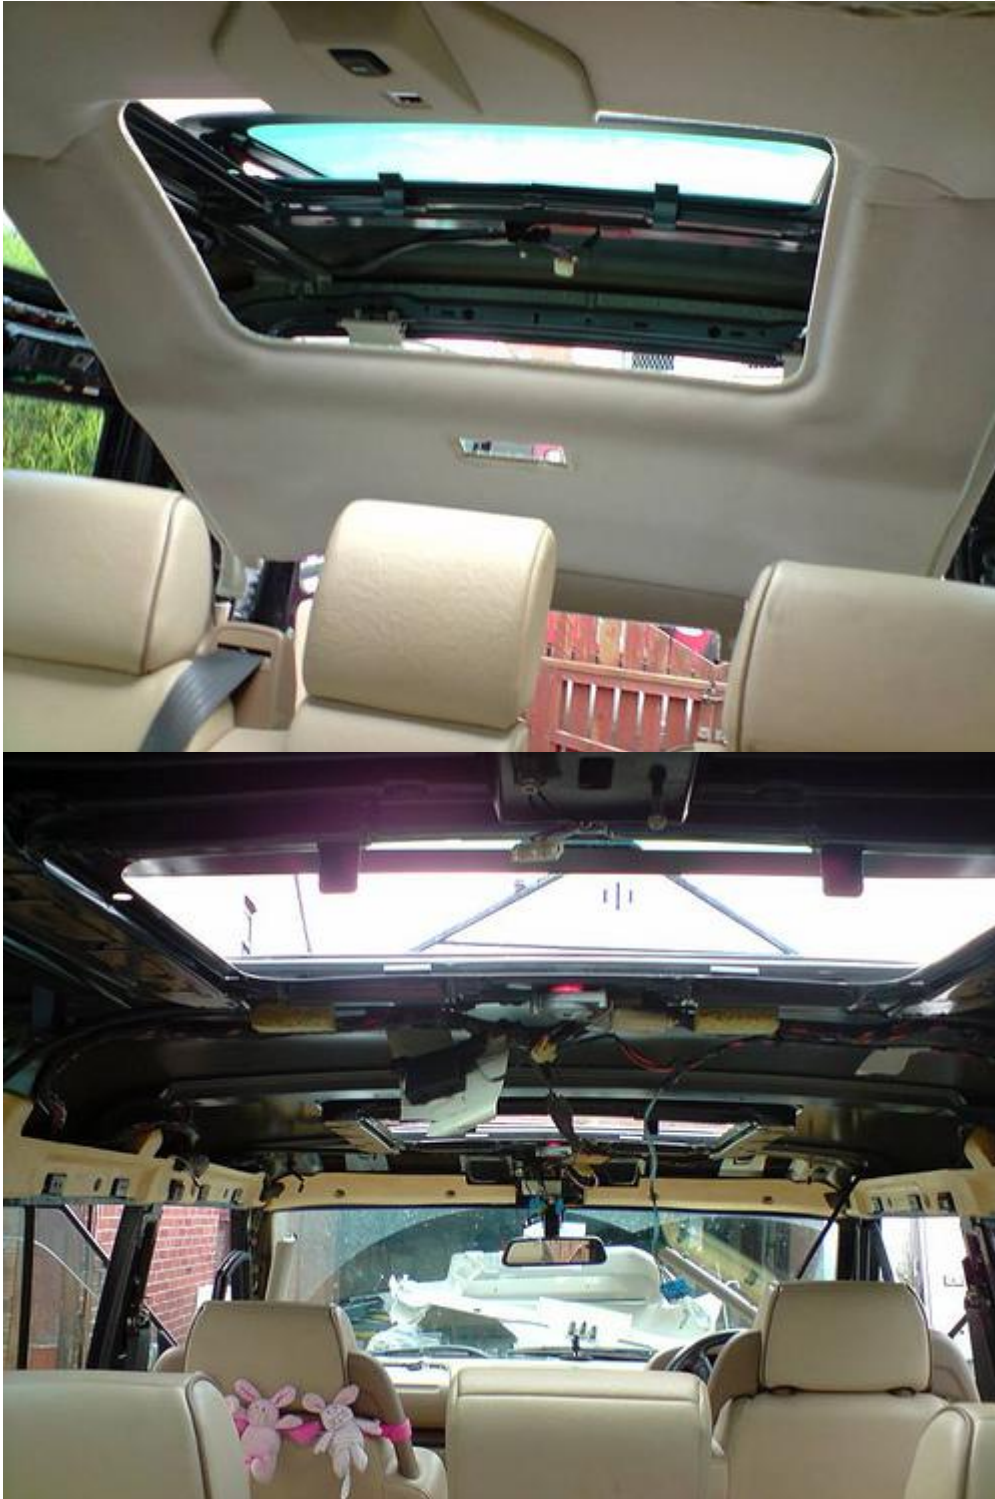
Once its all out it should look like this:-

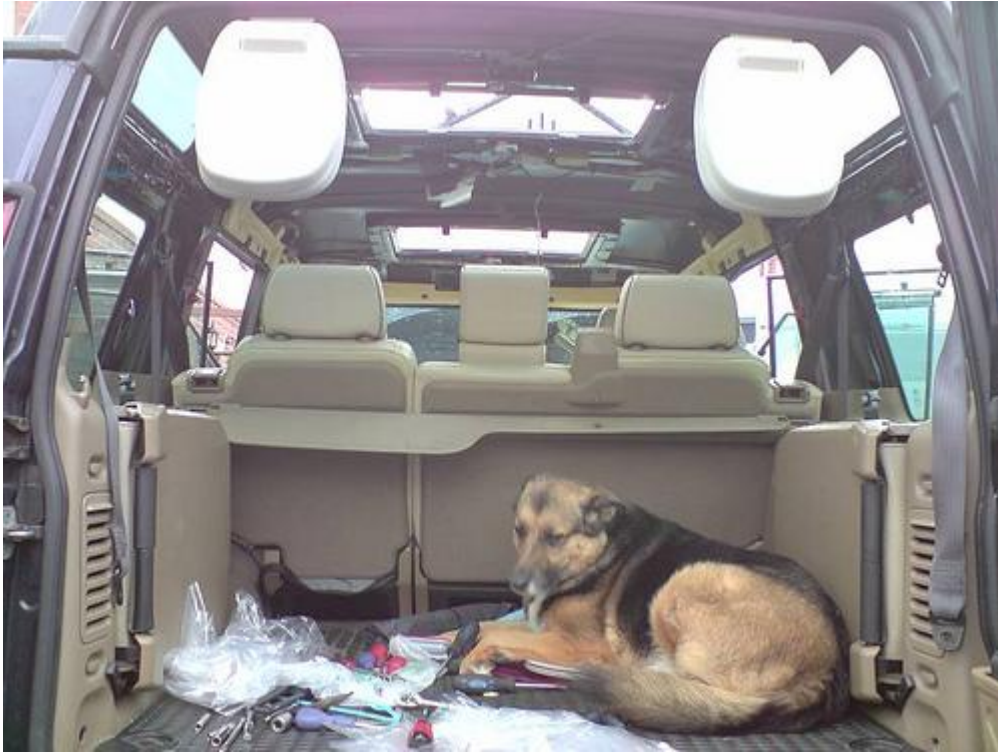
the problem I found was one of the drain pipes where it pushes onto the plastic tube on the drain cup had snapped. the end of the plastic drain cup was inside the pipe and it was a clean break.

Out came the araldite and glued it back on,
Whilst i was there and had access to all the drain pipes and plastic cups,
i made sure all the pipes were obstruction free and re-sealed all the plastic
cups to the sunroof frames.
