CIRCULATE TO:-			 
SERVICE MGR.	X		
RECEPTION	X		
WORKSHOP	X		
PARTS	X	SUBJECT	31/10/94
		Fusible Link-Repair	86/16/94/EN
MODEL Range Rover Classic		AFFECTED VEHICLES All V8 derivatives Range Rover from LH 610295 to LH 647644 and Discovery from LJ 034314 to LJ 081990

Page 2 of 2	SUBJECT Fusible Link Repair	31/10/94 86/16/94/EN
MODEL Range Rover Classic	AFFECTED VEHICLES All V8 derivatives Range Rover from LH 610295 to LH 647644 and Discovery from LJ 034314 to LJ 081990

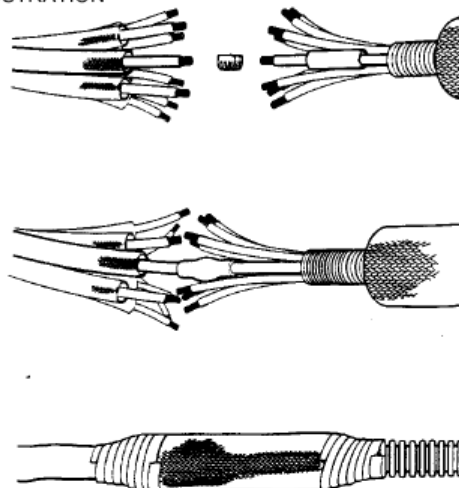
ILLUSTRATION

AMR 3927 Discovery kit
AMR 3928 Range Rover kit

- 1) Disconnect the battery positive and negative leads.
- 2) Locate the fusible links in the positive battery lead, covered by an expandable gauze sleeve.
- 3) Remove the tape wrap from the gauze sleeve and cut the gauze from the harness to expose the fusible links.

Note: Discovery-has 8 off 1 mm fusible links and dependant on the specification of the vehicle utilises upto all 8 of the links.
Range Rover-has 8 off 1mm and 2 off 2mm fusible links and dependant on the specification of the vehicle, utilises combinations of 1 and 2 mm links.
Identify which links are used and cut off the leads that are not used as close to the main cable as possible and insulate.

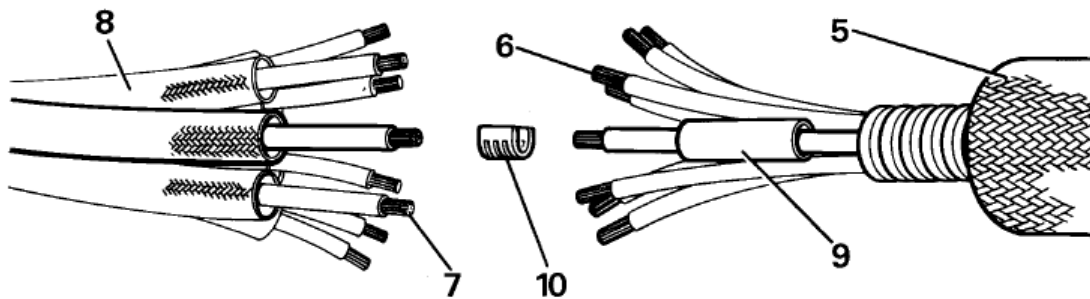
- 4) Cut each positive lead adjacent to the existing splice joint (on the main harness side of the splice). Ensure the cut is made through cables that are in good condition.
- 5) Fit the large gauze sleeve to the main harness and push back until the harness leads are exposed.
- 6) Trim back the insulation on the main harness leads 6 mm from the cut end.
- 7) Ensuring that the new fuse link selected matches the size (diameter) of the old, cut the new fusible link to a length appropriate to the positioning of the new individual splice joint. Trim back the insulation on the fusible link to 6 mm from the cut end.
- 8) Cut suitable lengths of gauze sheathing (to cover the complete length of the fusible link) to replace any damaged individual gauze sheaths and push back over the fusible links.
- 9) Fit a heat shrink sleeve over the individual main harness leads.

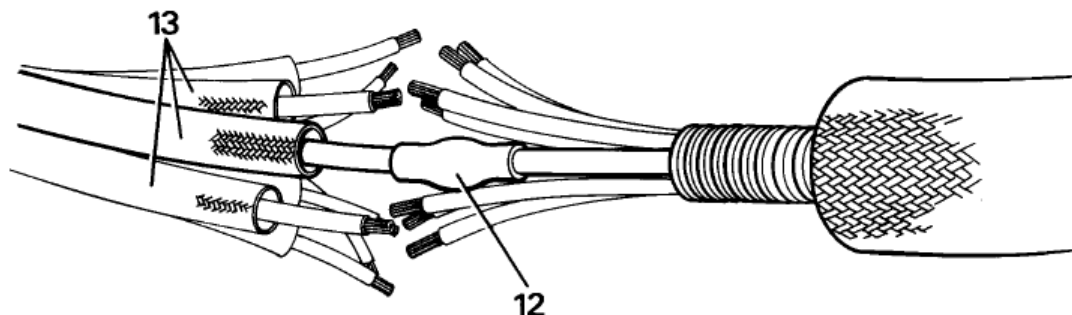
- 10) Using the inline splice overlap and crimp the individual fusible link to the appropriate main harness lead.
- 11) Solder the crimped leads together to provide a secure joint.
- 12) Position the heatshrink sleeve over the spliced joint and using a heat gun shrink the sleeve over the crimped/soldered joint.
- 13) Pull back the individual gauze sleeve to cover the full length of the fusible link.

NOTE: Repeat operations 1 to 13 for the remaining fusible links.

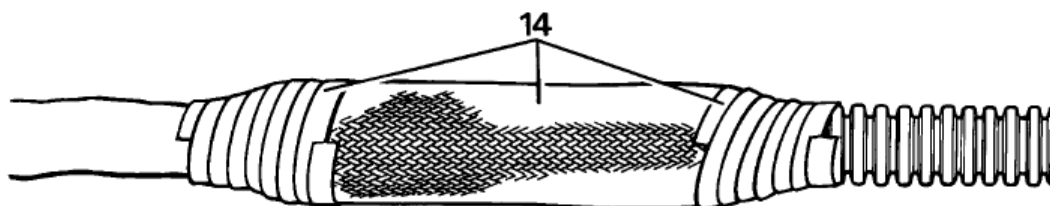
- 14) Pull back the large gauze sheath to cover the complete length of the link and securely tape the ends of the sheath to the main harness.
- 15) Reconnect the battery and re-input the radio CATS code.
