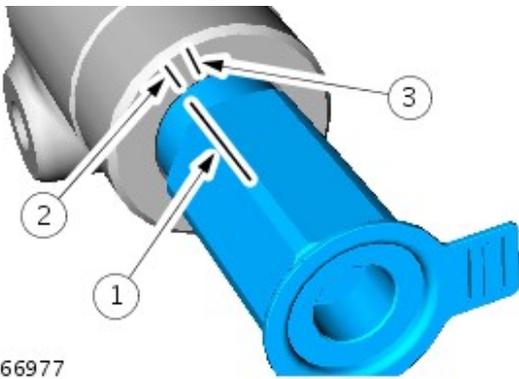
E66977

5. Tighten the fuel pressure relief valve and make sure that line (1) passes line (3).

- Tighten to 172 Nm (127 lb.ft).

6. If line (1) does not pass line (3) remove the fuel pressure relief valve and inspect for contamination and thread damage to the fuel rail. Reassemble from step 2.
