The Project

Decisions, Decisions.

Operation Lift Off

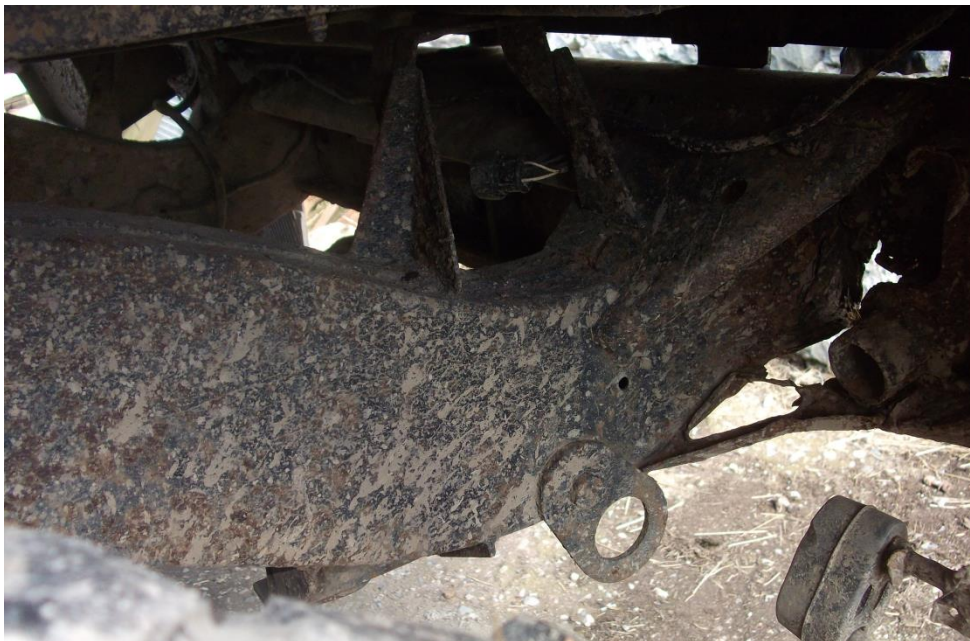
Rear cross member damage

The rear crossmember and the front outrigger both need replacement. I ordered these from Paddocks and they arrived promptly within a few days. I must admit that I was surprised at the lightness of the cross member. My old one had suffered a collision and was badly holed where it was bent, the outrigger is just gone gone gone ! I had done a quick check on the chassis on the first viewing and was happy that it didn't look too bad. The PO had stripped layers of body sealer from the rails and they looked rusty, but not holed. Access looked pretty straight forward also, plenty of headroom and plenty of space between chassis and body for welding access. I wasn't worried. When I got it home however, the more I looked at it the more I thought that it would be a botch job replacing the outrigger and cross member with the body still on, but always there is the nagging voice saying how do you line up the rear cross member with the body off ? After coming across some chassis drawing I decided that I should be able to do some measuring and use a chalk line to line the rear cross member up off-body.

So decision made, I would lift the body, clean up the chassis, fit the new rear cross member and outrigger, treat the chassis with rust killer, paint and waxoyl. Not what I planned on when I first saw the add, but sure it would be an experience.

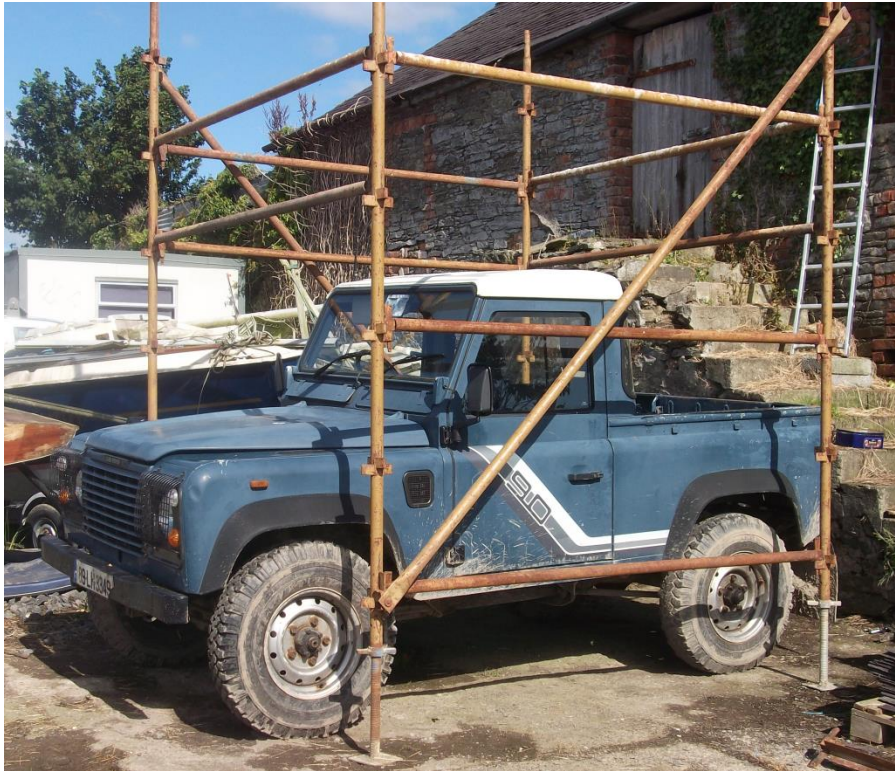
Shed space is at a premium at the moment, and anyway that waxoyl looks like a filthy job, so I guess we will try the great outdoors. There is a bit of scaffolding lying about and I have a one ton chain hoist. A bit of begging produced another hoist (thanks Stephen).

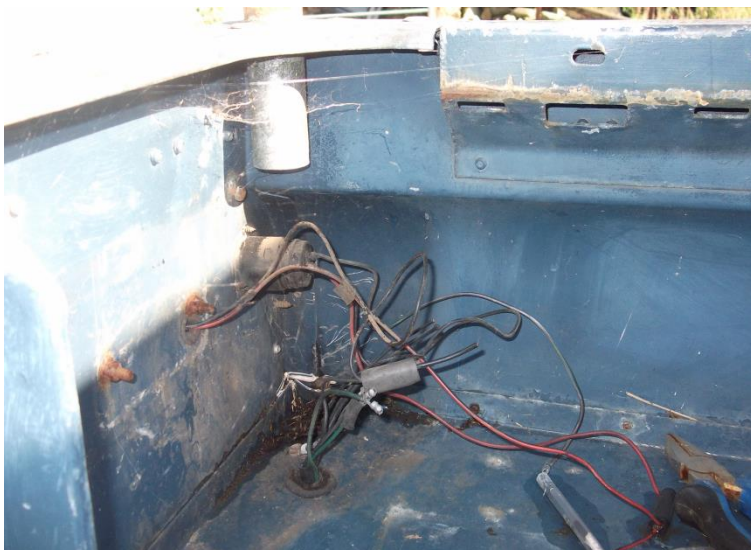
Disconnected the wiring to the rear lights by removing the panels behind each cluster and disconnecting, taking note of what goes where.

If I was doing this again I would cut the loom under the tub after it comes out of the chassis and fit a decent connection box , something like a “Rubberite” one. This would also provide a good interface for the tow bar socket.

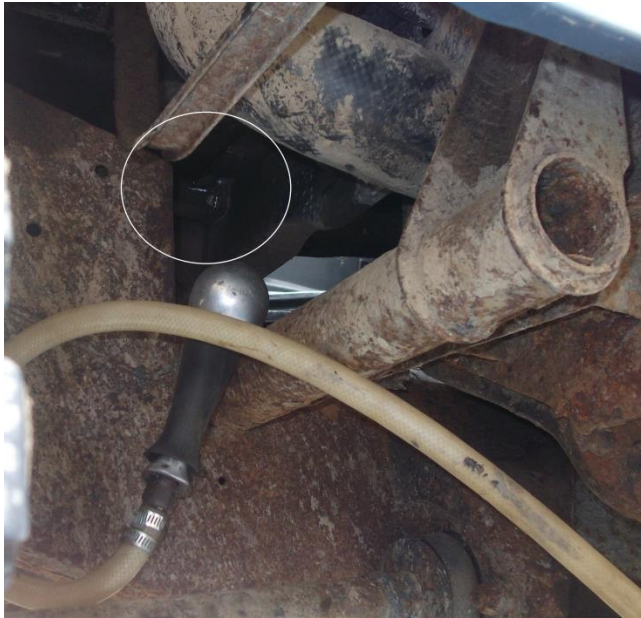
Moving forward, there are two brackets coming off the middle cross member to the tub. The one on the driver side ended up a disaster for me. The tank left very poor access, and the bolt head was spinning in spanners. Couldn't get a socket on it. Ended up spending a couple of hours with an air chisel. These are the times when I wished I had cutting gas or a plasma cutter !

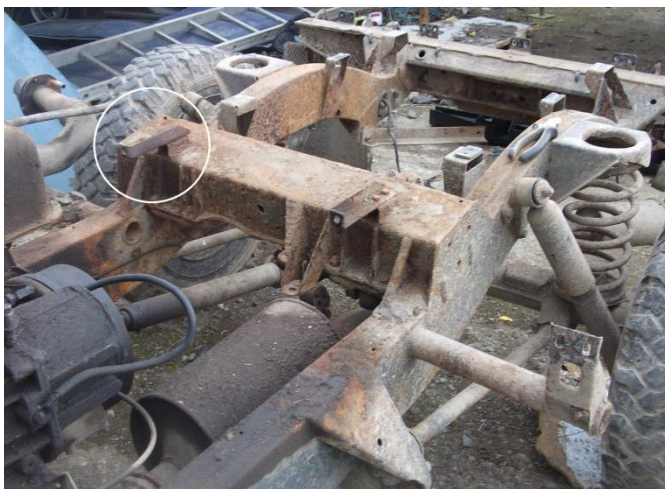
If only you could fast forward for easy access....

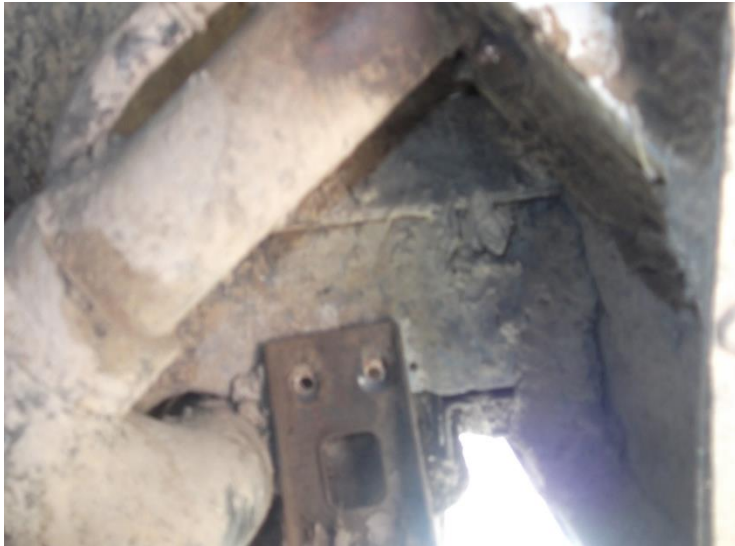
Next up, remove two bolts on each of the rear out riggers. No bother with these.

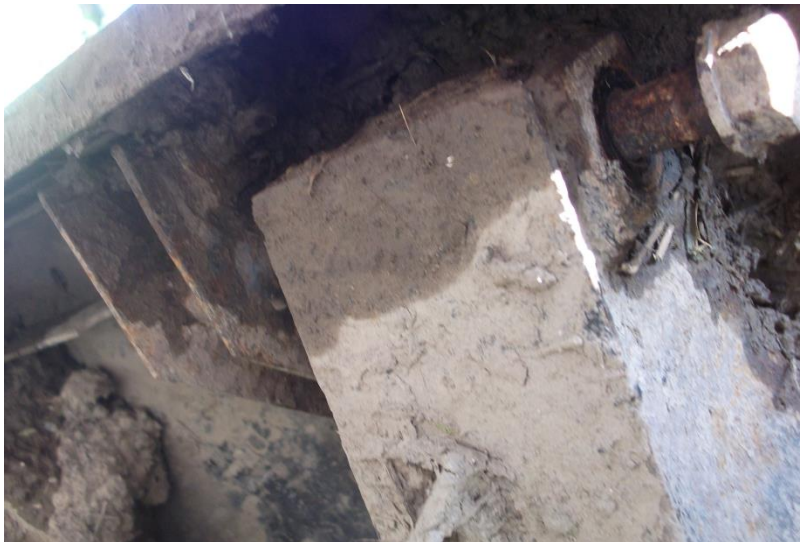
One big bolt on each of the front outriggers. I had to drive them out with a punch. I guess these could be fun putting back in.

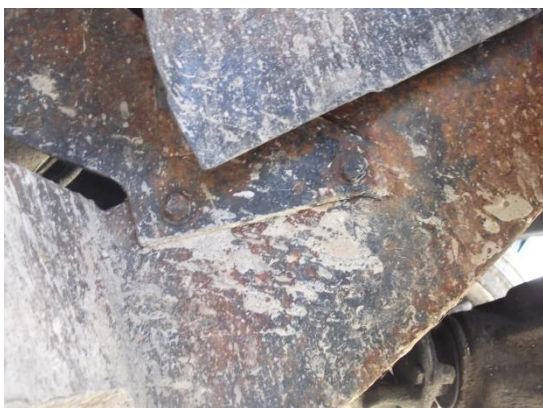
Remove the two bolts that go through the chassis legs, from the bulkhead brackets, just forward of the front outriggers.

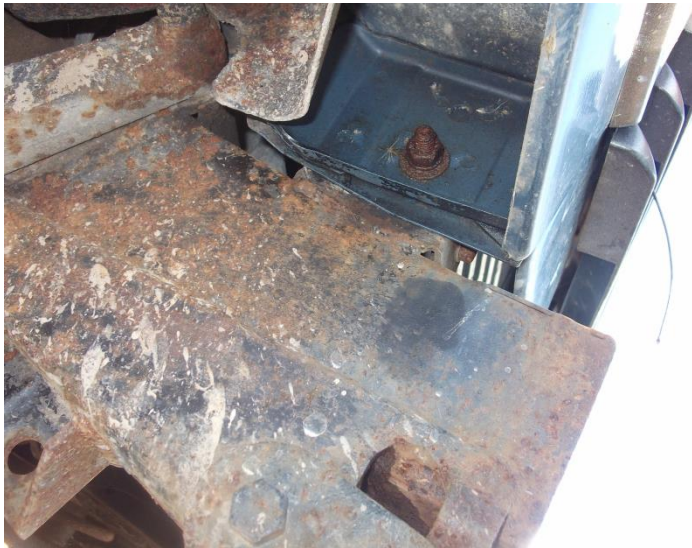
There is a bolt underneath to the chassis on each side

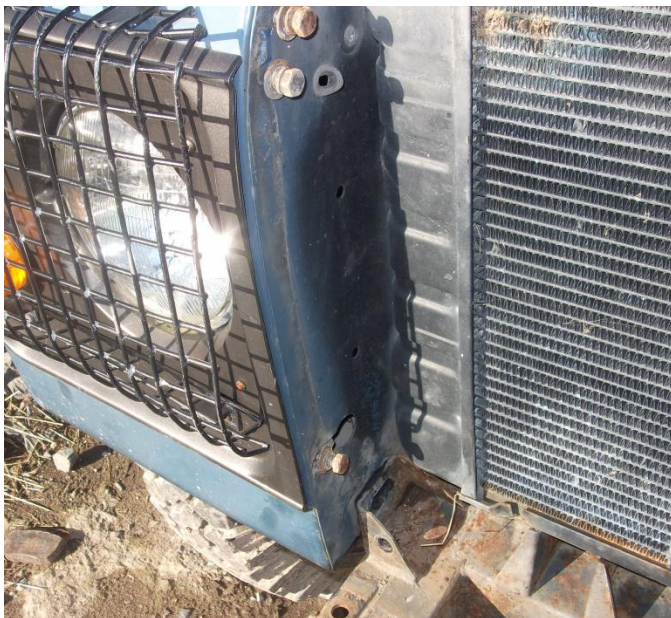
And a couple each side into the front wings

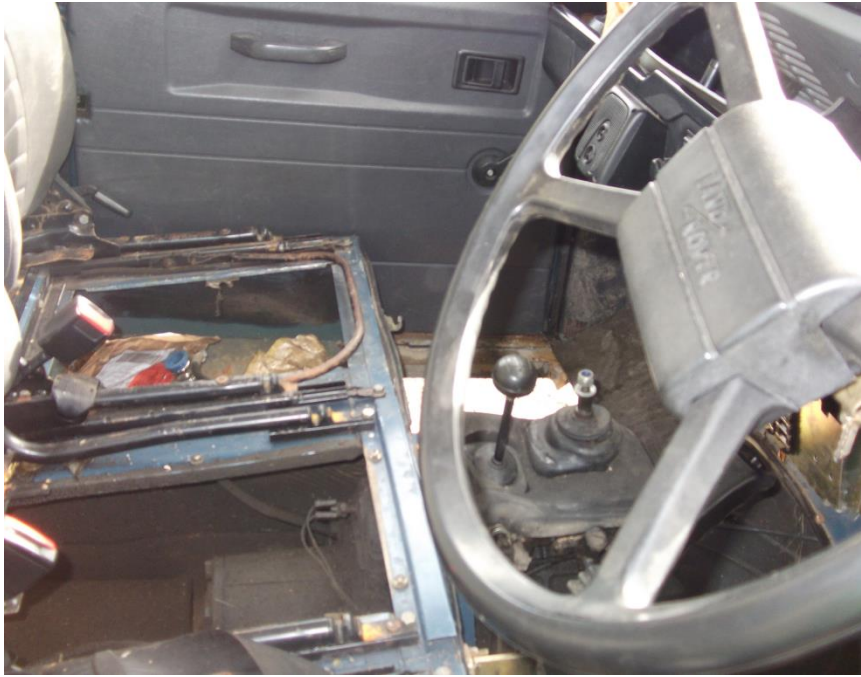
Into the cab now and remove the seat bases and floor plates, remove the battery and push the battery cables down out of the compartment. Remove the main gear lever and the tunnel cover.

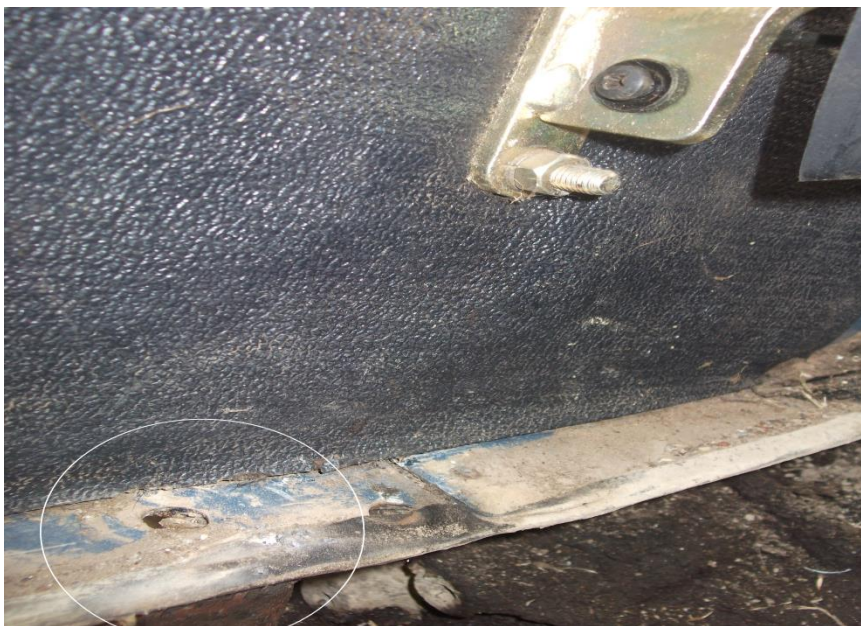
There are two bolts from the floor pan to the chassis, one each side of the gearbox, just in front of the seat box.

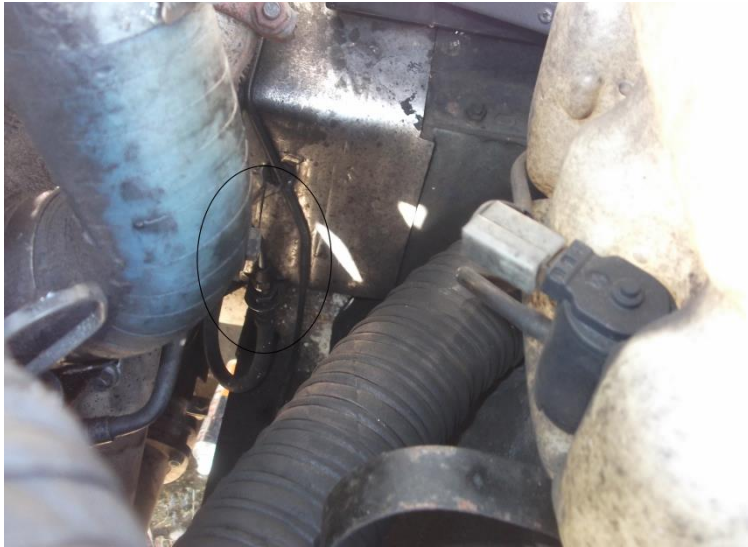
Into the engine bay now and disconnected heater hoses from the heater. I removed the air cleaner and piping. Disconnected the wiring harness under the brake servo. Disconnected the heater plug feed from the first plug. Disconnected the throttle cable. Disconnected brake pipes at callipers and some on the bulkhead. Unbolted the diesel filter housing, complete with pipes, from the bulkhead. Unbolt the header tank and power steering reservoir from the inner wings and leave dangling. (probably missed some stuff here, but you get the idea). Disconnected the clutch hydraulic pipe.

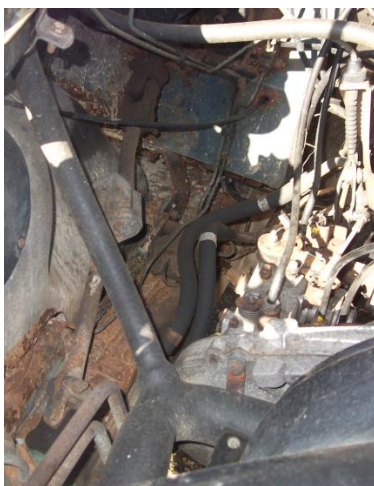
For the steering shaft, I loosened and removed the pinch bolts on the upper and lower u/j's. The shaft can then be pushed further up into the top u/j until the bottom one clears the steering box shaft and can then be removed. My lower u/j is shagged so this adds to the shopping list.

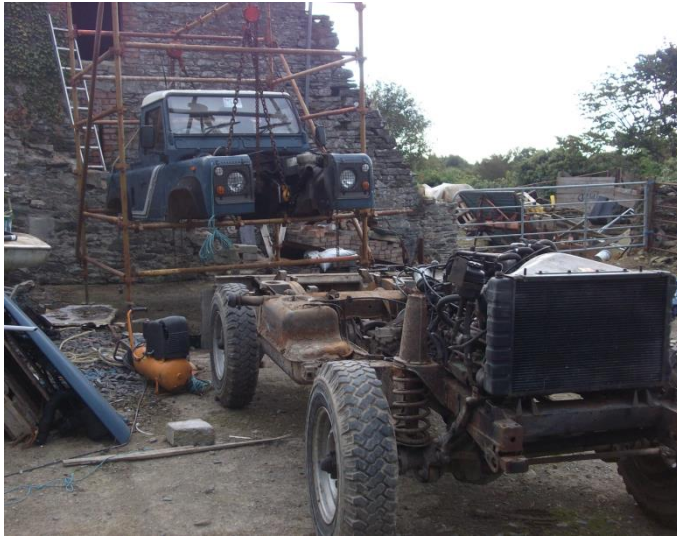
For lifting the body, I erected scaffolding and two chain hoists. At the rear I used a lifting strap under the tub at the wheel arches. At the front I used a chain connected to the bulkhead chassis brackets.

The body lifted freely from the chassis, the tub needed a slight lever.

I lifted the body about a foot and then wheeled the rolling chassis forward out of the body.
