SERVICE MGR.	<input checked="" type="checkbox"/>	SUBJECT 'E' Post Trim Area - Water Ingress		issue 2		
RECEPTION	<input checked="" type="checkbox"/>

WORKSHOP	<input checked="" type="checkbox"/>					
PARTS	<input checked="" type="checkbox"/>					
MODEL		AFFECTED VEHICLES				
Discovery		LP				
		LH				
		LJ	081991 onward			
		LD				
<p>DETAIL</p> <p>Investigations have shown that on some vehicles water can enter into the vehicle around the 'E' post, there can be several causes for water ingress in this area, all known water ingress paths and fixes are detailed on the flow chart attached.</p>						
<p>ACTION REQUIRED</p> <p>Upon customer complaint of water ingress around the 'E' post, follow the flow chart overleaf.</p>						
<p>PARTS INFORMATION</p> <p>Not applicable</p>		<p>ILLUSTRATION</p>

SUBJECT	
Rear End Door Seal - Water Ingress	
MODEL	AFFECTED VEHICLES
Discovery	LP LH LJ All LD

SUBJECT
Sunroof -Water Ingress

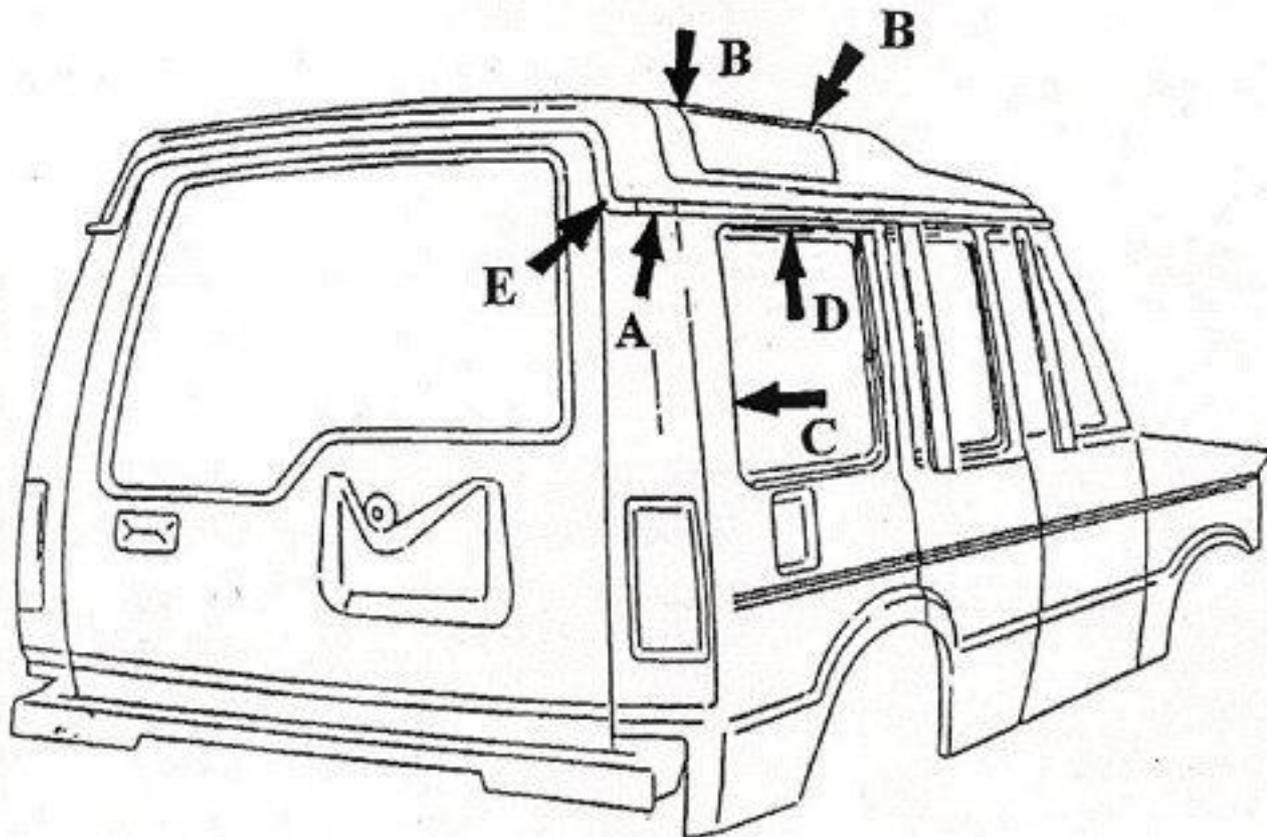
Water drips from alpine light
(see illustration, arrow B)

Check for cracks around flange see 'E' on
illustration; reseal each side of flange.
The flange has been moved inside can't
rail to improve water ingress concerns from
Vins 199607 and 530346.

Reseal alpine light glass to rubber and rubber to
body on outside surface
