Discovery Water Ingress Manual

CIRCULATE TO:-		TECHNICAL INFORMATION		LAND-ROVER
SERVICE MGR.	<input checked="" type="checkbox"/>	SUBJECT 'E' Post Trim Area - Water Ingress		issue 2
RECEPTION	<input checked="" type="checkbox"/>

SUBJECT		
Upper Windscreen Rubber - Water ingress		
MODEL	AFFECTED VEHICLES	
Discovery	LP	
	LH	
	LJ	
	LD

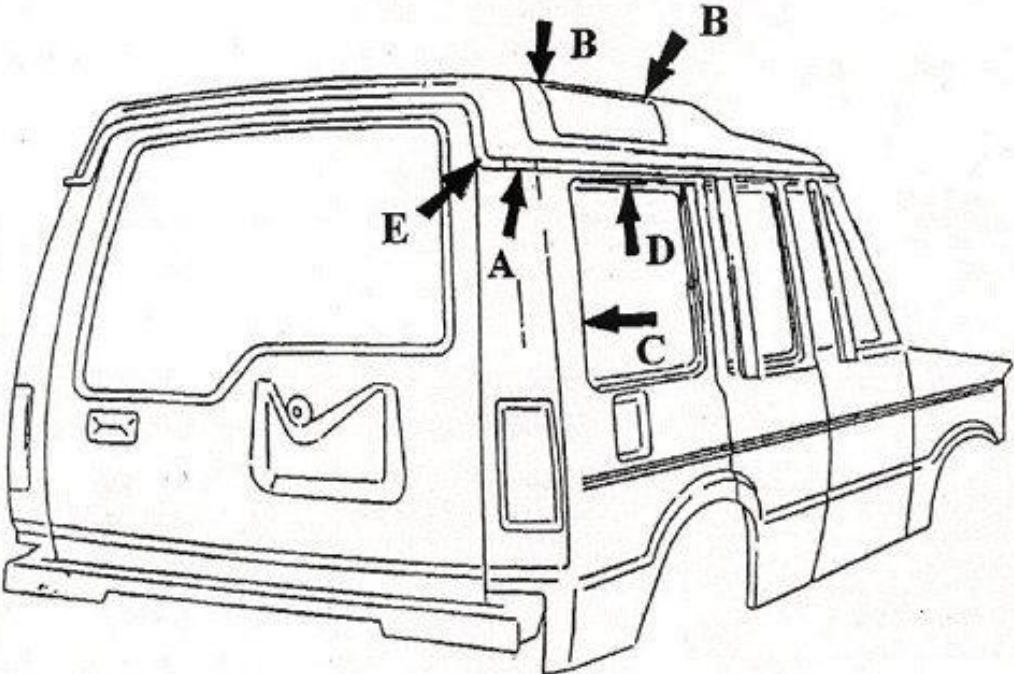
Water drips from alpine light
(see illustration, arrow B)

Check for cracks around flange see 'E' on
illustration, reseal each side of flange.
The flange has been moved inside can't
rail to improve water ingress concerns from
Vins 199607 and 530346

Reseal alpine light glass to rubber and rubber to
body on outside surface
