Technical Service Bulletin

No.LTB00292
25
May 2010

Subject/Concern: Unable to Open Fuel Filler Flap or Tailgate

Models:
Freelander 2 | | VIN- range: H032502 Onwards

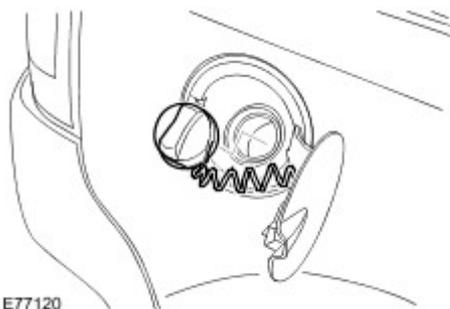
- 1 . Raise and support the vehicle (see Global Technical Reference GTR Workshop Manual, section 100-02).
- 2 . Remove the right-hand rear wheel and tire (see Global Technical Reference GTR Workshop Manual, section 204-04).
- 3 . Remove the fuel filler cap.
 - 1 . Release the fuel filler cap from the fuel filler neck.
 - 2 . Release the retaining clip.

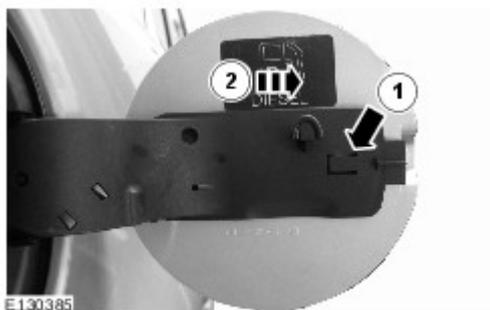
4 . Remove the fuel filler door cover.

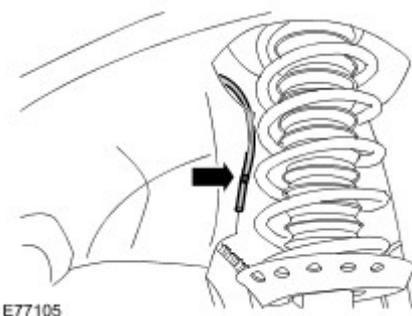
5 . Release the breather pipe.

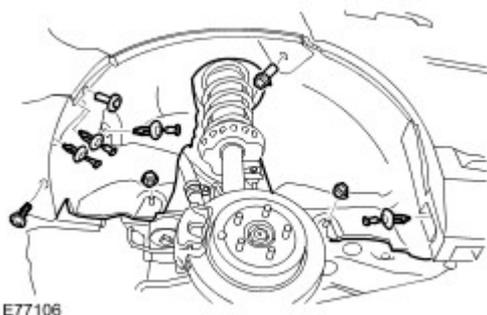
6 . Remove the right-hand rear wheel arch liner.

- 1 . Remove the two screws.
- 2 . Remove the torx screw.
- 3 . Remove the two scrivenets.
- 4 . Remove the two nuts.
- 5 . Release the two clips.

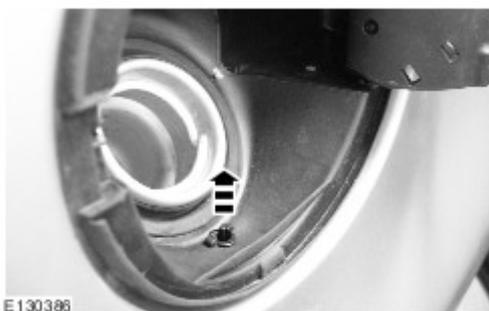
7 . Remove the breather hose.

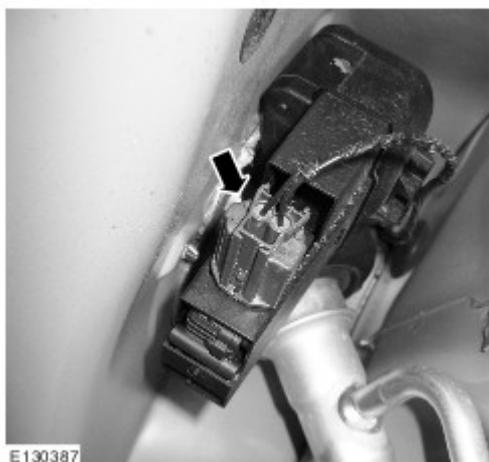
8 . Disconnect the electrical connector.

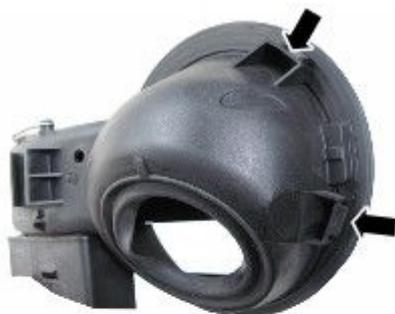
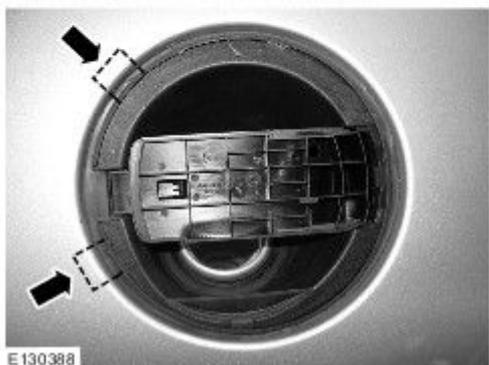
9 . **NOTE:** Make sure the fuel filler flap is in the closed position.

Remove the fuel filler housing.

1 . Release the two clips.
