A BUSY FEW DAYS

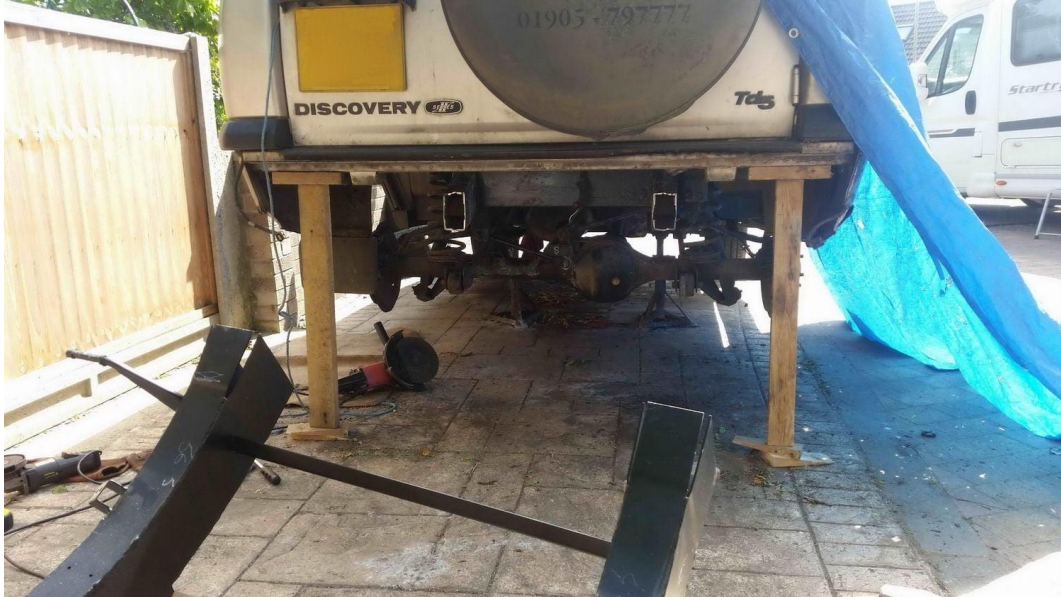
HI all have a busy few day, my disco failed it test, rust hole in the chassis at the back, so ordered a new section. several choices, I decided to replace the back section so I have to drain the tank, yes it was full , but by jacking up on the filler cap side as high as I could I syphoned it all out , possible the worse bit to do I first chopped off the rear cross section, to reduce the weight , when the new chassis arrived measure up the chopped the two side legs to length

Basically, you measure 565 mm from the centre of the rear mounting bolt, that the weld point, I did two cuts, one about 100 mm from the back cross member on both sides and removed the cross member, then after my new section arrived did a final check for my second cut, pointing is 500mm, this way it was easier to remove one side at a time the new section slides over the original if you look at the photos I posted you can see the weld end is splayed out to go over, once fitted, bolt the new section back up at the rear of the body this lines it all up the clamp the top and bottom on both sides to get it lined up finally clamp up the sides so you will need 6 -8 clamps, once its all clamped up, weld it up, to be honest the hardest part was removing the fuel from the tank, it all went very well after I had emptied the tank it was not difficult to do have fun , Im just installing my new steel front bumper

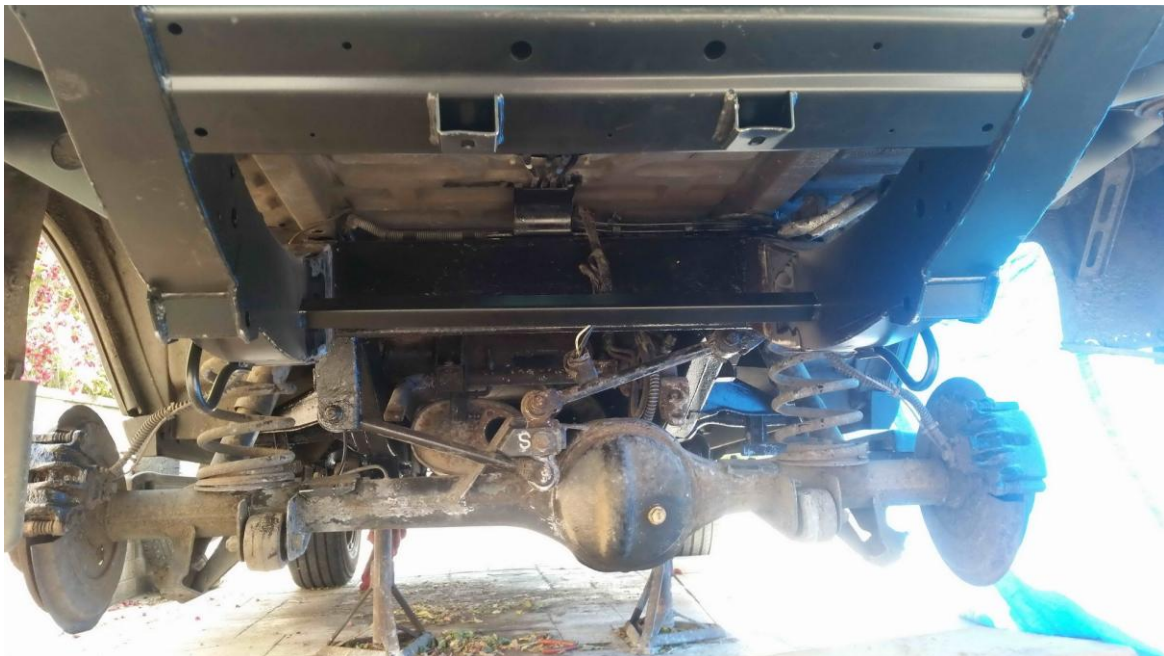
the new bit fitted well, did a trail fit, removed it cleaned up the original sections were it will weld on the refitted it and bolted it up in place

All ready for welding now

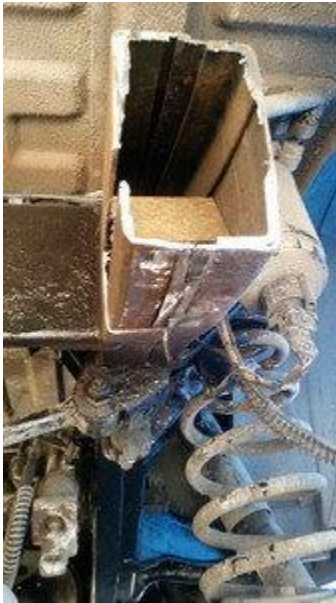
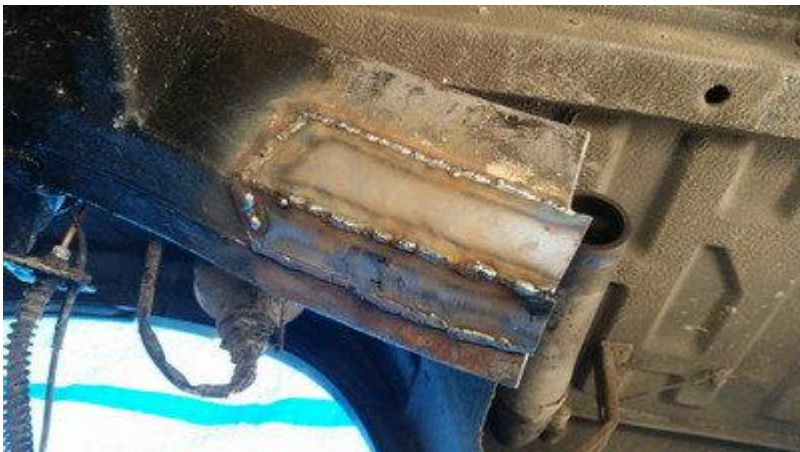
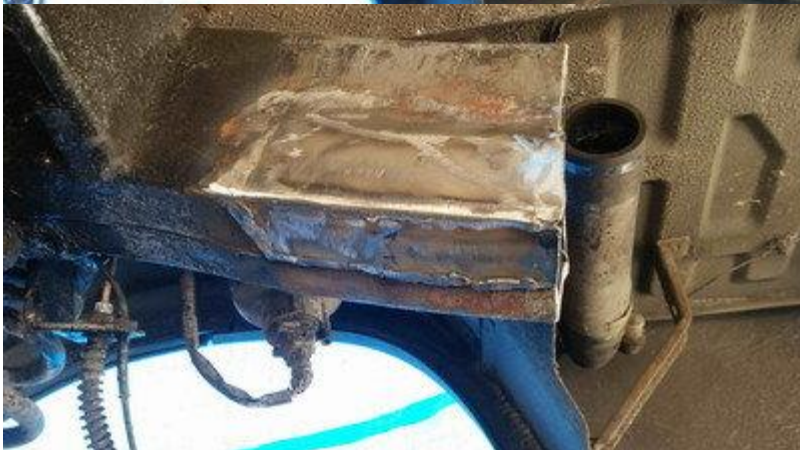
well all finished now had a few extra bits to do but the fit of the new section was very good

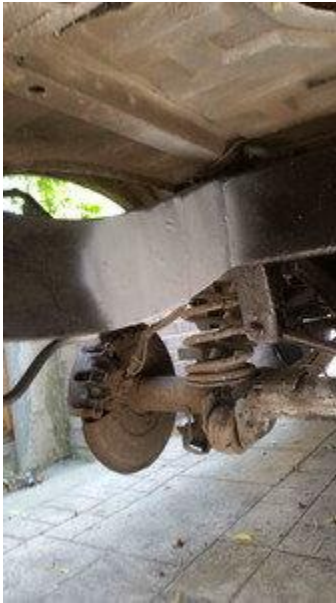
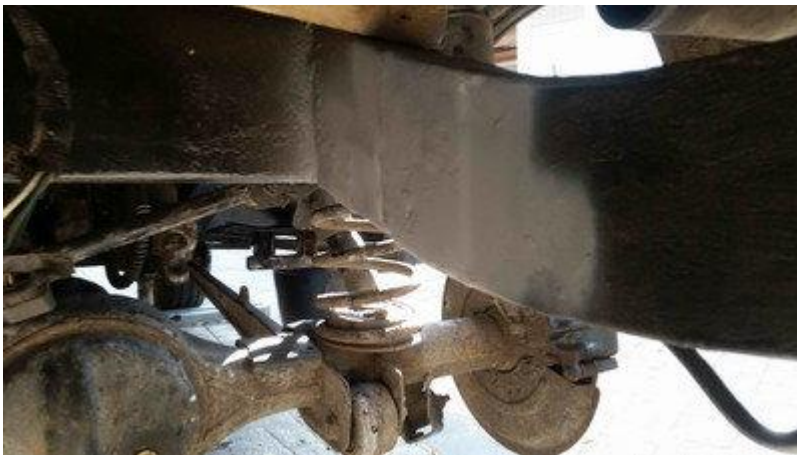
the finished job
