Connector: **C0071**

Harness: **WING LH HARNESS**

Description: **Motor-Headlamp-levelling-LH**

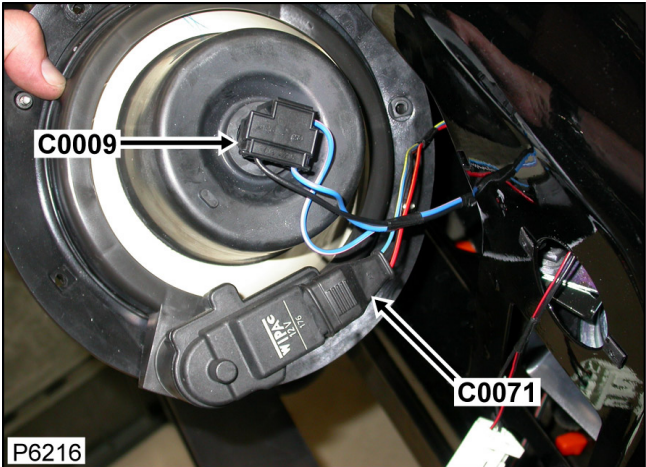
Part No.: **YPCI0426**

Cavities: **3WY**

Location: **Behind LH headlamp**

CAV	TERMINAL	CSA	COL	CCT	DESTN
1	YPLI0073	0.5D	UY	I07	CI265
2	YPLI0073	0.5D	B	I07	CTAP
3	YPLI0073	0.5D	RO	I07	CI265

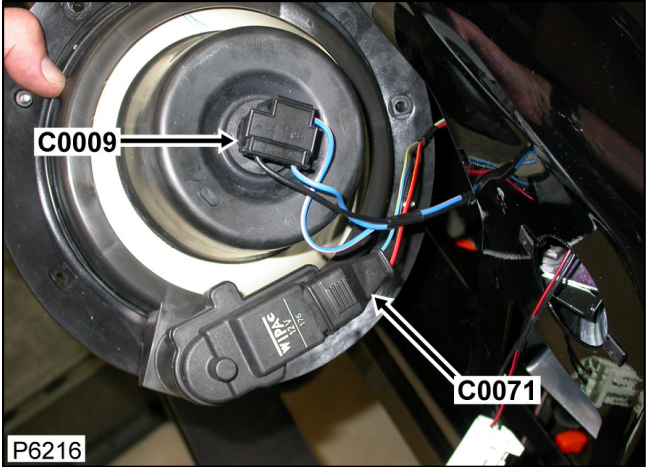
Connector: **C0071**

Part No.: **YPCI0426**

Cavities: **3WY**

Description: **Motor-Headlamp-levelling-LH**

Location: **Behind LH headlamp**

CAV	TERMINAL	CSA	COL	CCT	DESTN
1	YPLI0073	0.5D	UY	I07	CI265
2	YPLI0073	0.5D	B	I07	CTAP
