PUBLISHED: 04-FEB-2013  
2011.0 RANGE ROVER (LM), 303-01A

ENGINE – TDV8 4.4L DIESEL

# INTAKE MANIFOLD PLENUM CHAMBER (G1313558)

## REMOVAL

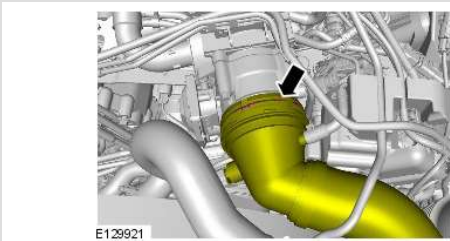
3. **⚠ CAUTION:**

Make sure that all openings are sealed. Use new blanking caps.

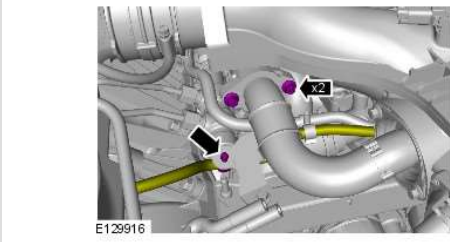
6.

#### NOTES:

- Remove and discard the gasket.
- Install a new gasket.

*Torque: 10 Nm*

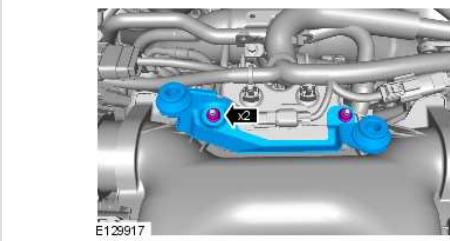
7.

*Torque: 10 Nm*

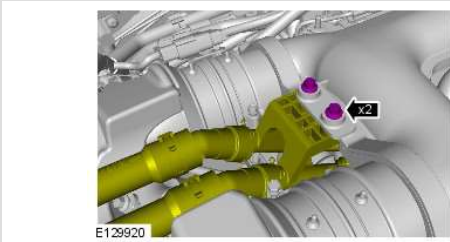
8.

*Torque: 10 Nm*

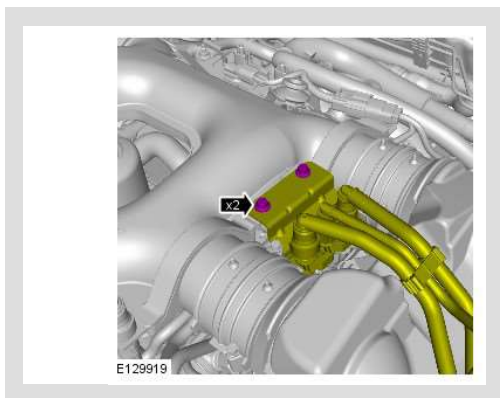
9.

**⚠ CAUTION:**

Take extra care not to damage the component.

*Torque: 10 Nm*

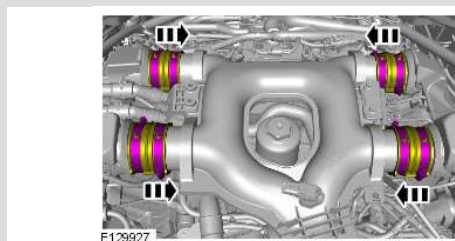
12.

*Torque: 4 Nm*

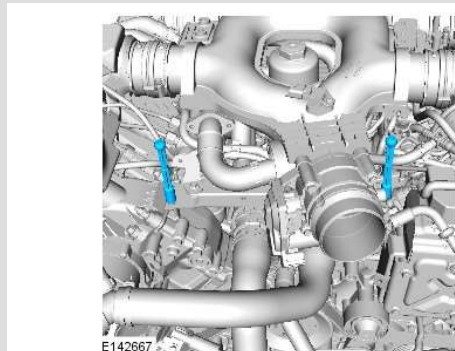
13.

*Torque: 2 Nm*

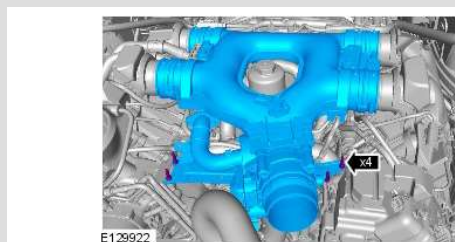
14.

**⚠ CAUTION:**

Make sure that all openings are sealed. Use new blanking caps.

*Torque: 10 Nm*

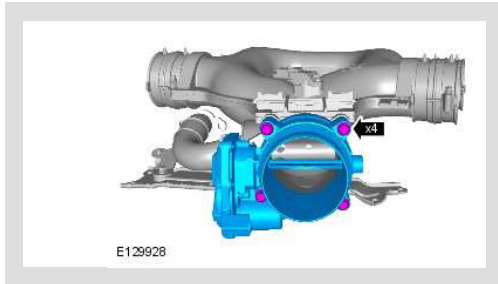
15.

**⚠ CAUTION:**

Make sure that all openings are sealed. Use new blanking caps.

**△ NOTE:**

Do not disassemble further if the component is removed for access only.

*Torque: 12 Nm*

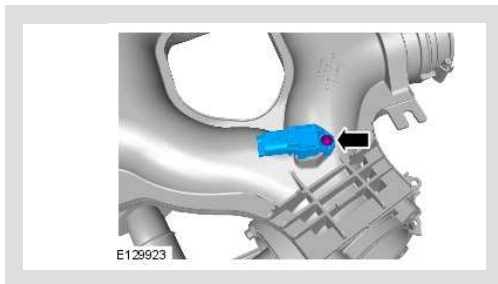
16.

**⚠ CAUTION:**

Make sure that all openings are sealed. Use new blanking caps.

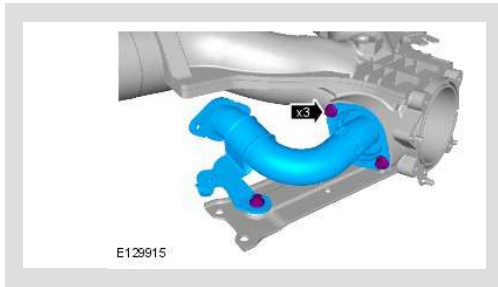
18.

**⚠ CAUTION:**

Make sure that all openings are sealed. Use new blanking caps.

*Torque: 10 Nm*

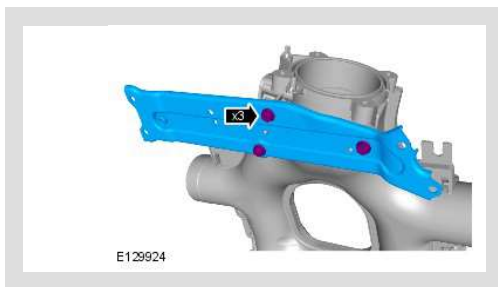
19.

*Torque: 10 Nm*
