Connector: **C0237**

Description: **Heated seat-LH**

Location: **Beneath front seat**

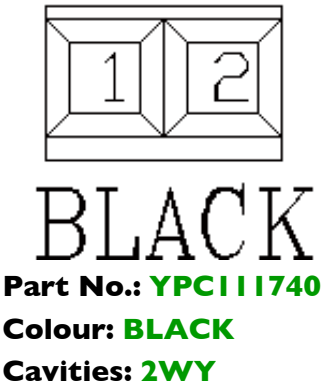
Qualifier: **RH side illustrated LH side similar**

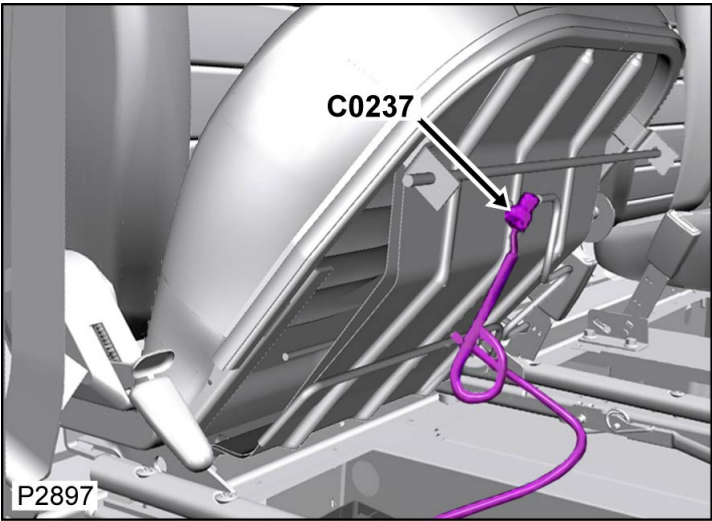
Harness: **SEAT LINK HARNESS**

CAV	TERMINAL	CSA	COL	CCT	DESTN
1	YPL101910	0.75D	US	56	C0751
2	YPL101910	0.75D	B	56	C0751
