Connector: **C1661**

Description: **Ground point**

Location: **Lower LH front of engine compartment**

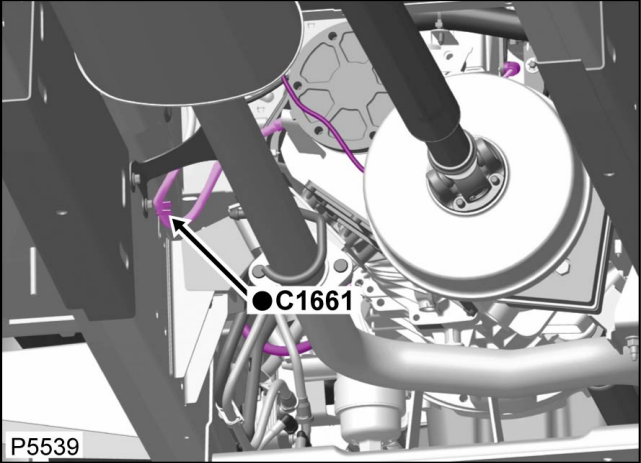
Part No.: **YPG900050**

Colour: **TIN PLATED**

Cavities: **IWY**

Harness: **BATTERY NEGATIVE HARNESS**

CAV	TERMINAL	CSA	COL	CCT	DESTN
I	-	50.0D	B	499	C0045
I	-	50.0D	B	499	C3307

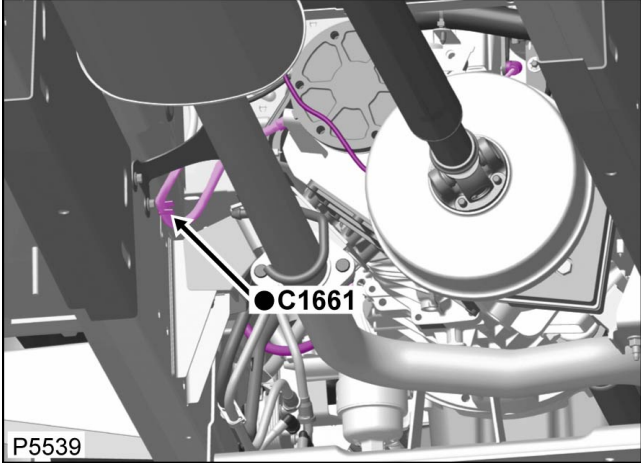
Connector: **C1661**

Description: **Ground point**

Location: **Lower LH front of engine compartment**

Part No.: **YPG900050**

Colour: **TIN PLATED**

Cavities: **IWY**

Harness: **BATTERY NEGATIVE HARNESS**

CAV	TERMINAL	CSA	COL	CCT	DESTN
I	-	50.0D	B	499	C0045
I	-	50.0D	B	499	C3307
