Connector: **C1661**

Harness: **BATTERY NEGATIVE HARNESS**

Description: **Ground point**

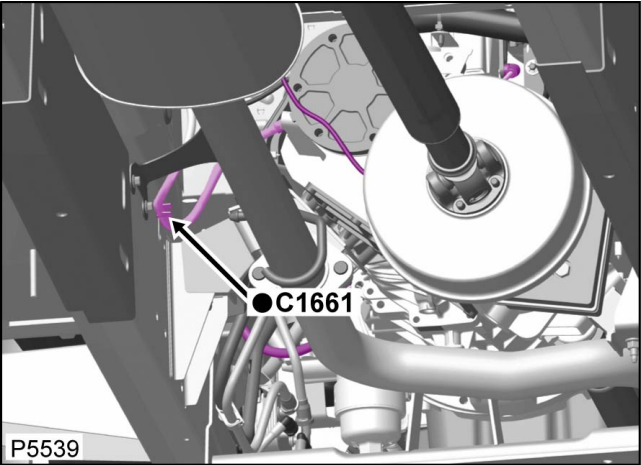
Part No.: **YPG900050**

Location: **Lower LH front of engine compartment**

CAV	TERMINAL	CSA	COL	CCT	DESTN
I	-	50.0D	B	499	C0045
I	-	50.0D	B	499	C3307

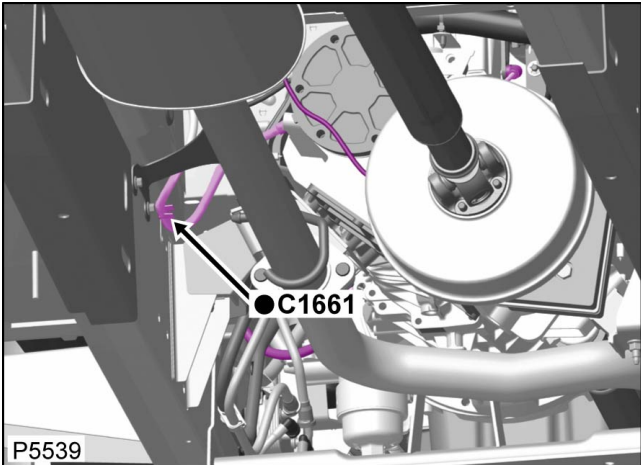
Connector: **C1661**

Part No.: **YPG900050**

Harness: **BATTERY NEGATIVE HARNESS**

Description: **Ground point**

Location: **Lower LH front of engine compartment**

CAV	TERMINAL	CSA	COL	CCT	DESTN
I	-	50.0D	B	499	C0045
I	-	50.0D	B	499	C3307
