Connector: **C0361**

Part No.: **YPG900270**

Harness: **MAIN LH + RH HARNESS**

Description: **Earth-Radio**

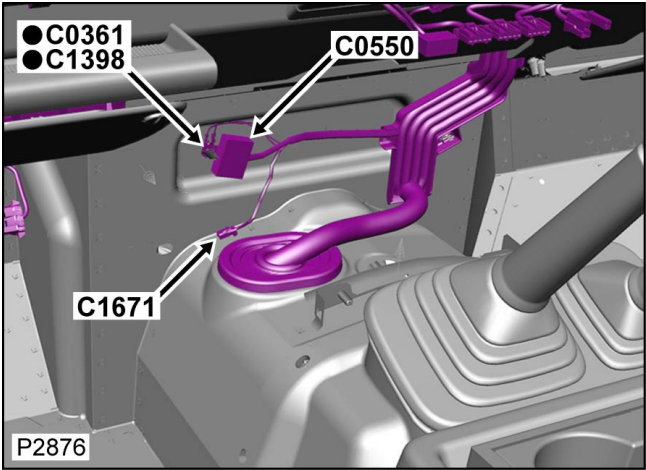
CAV	TERMINAL	CSA	COL	CCT	DESTN
I	-	I.0D	B	499	C0098

Location: **Behind center of Instrument panel**

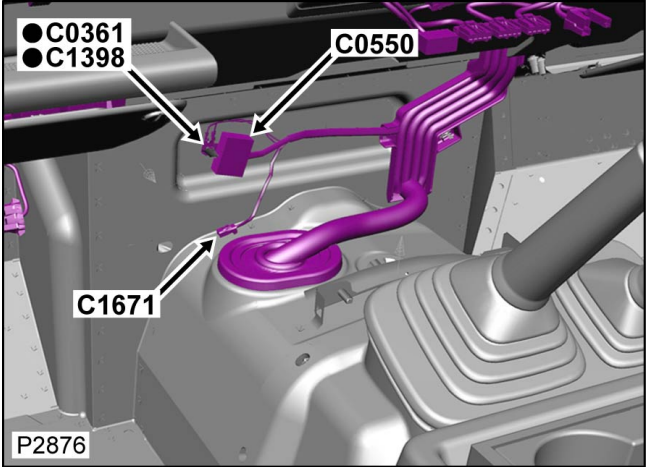
Connector: **C0361**

CAV	TERMINAL	CSA	COL	CCT	DESTN
I	-	I.0D	B	499	C0098

Description: **Earth-Radio**

Location: **Behind center of Instrument panel**
