Full Service Schedule

Job No: MWJ104141

LAND ROVER DEFENDER 110 2.5L DIESEL 2006 VAN
Mileage: 118005

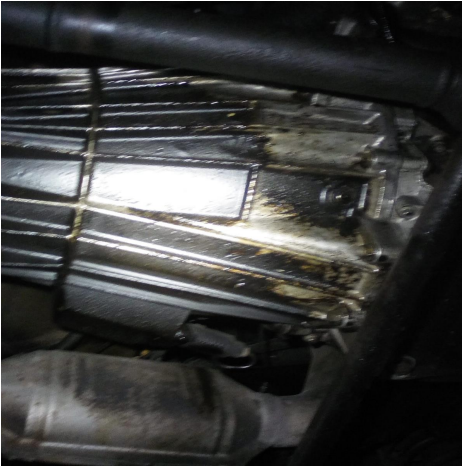
Fig 1 - Supporting Image Check / advise general oil leaks

Check / advise general oil leaks	Amber	●
	(See fig 1)	
Top up antifreeze if required	Amber	●
	Notes: Coolant low topped up.monitor.	
Check coolant hoses for leaks and condition, incl. header tank	Amber	●
	Notes: Topped up	
Check condition and tension of auxiliary drive belts (excl. timing belt)	Amber	●
	Notes: Cracked	
Check timing belt replacement interval & report if due according to mileage/age	Red	●
	Notes: Not in book

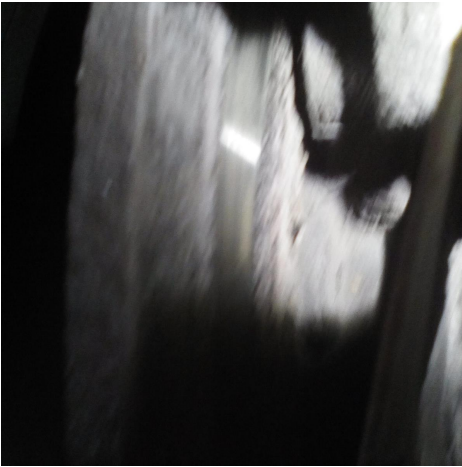
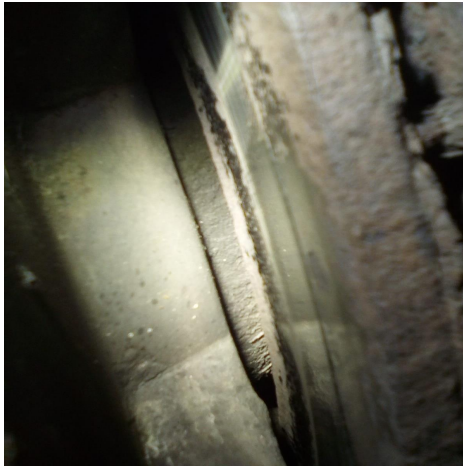
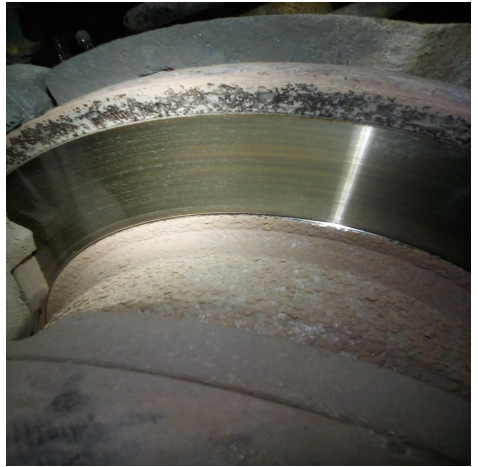
Fig 2 - Supporting Images Visual check of brake discs, shoes and cylinders for wear or damage

Top up brake fluid if required	Amber	●
	Notes: Next year	
Visual check of brake discs, shoes and cylinders for wear or damage	Amber	●
	(See fig 2)	
	Notes: Rear N\S disc uneven ware	
	Front discs uneven ware

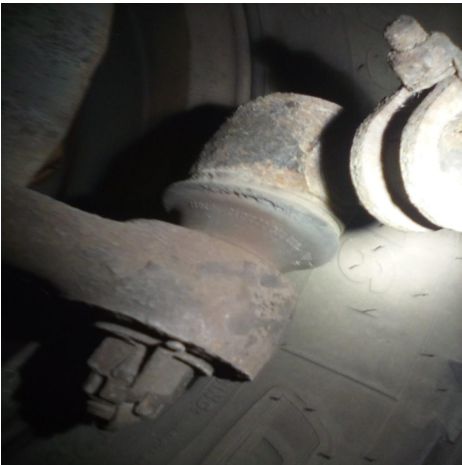
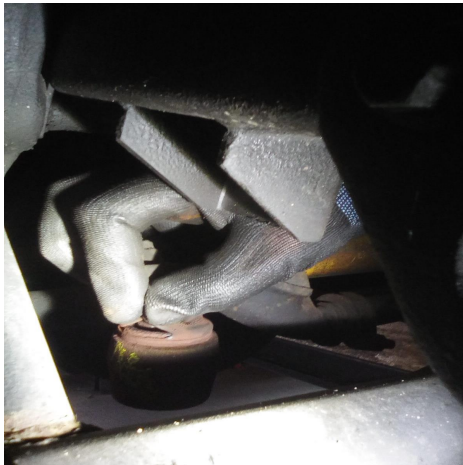
Fig 3 - Supporting Images Check steering / suspension components for wear and corrosion

Check steering / suspension components for wear and corrosion

(See fig 3)
Notes: Track rod ball joint has play at n\S and I\S and boots are split
Play in steering box

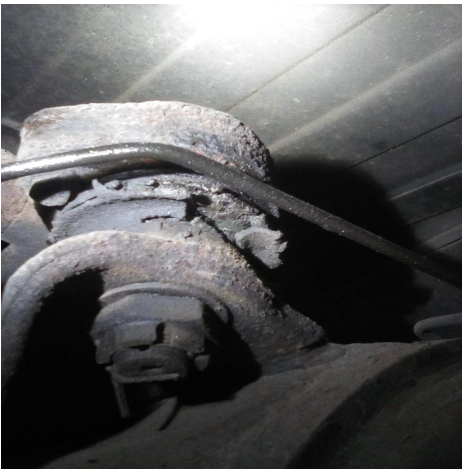
Fig 4 - Supporting Image Check gear box fluid level manual / automatic differential (If applicable)

Check	Result
	<div>Red</div>
Check gear box fluid level manual / automatic differential (If applicable)	(See fig 4) Notes: Rear diff bushes deteriorated Advise oil change for front and rear diff
